Landmarks Certificate of Appropriateness & Overlay District Permit

| Louisville Metro Planning & Design Services | | | | | |
|--|---|--|--|--|--|
| Project Name: Conti Carriage House RECFIVED |) | | | | |

Existing Garage Structure 2026 Midland Avenue Rear Louisville, Kentucky AUG 2 0 2018
PLANNING &
DESIGN SERVICES

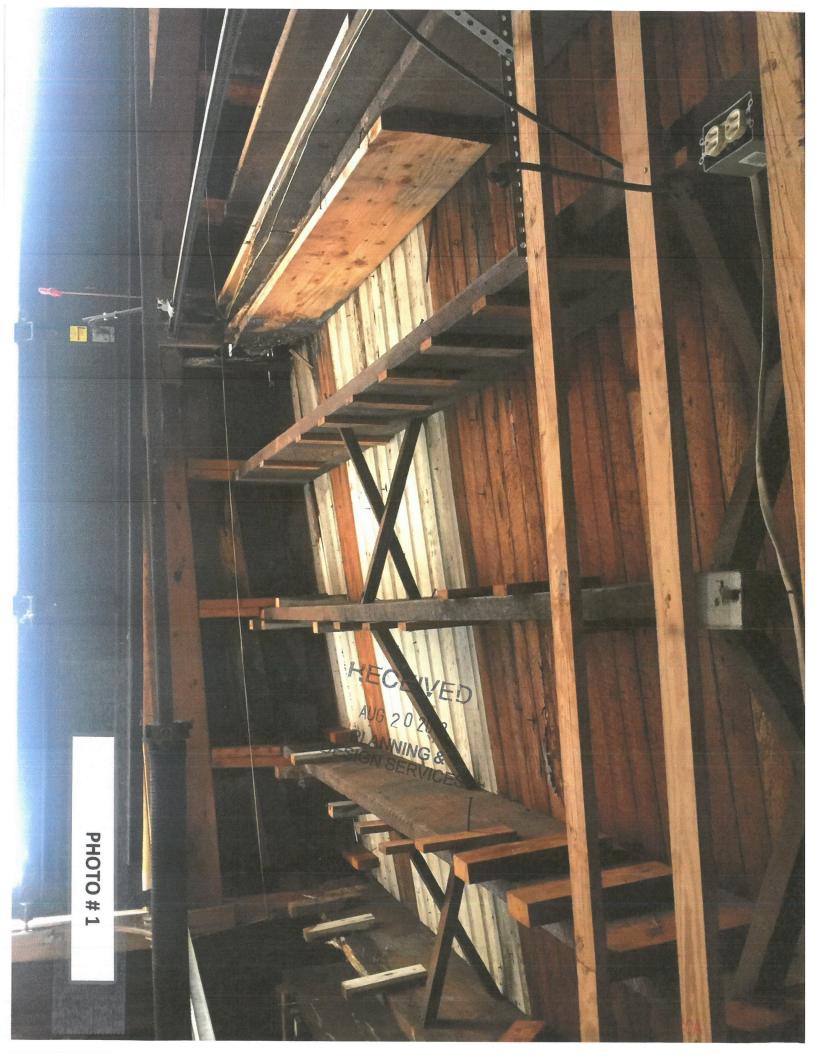
2. The interior of the existing structure at the location of the overhead door (photos 1, 2, 3, & 4) has sustained fire damage that has resulted in a weakening of the roof and overhead door frame in this area.

It is our opinion that the structure in its present condition is unsafe for entry and use. The repair/rehabilitation of the structure is impractical due to the observed structural defects, lack of structural stability (current day shifting of the structure) and the overall deterioration of the existing building components. Our recommendation is that the entire structure be demolished.

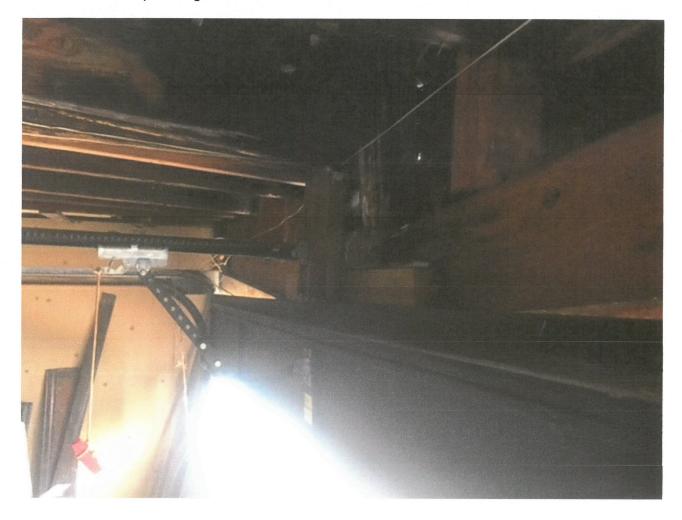
PHOTO #5

Our second visit to the property confirmed that the framing for the overhead door and the roof structure within this area has experienced additional downward movement in the several weeks since our initial visit. Photo # 5 taken during our second visit shows the garage door header resting on the top of the garage door. Coincident with the failure of the garage door header and the sagging roof the corners of the structure now reflect a "Bow" inward.

This is a photo showing the header and roof now resting on the door if you need it. Can I get the letter tomorrow so I can schedule the city meeting?

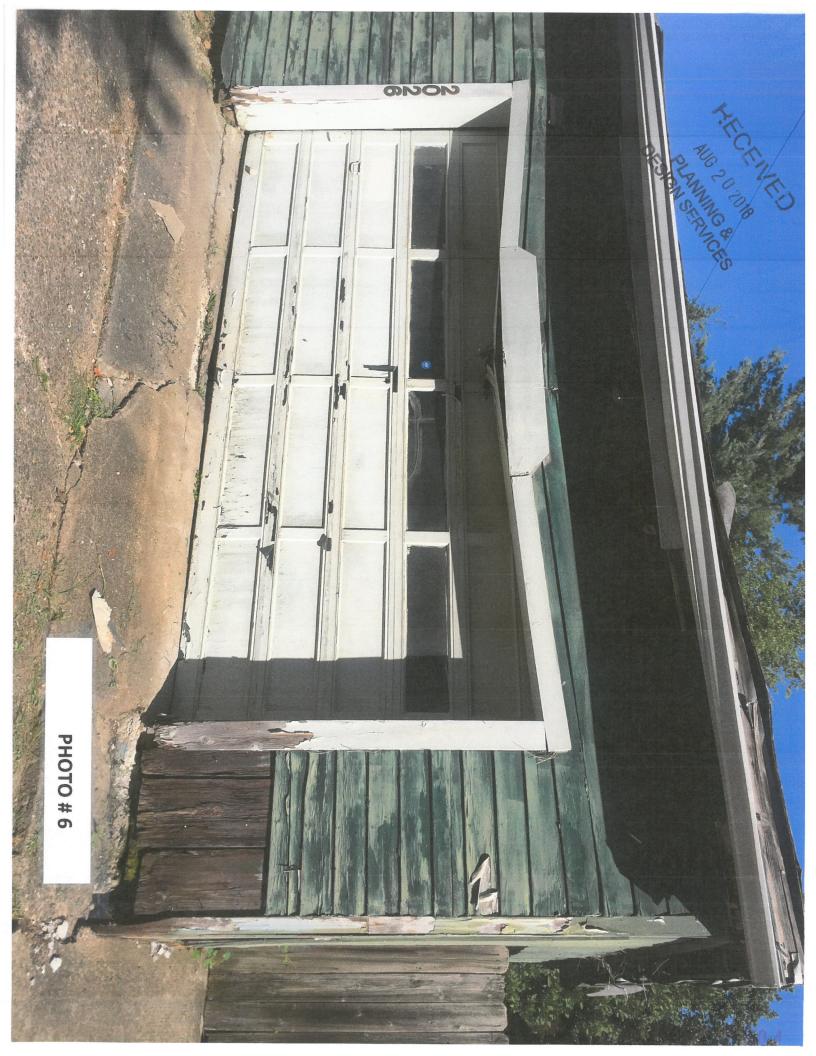
- 3. The exterior of this structure exhibits deterioration in virtually all areas:
 - a. The exterior view of the garage door and roof (photos 5, & 6) indicate clearly the deteriorated condition of the door frame and roof cornice above the door. This sagging roof condition has worsened during the several weeks since our initial visit.
 - b. The condition of the building walls on either side of the overhead garage door (phots 7 & 8) evidence the deteriorated condition of the outer walls as well as the fact that these walls are not supported by any type of building foundation.
 - c. The condition of the end wall (west facing) and rear walls (North facing) also exhibit severe visible deterioration (phots 9, 10, & 11) as well as a lack of foundation support for the walls.
