Landmarks Certificate of Appropriateness & Overlay District Permit Louisville Metro Planning & Design Services

Re: Structural Review

1737 Payne St.

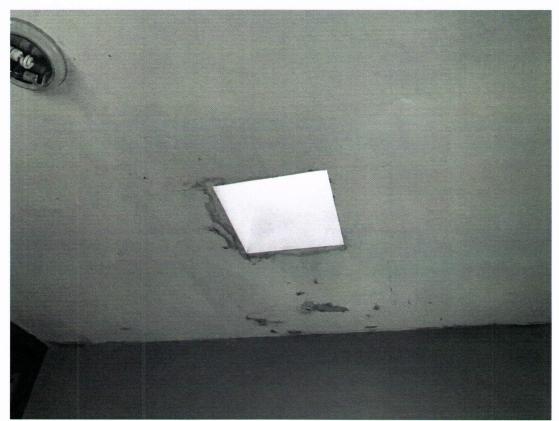
While the majority of wall and roof framing was not visible during our inspection is should be noted that there was evidence of water infiltration as seen in the water staining in ceiling. Roof framing located above the side door was not framed in accordance with current building codes and showed signs of disrepair. With the evidence of termites in the floor framing it should be noted that there is a good possibility of other hidden areas of termite damage.

Water staining and damage to existing ceiling.

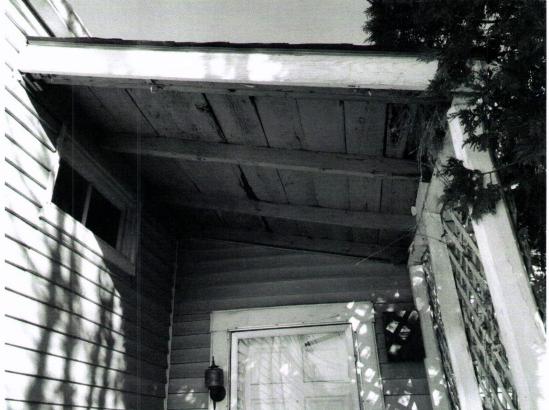
Side door porch roof framing.
