**Landmarks Certificate of Appropriateness & Overlay District Permit**

Case No.: 18COA-1305 Intake Staff: NH

Project Name: Repair of roof rain water drainage systems.

Project Address / Parcel ID: 1201 S. 3<sup>rd</sup> St., Louisville, KY / 032800110000

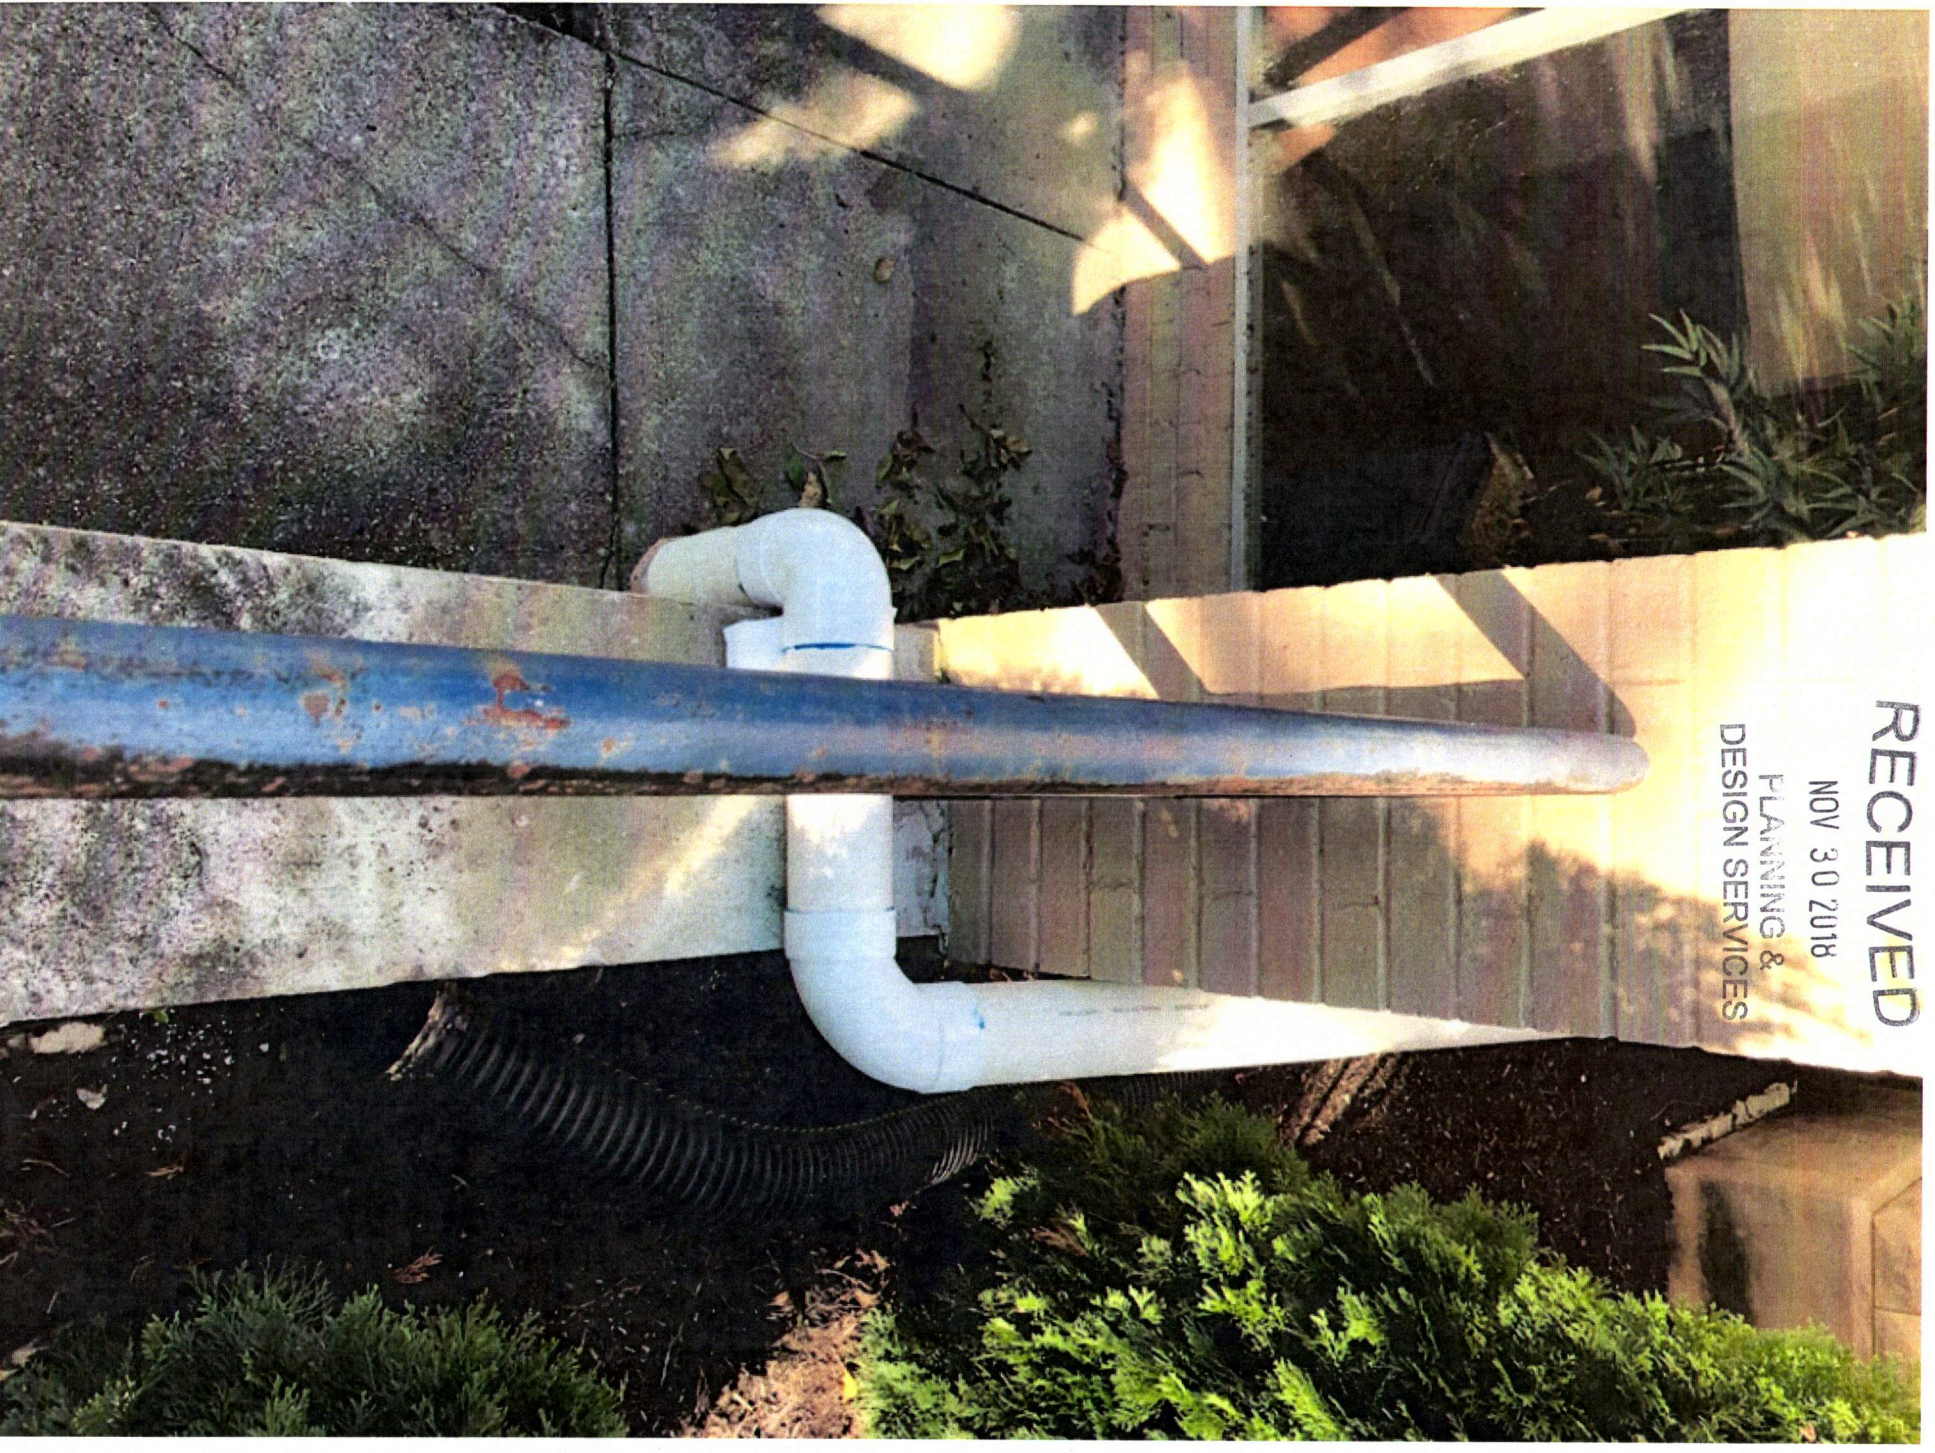
In regards the color of paint to be used for both water drainage systems, I would suggest a grey color as on the original destroyed downspout (see photo - Original Downspout Color). I will use the color that you recommend and would appreciate you recommending the color of paint that you want us to use.

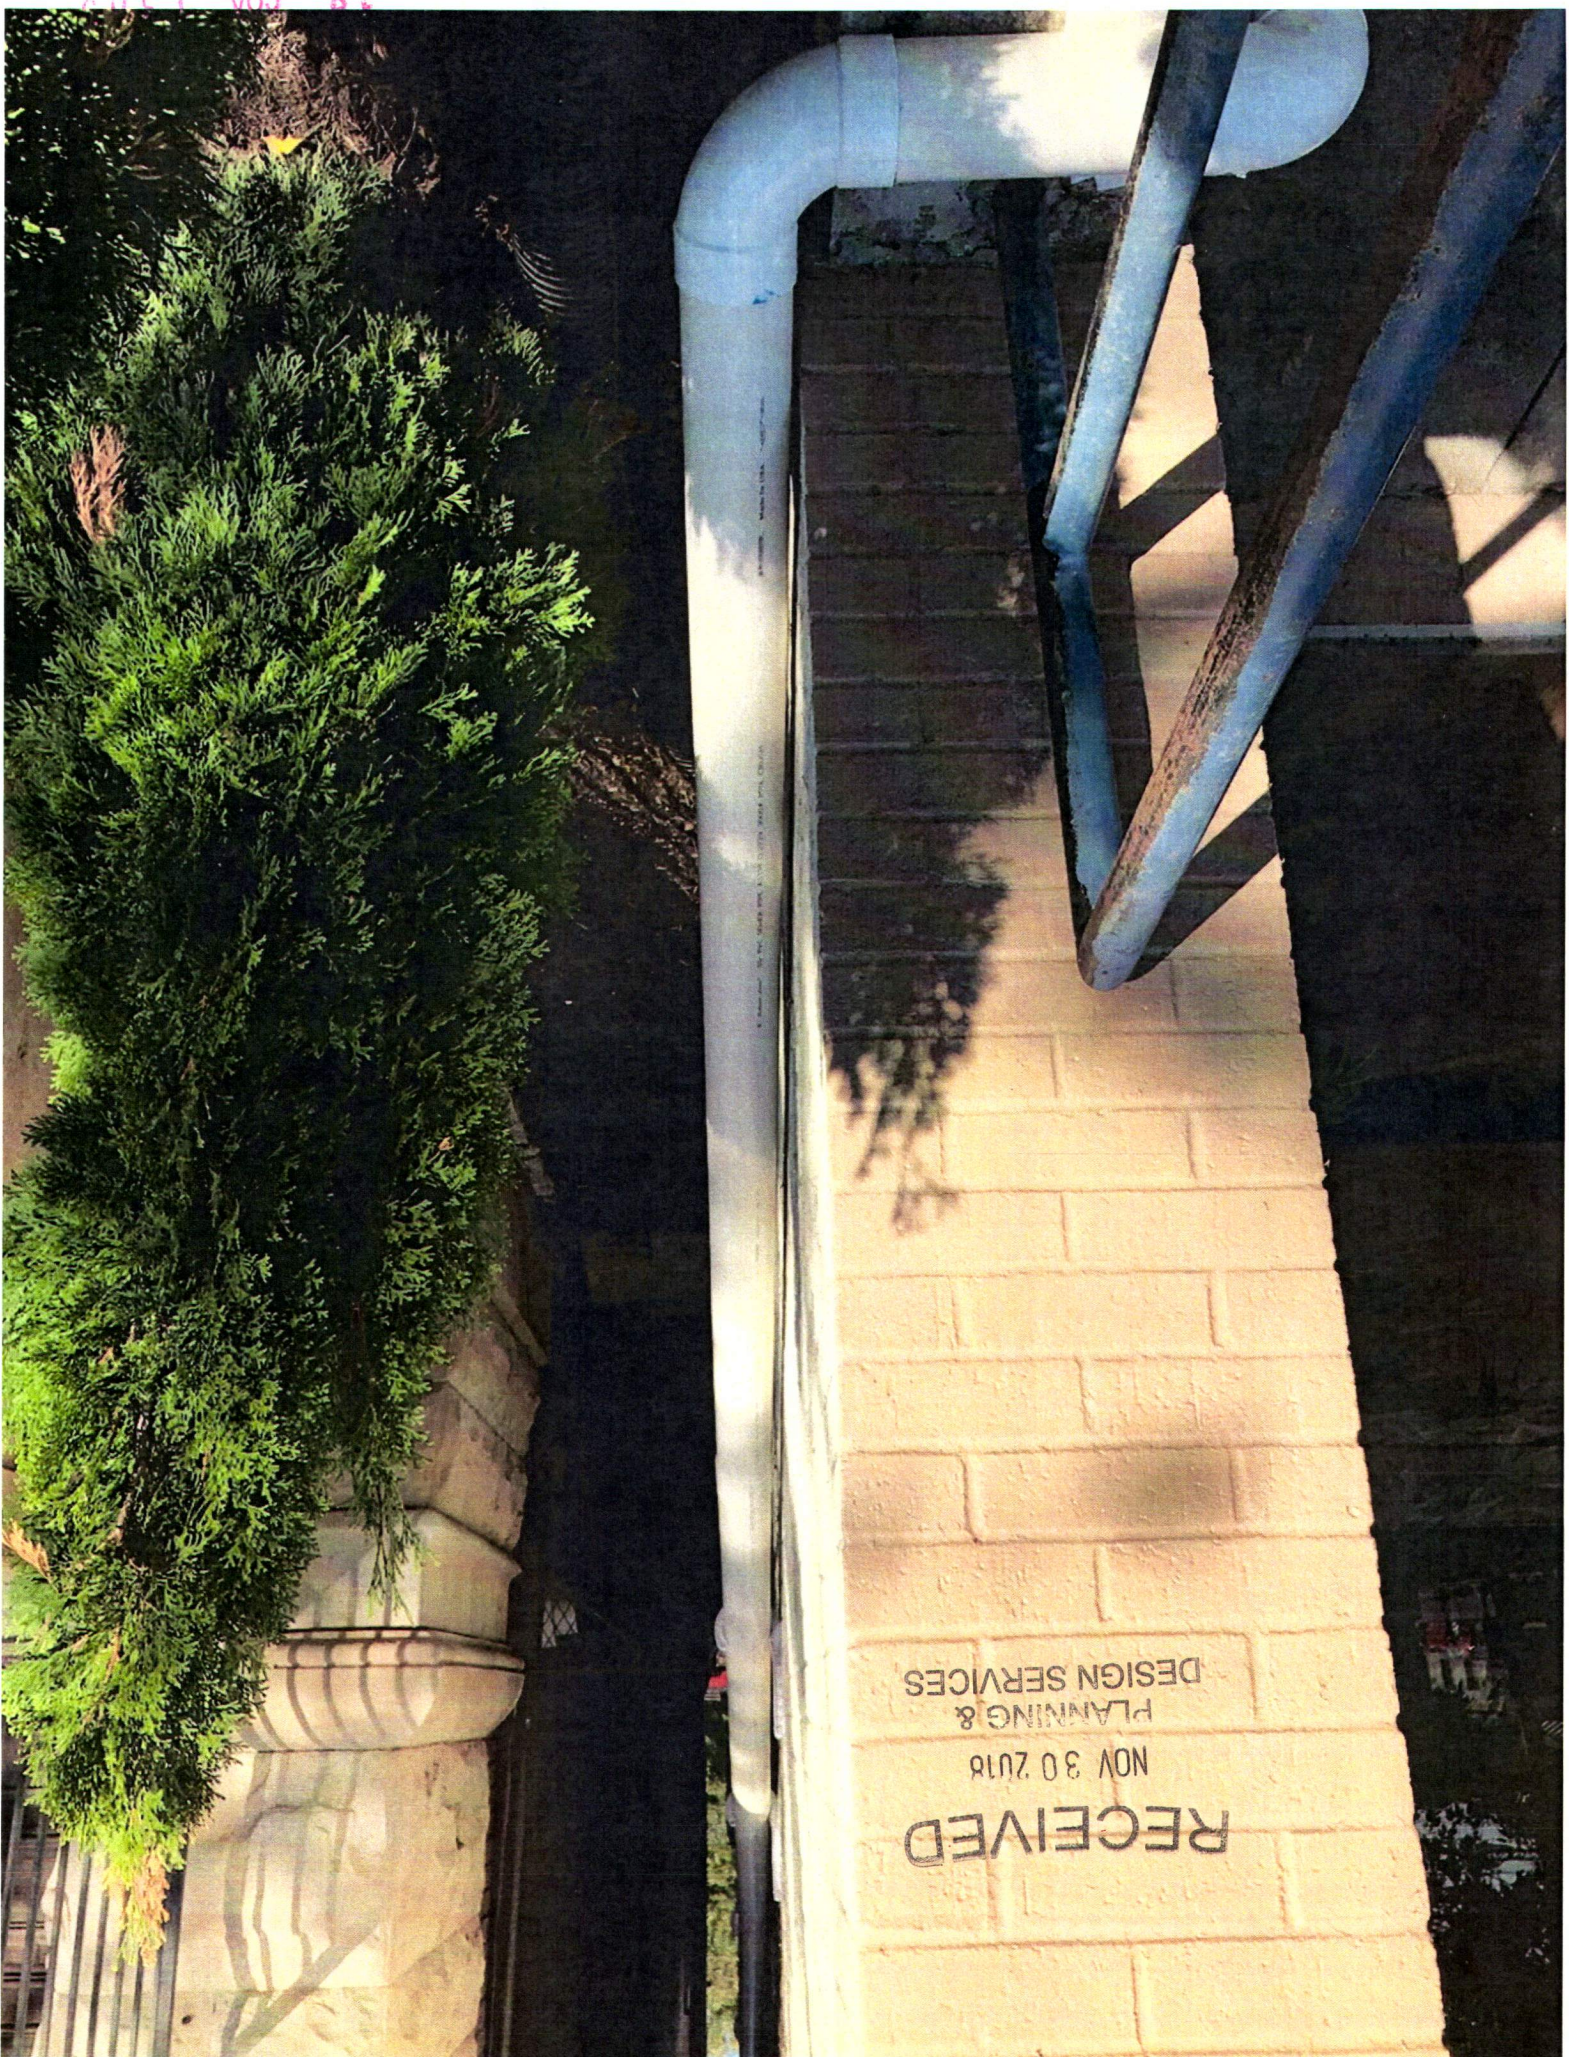
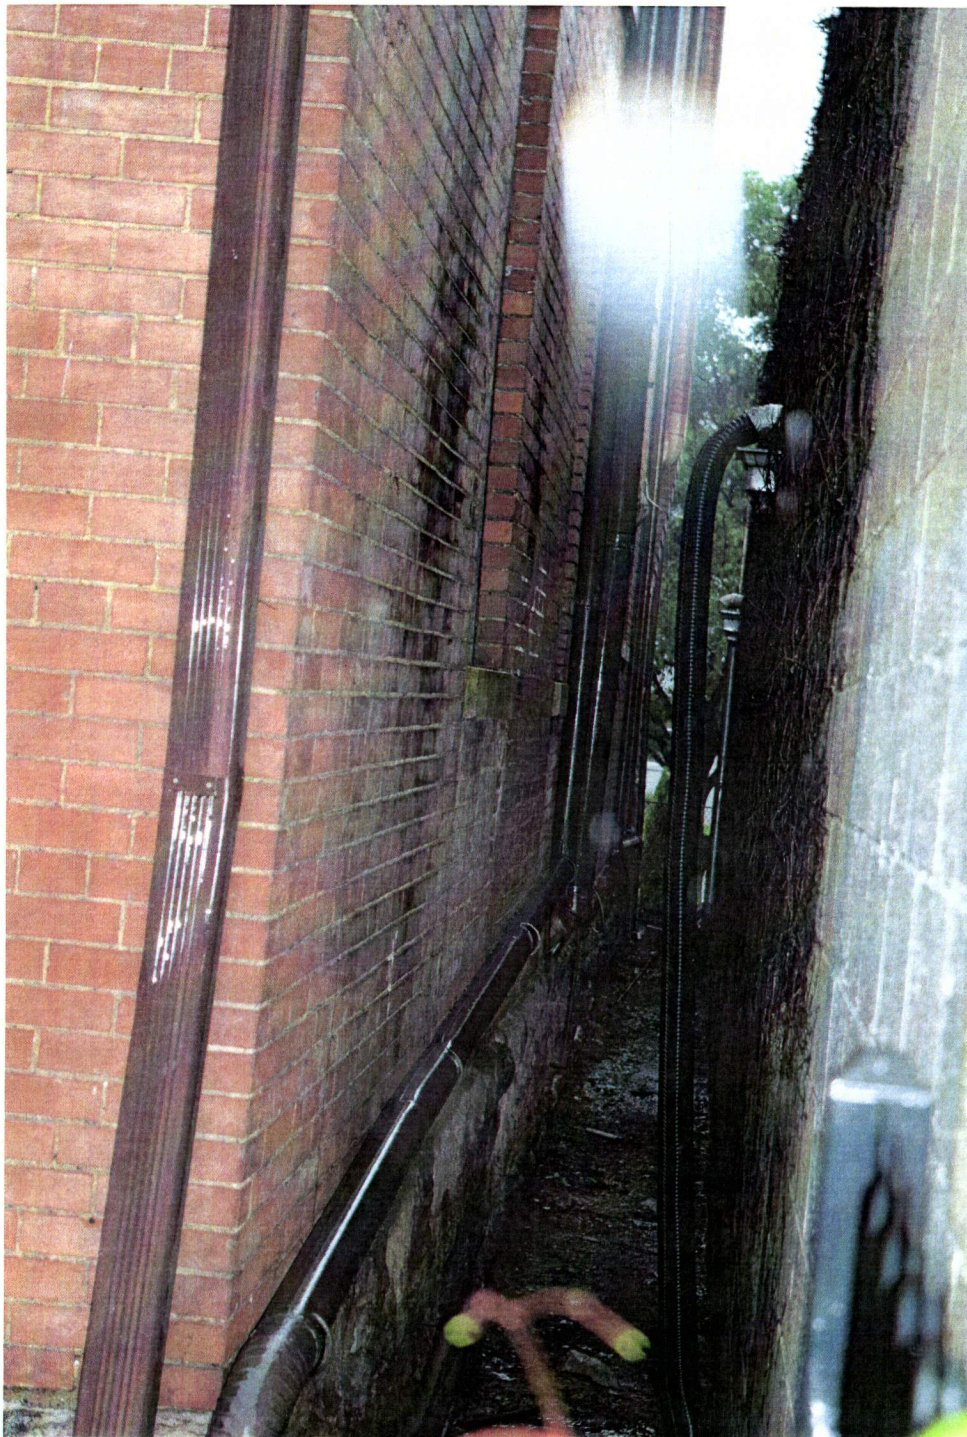
Please see the photos (West Drainage System 1, 2, and 3) of the repaired West water drainage system as it now stands. This presently constructed West water drainage system consists of 4 inch diameter pipes, the same as in the original, damaged water drainage system. The only modification from the original water drainage system is the diagonally sloping downspout pipe instead of a vertical pipe to improve the water drainage. This presently constructed West water drainage system is representative and the example of what I am asking a Certificate Of Appropriateness for regarding both drainage systems. The only thing left to be done on this West water drainage system is to paint it to blend in with the building that it is attached to. This West water drainage system has not been painted and the damaged East water drainage system has not yet been repaired/constructed because the adjacent land owner has now refused me unlimited access to my building's exterior South wall (see below explanation).

In reviewing the attached photos, please note in the West Drainage System 3 photo of the repaired West water drainage system as it now stands that there is a black flexible hose partially buried in the ground. This is no part of the present, repaired water drainage systems I am seeking a Certificate Of Appropriateness for. This said hose is a remnant of my original, destroyed water drainage system that has been drug over on to the adjacent land owners property and partially buried by him. Because of his refusal to let me or my representatives on to his property (see below explanation), I have been unable to remove this unused, discarded hose.

The repaired East water drainage system is to be the same as the repaired West water drainage system illustrated in the attached photos with one exception: The slope of the downspout will be down from West to East, the reverse of the East to West downward slope on the already constructed, repaired West water drainage system. We do intend, at ground level, and as originally constructed, to attach a flexible hose to the bottom end of this repaired East water drainage system to drain the water in to the alley East of my building.

This is the preferred C.O.A. being requested. The proposed redesign and rerouting of the present roof water drainage systems will remove the two roof water drainage systems on the building's exterior South wall (See photos: West Drainage System 1, 2, and 3). The new roof water drainage system will use two roof drains as in the present system. Each drain will be connected at its bottom to a drainage pipe. These two drainage pipes will lie under the roof, inside the building, and out of sight as in the present two systems. Each drainage pipe will then connect to a vertical downspout which will emerge in to outside view through the soffit of the mansard roof and run vertically down to and end at the ground. Both visible downspouts will be made of metal guttering downspout material, colored similar to the downspout guttering on the adjacent old building (See photo: Adjacent Property Downspout Color). The location of both downspouts on either the East, North, and/or West exterior walls of the building will be determined by the contractor hired to complete the job.
