20-COA-0010
1249 Everett Avenue

Cherokee Triangle Architectural Review Committee
Public Hearing

Kat Groskreutz, Historic Preservation Specialist
July 08, 2020

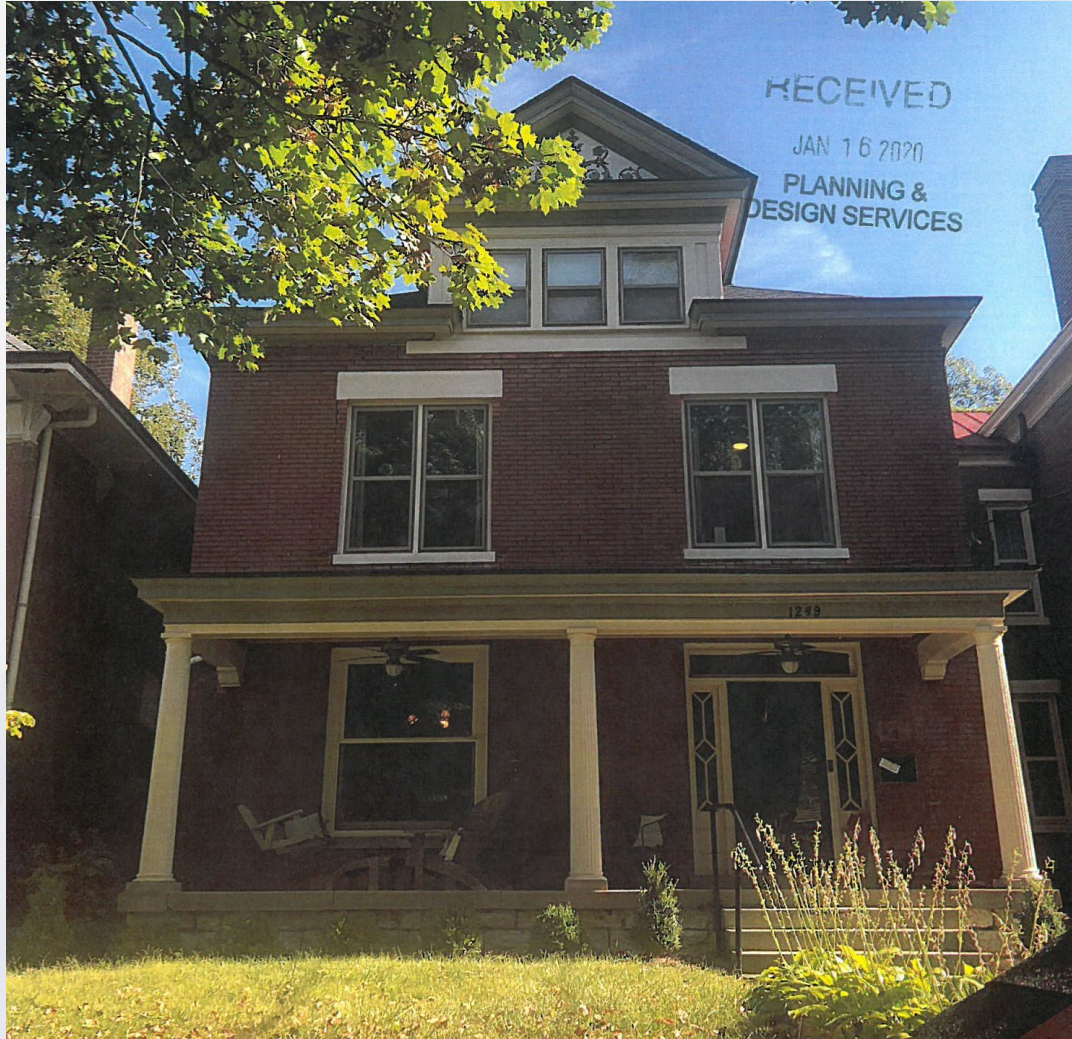
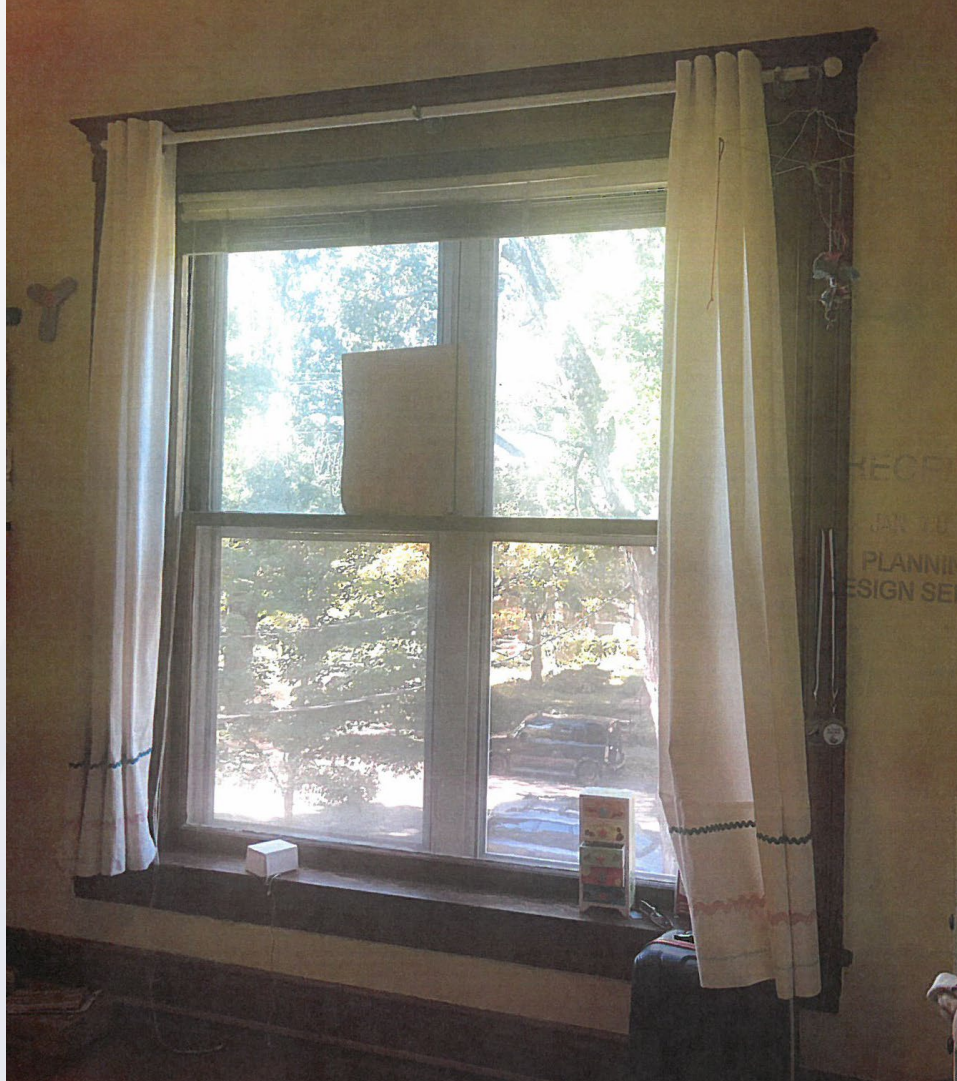
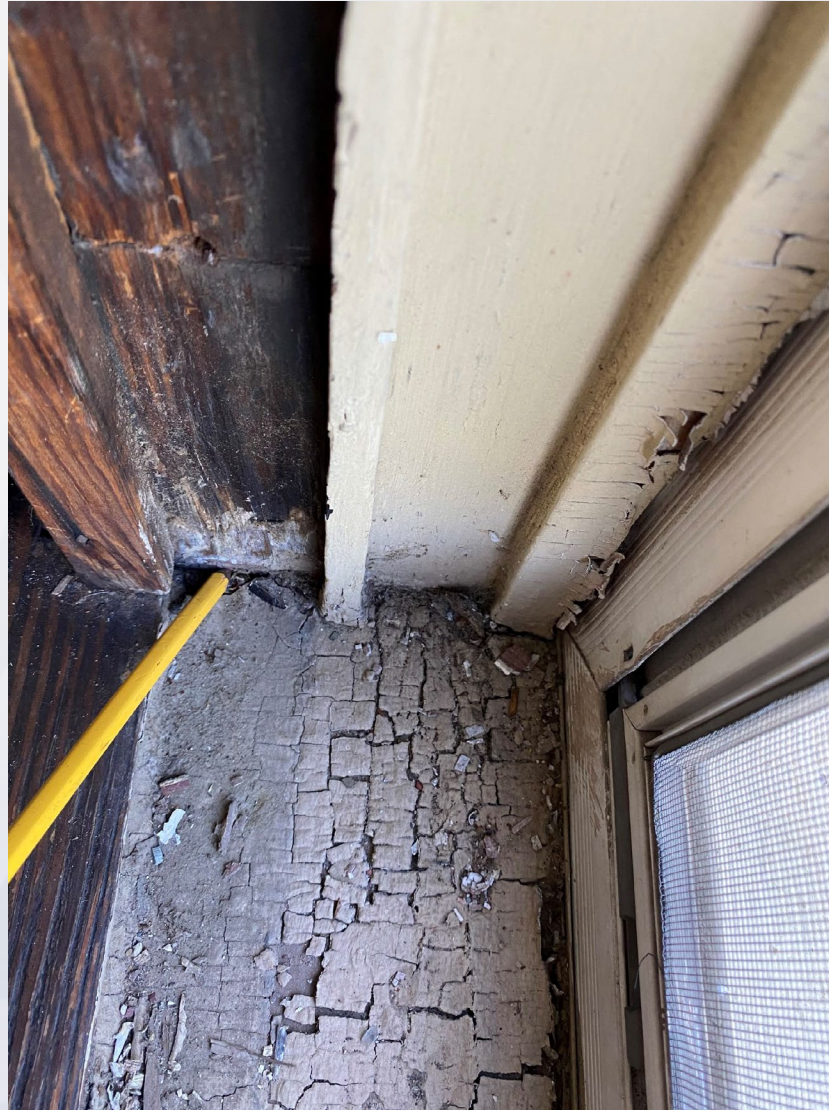
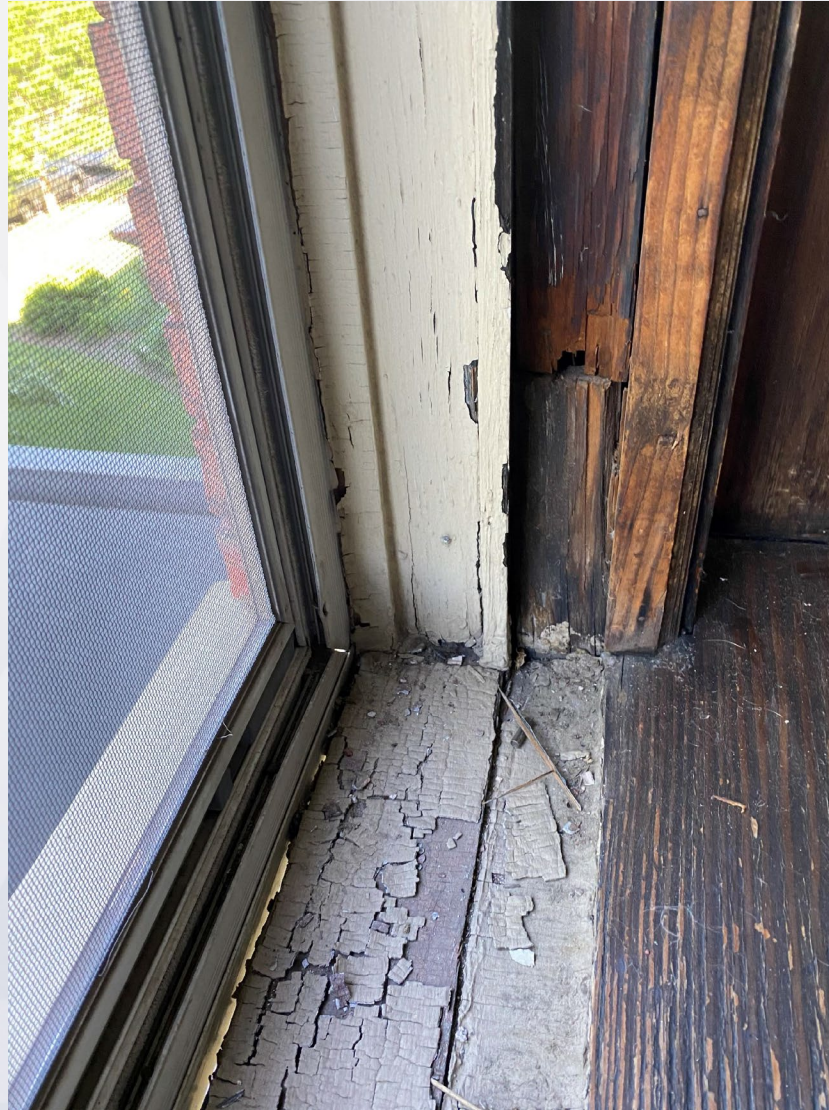
- The interior window sills and the bottom portions of the jambs show some signs of deterioration and water damage.
- There is paint alligatoring on both which is partially obscuring the condition of the wood underneath.
- One of the storm windows is no longer flush with the bottom of one of the windows which may be allowing water into the sill.
- The interior sashes do not appear to be severely deteriorated.

- Staff suggests denial based on the following:
 - Overall, Staff does not find that the windows meet design guideline **W1** for complete replacement.
 - Staff believes the windows fall within Stage Two “Stabilization” or possibly up to Stage Three “Partial Replacement” of the Window Conditions Checklist.
 - The proposed replacement does conform with the applicable Window Design Guidelines **W2; W4; W6; W7; and W10**.
 - If more clear evidence of severe deterioration can be demonstrated, then the proposed replacement windows may conform to the applicable Window Design Guidelines **W1**.

1. The applicant shall use replacement sashes that fit the historic window openings. Original openings should never be blocked-in to accommodate stock windows.
2. The new windows shall match the historic sash dimension, muntin configuration, reveal depths, glass-to-frame ratios, glazing patterns, frame dimensions, trim profiles, and decorative features when repair of original windows is impossible.
3. The Low-E treatment shall not be smoked, tinted, or reflective.
4. If the design or material changes, the applicant shall contact staff for review and approval.
