21-COA-0033

2012 Baringer Ave.

Cherokee Triangle Architectural Review Committee

Public Hearing

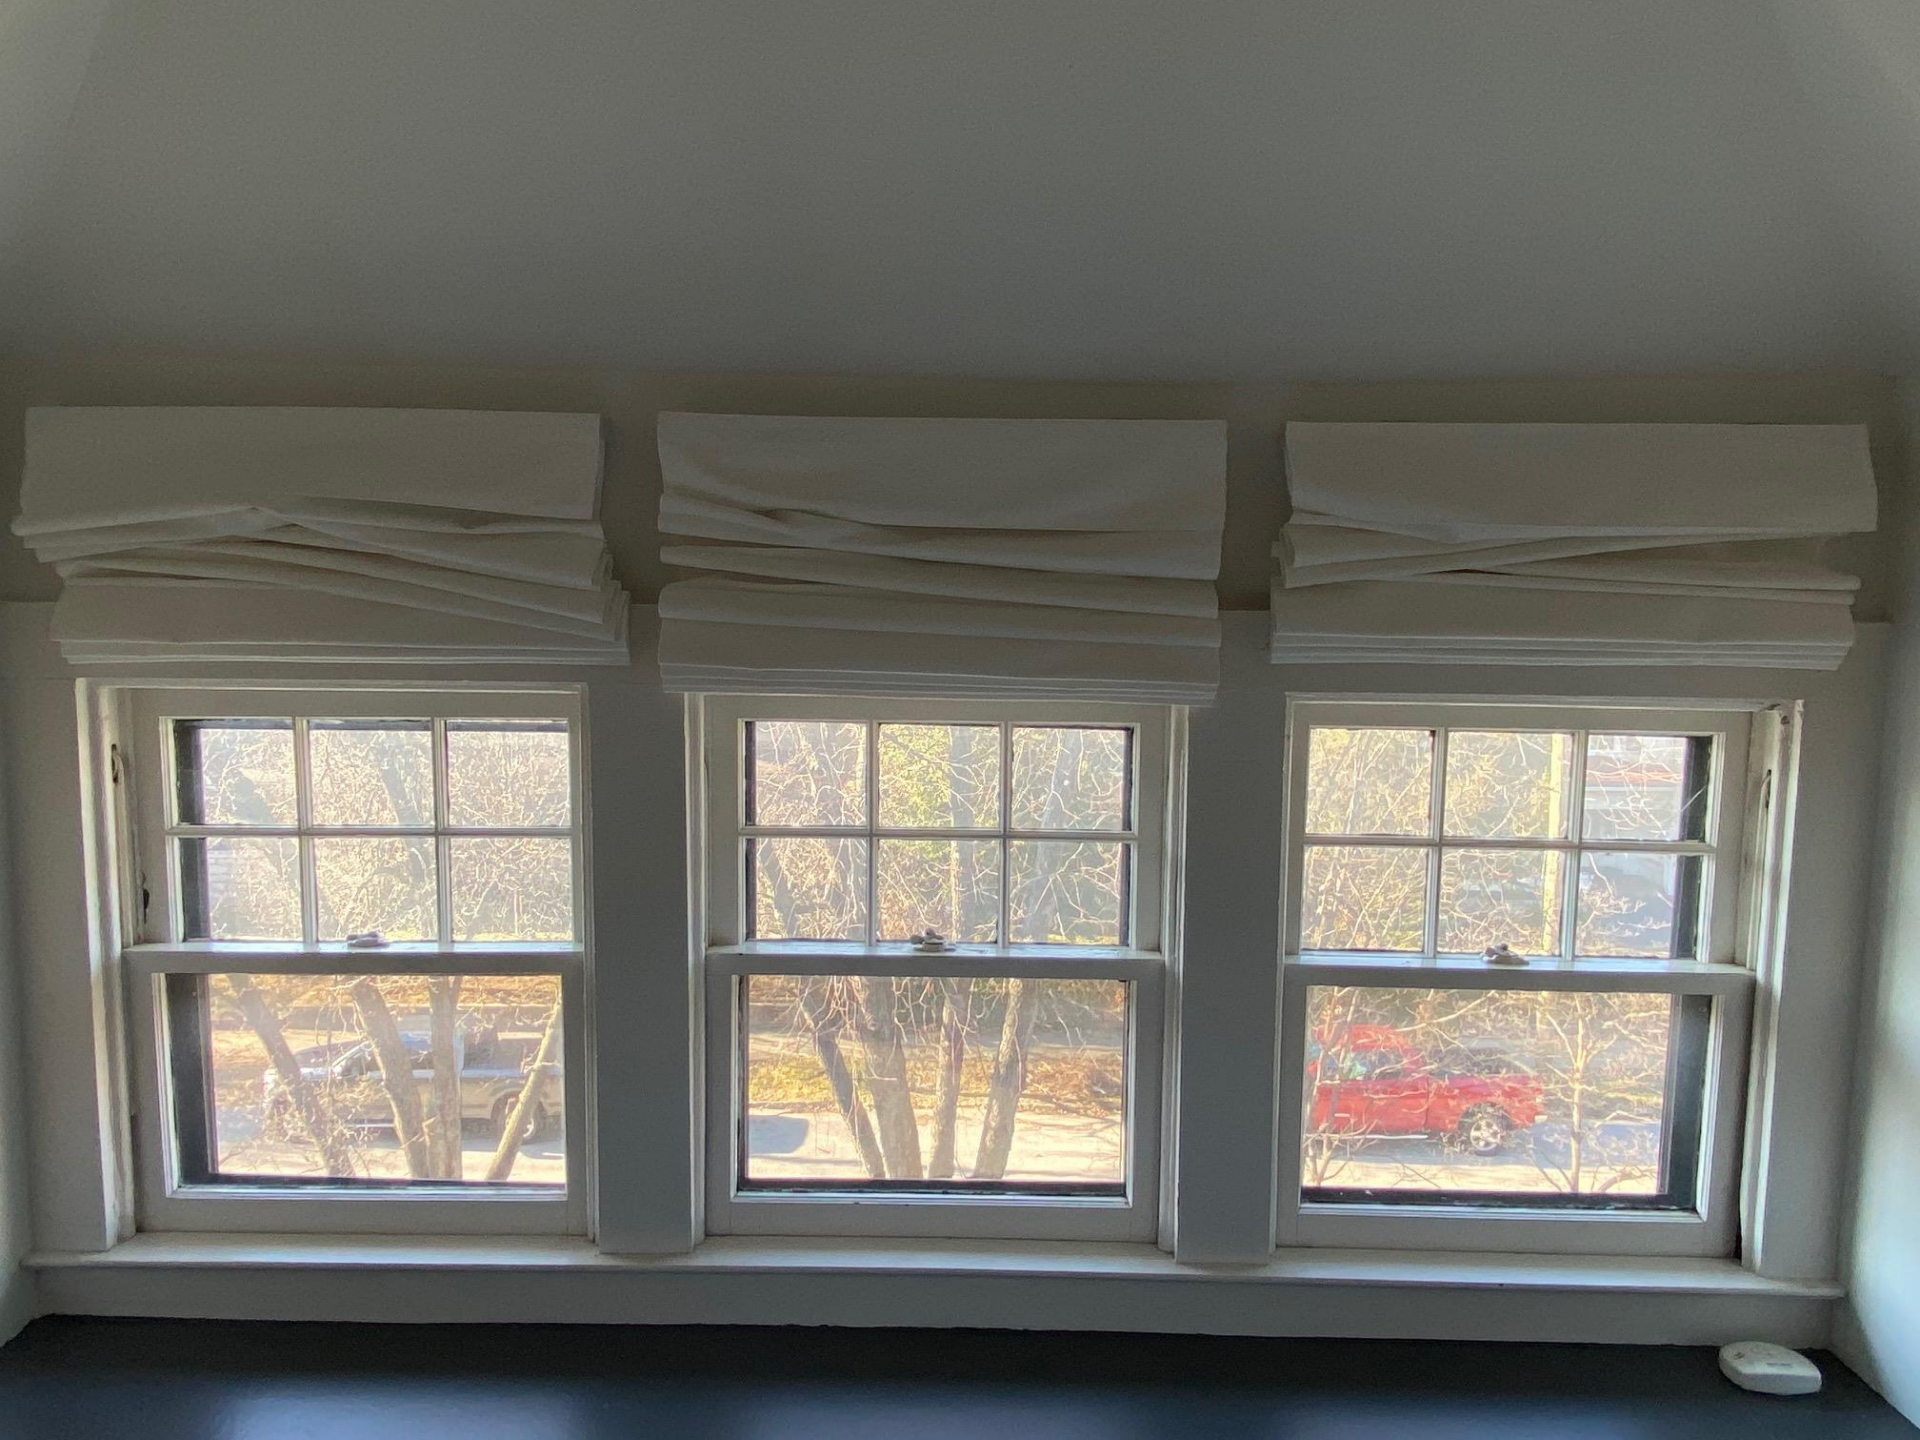
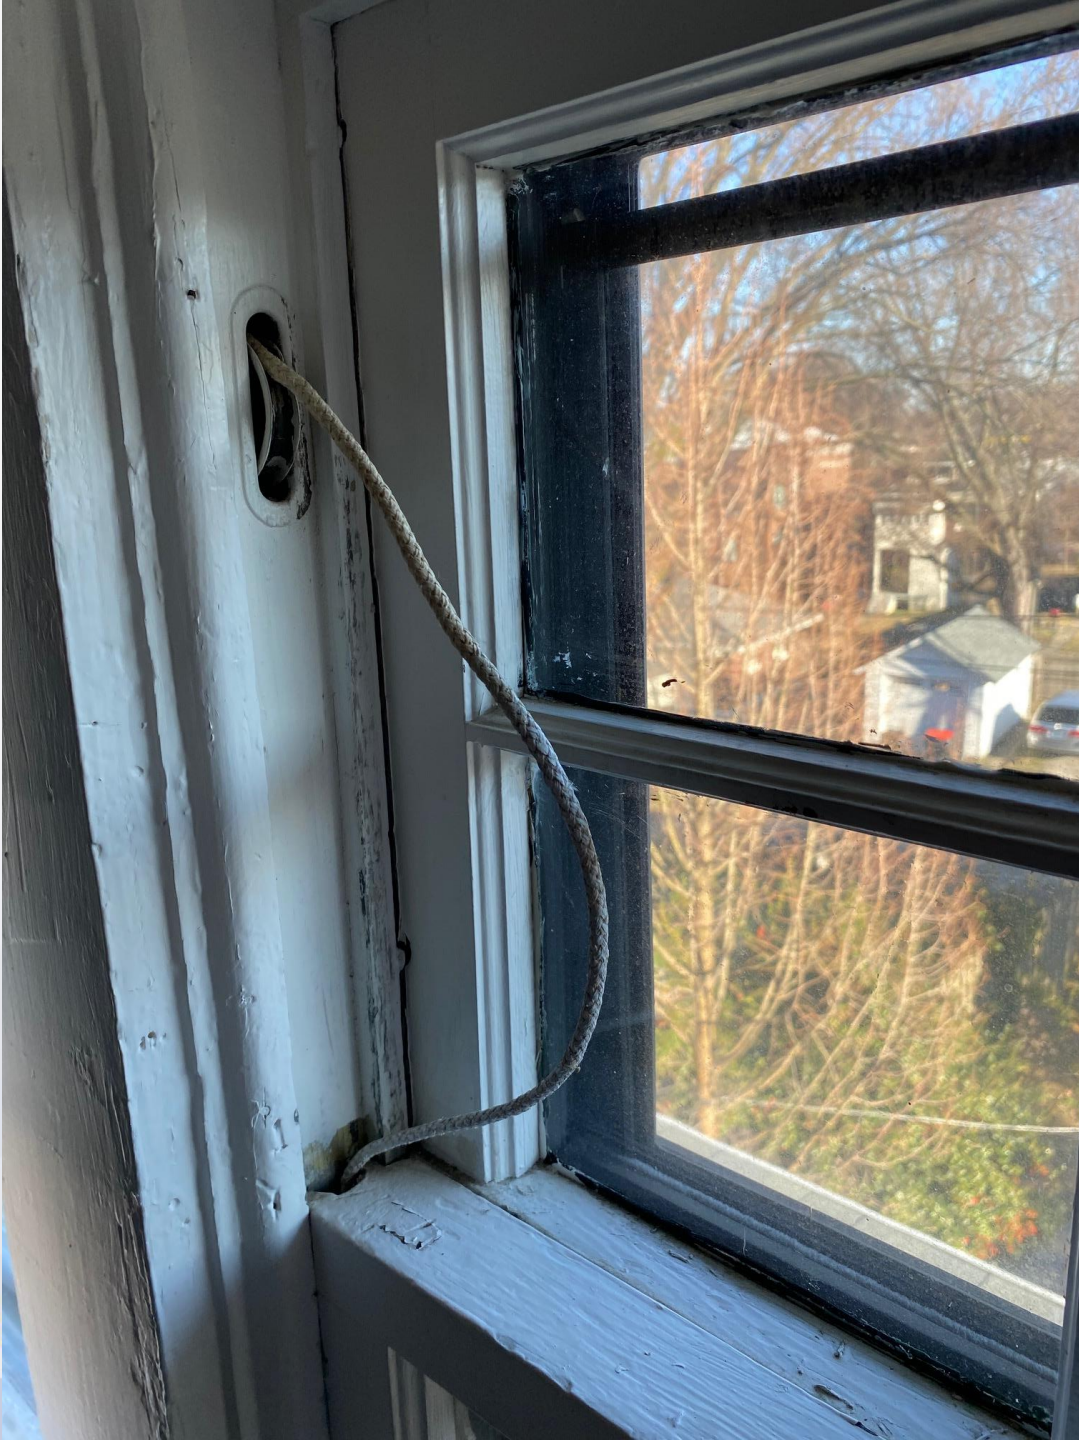
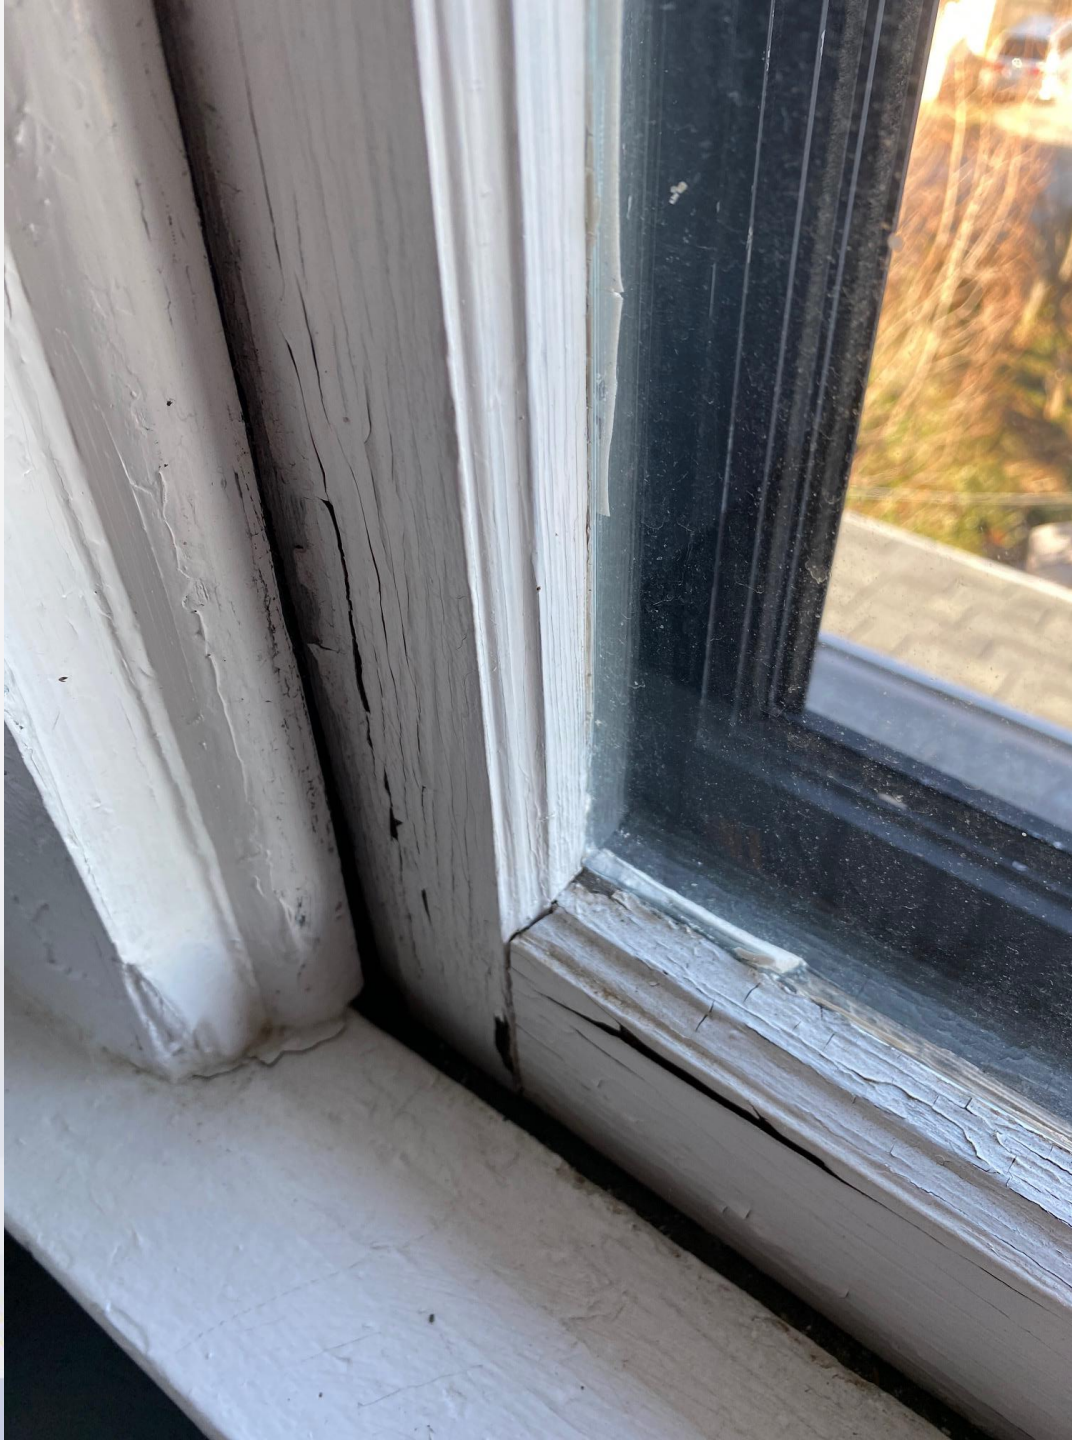
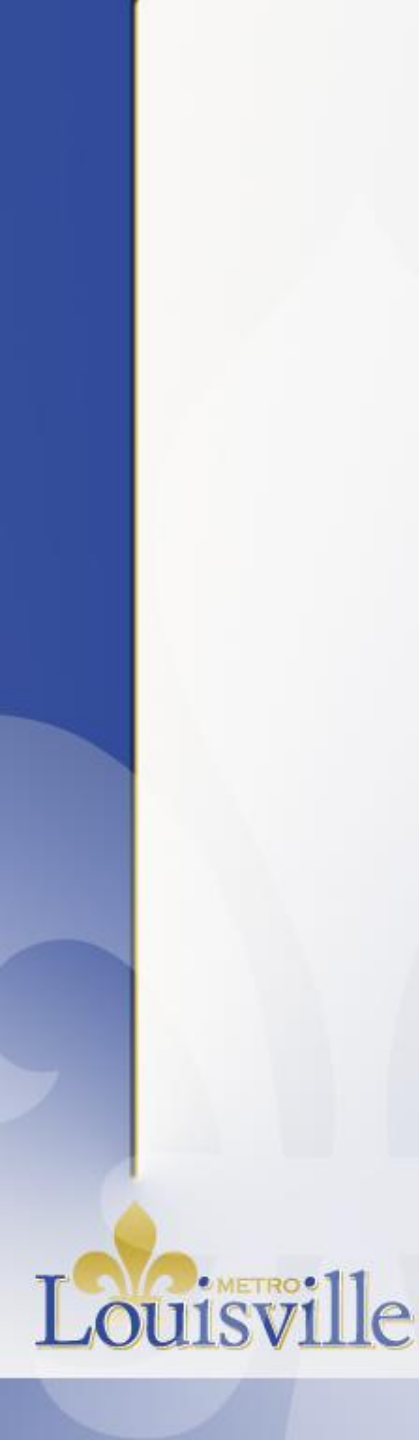
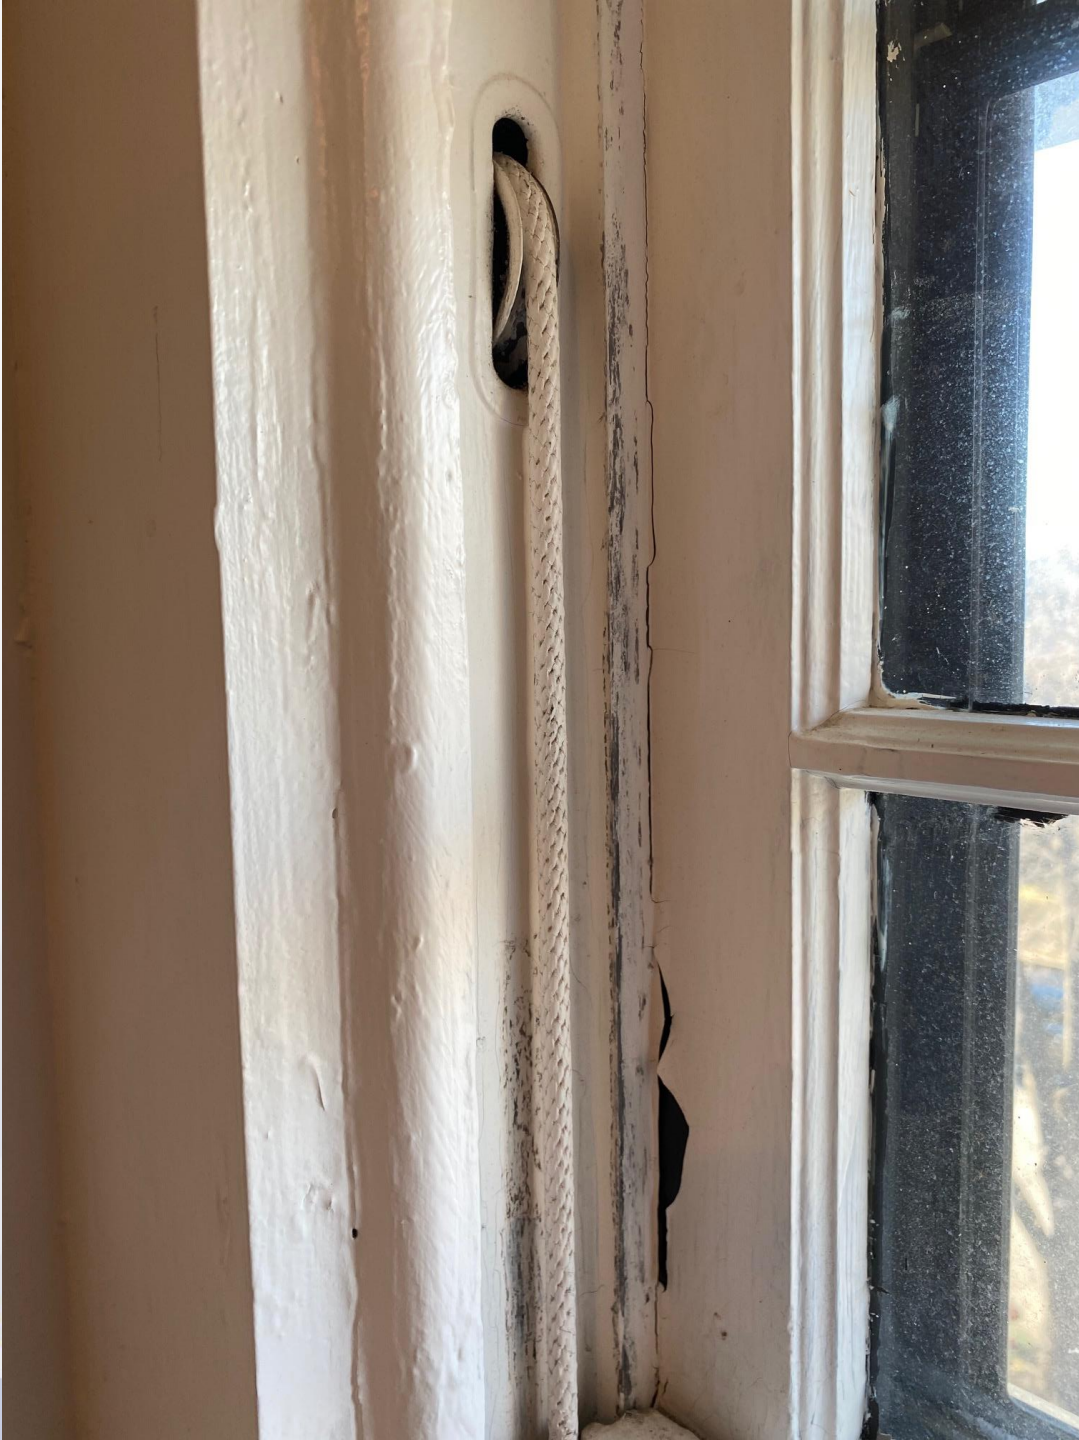
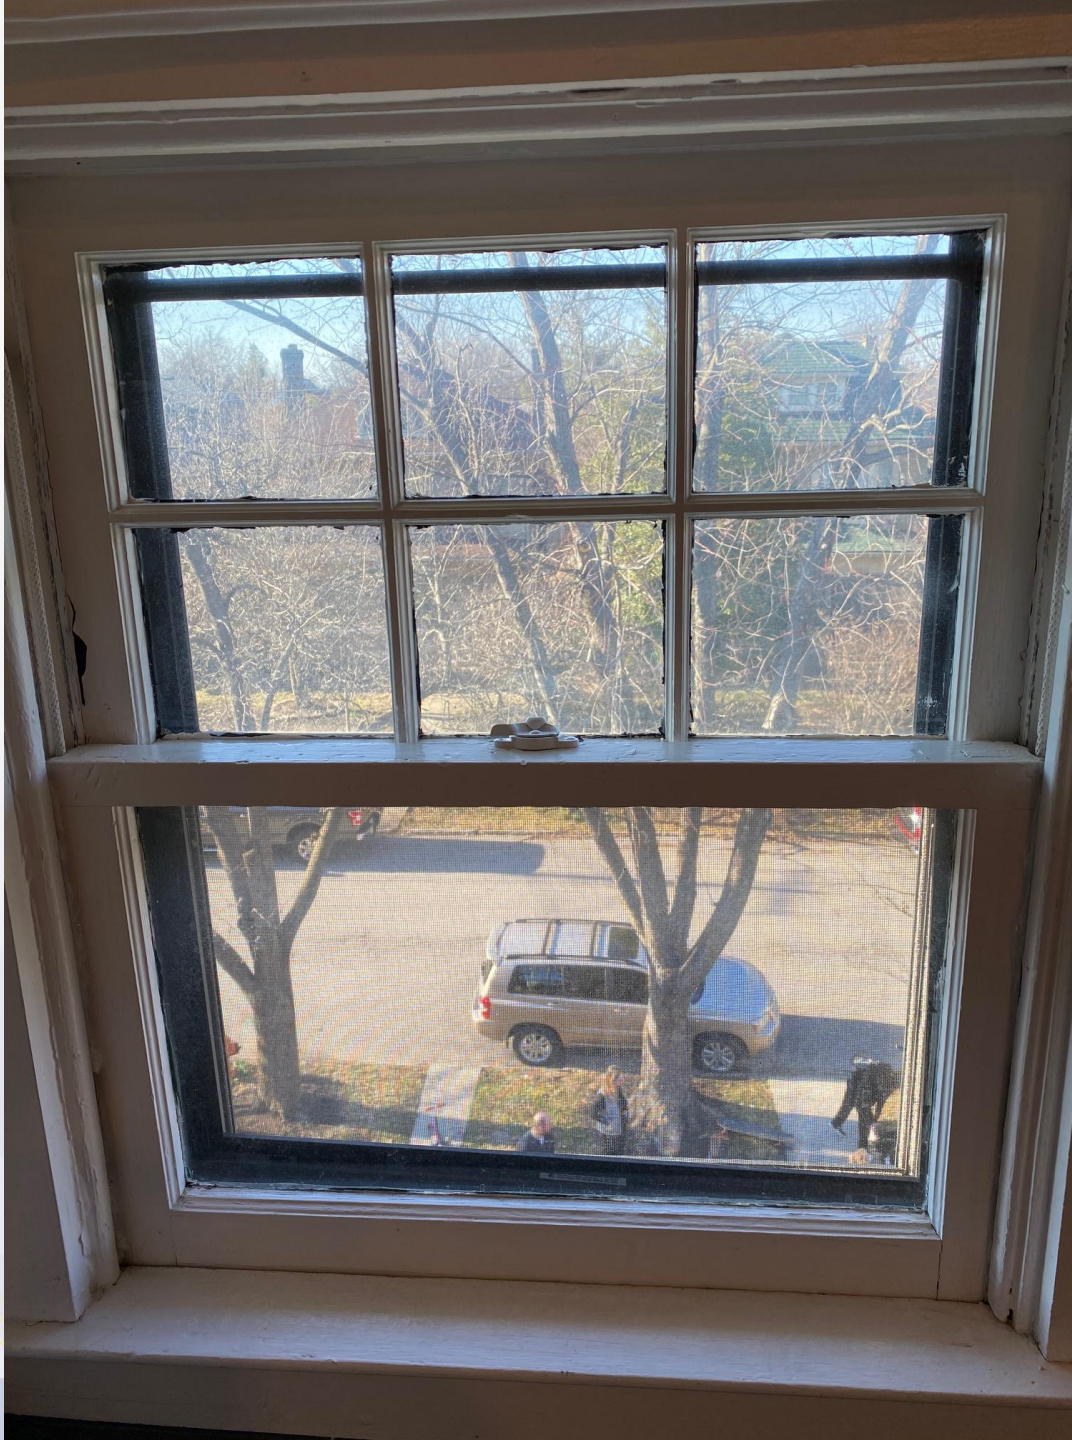
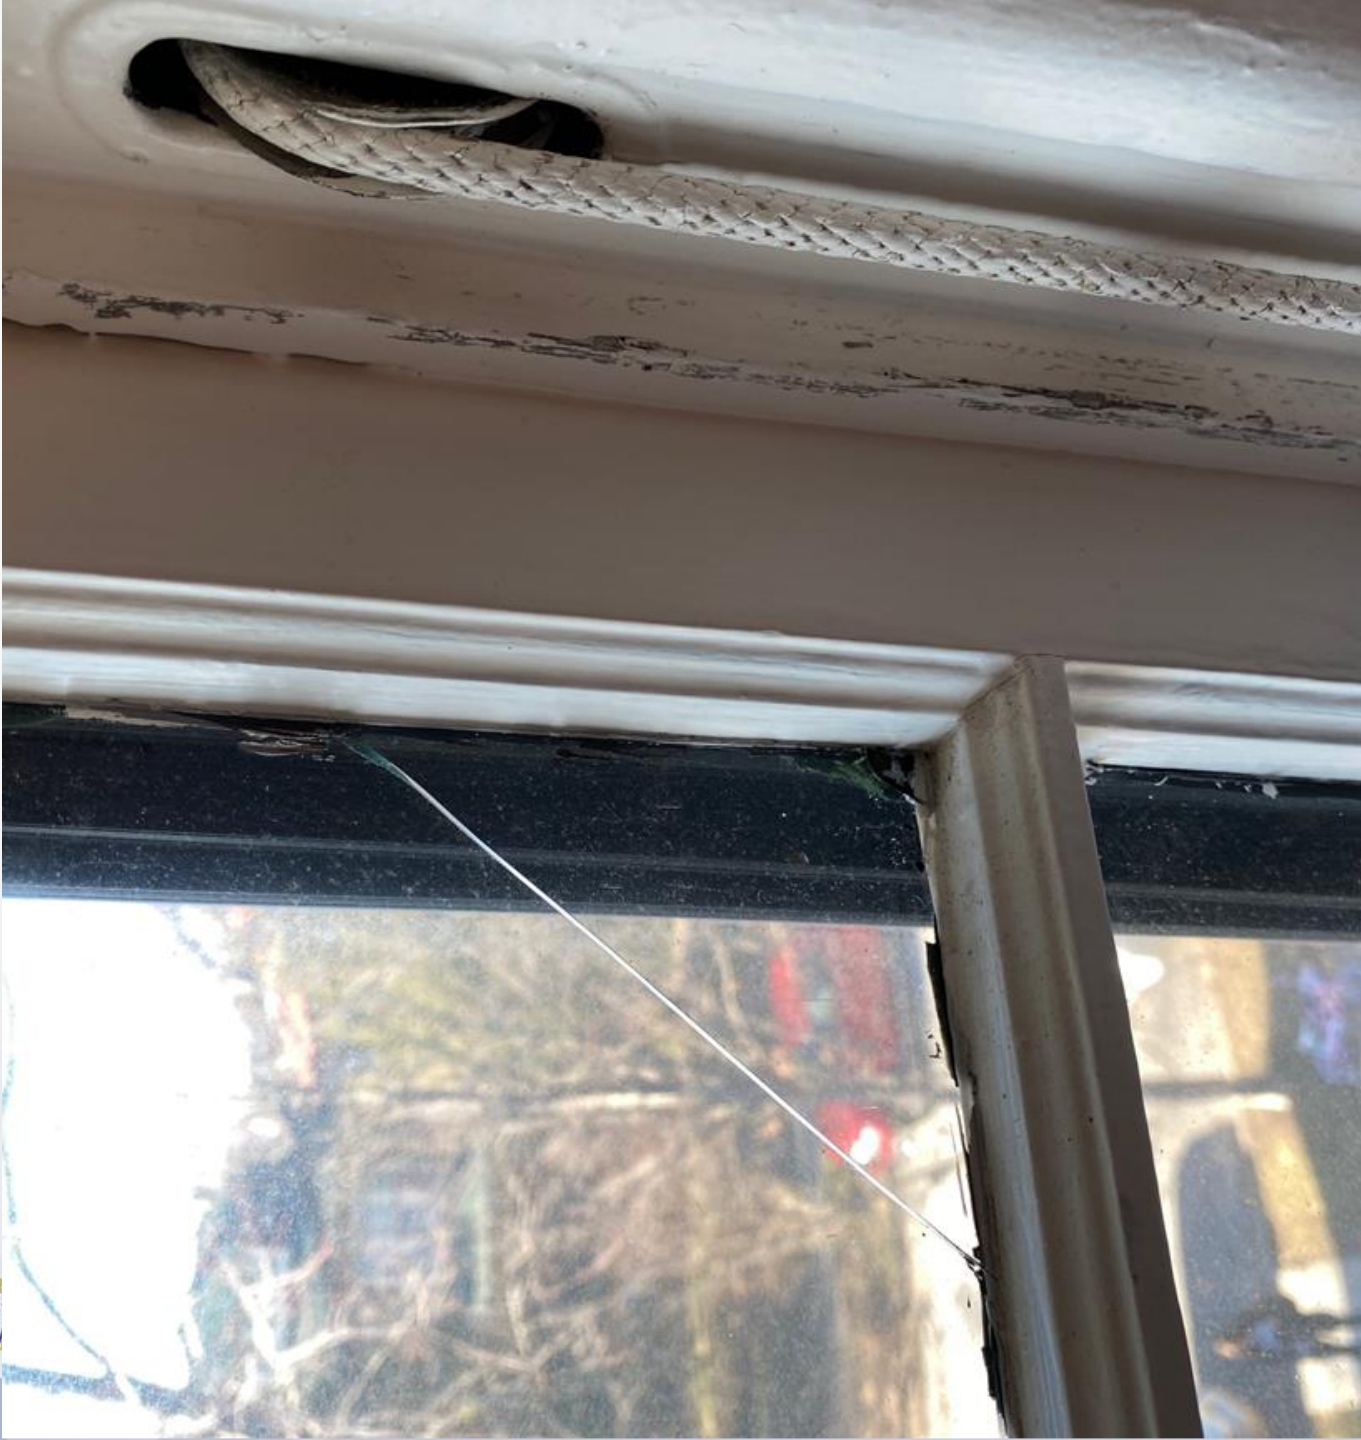
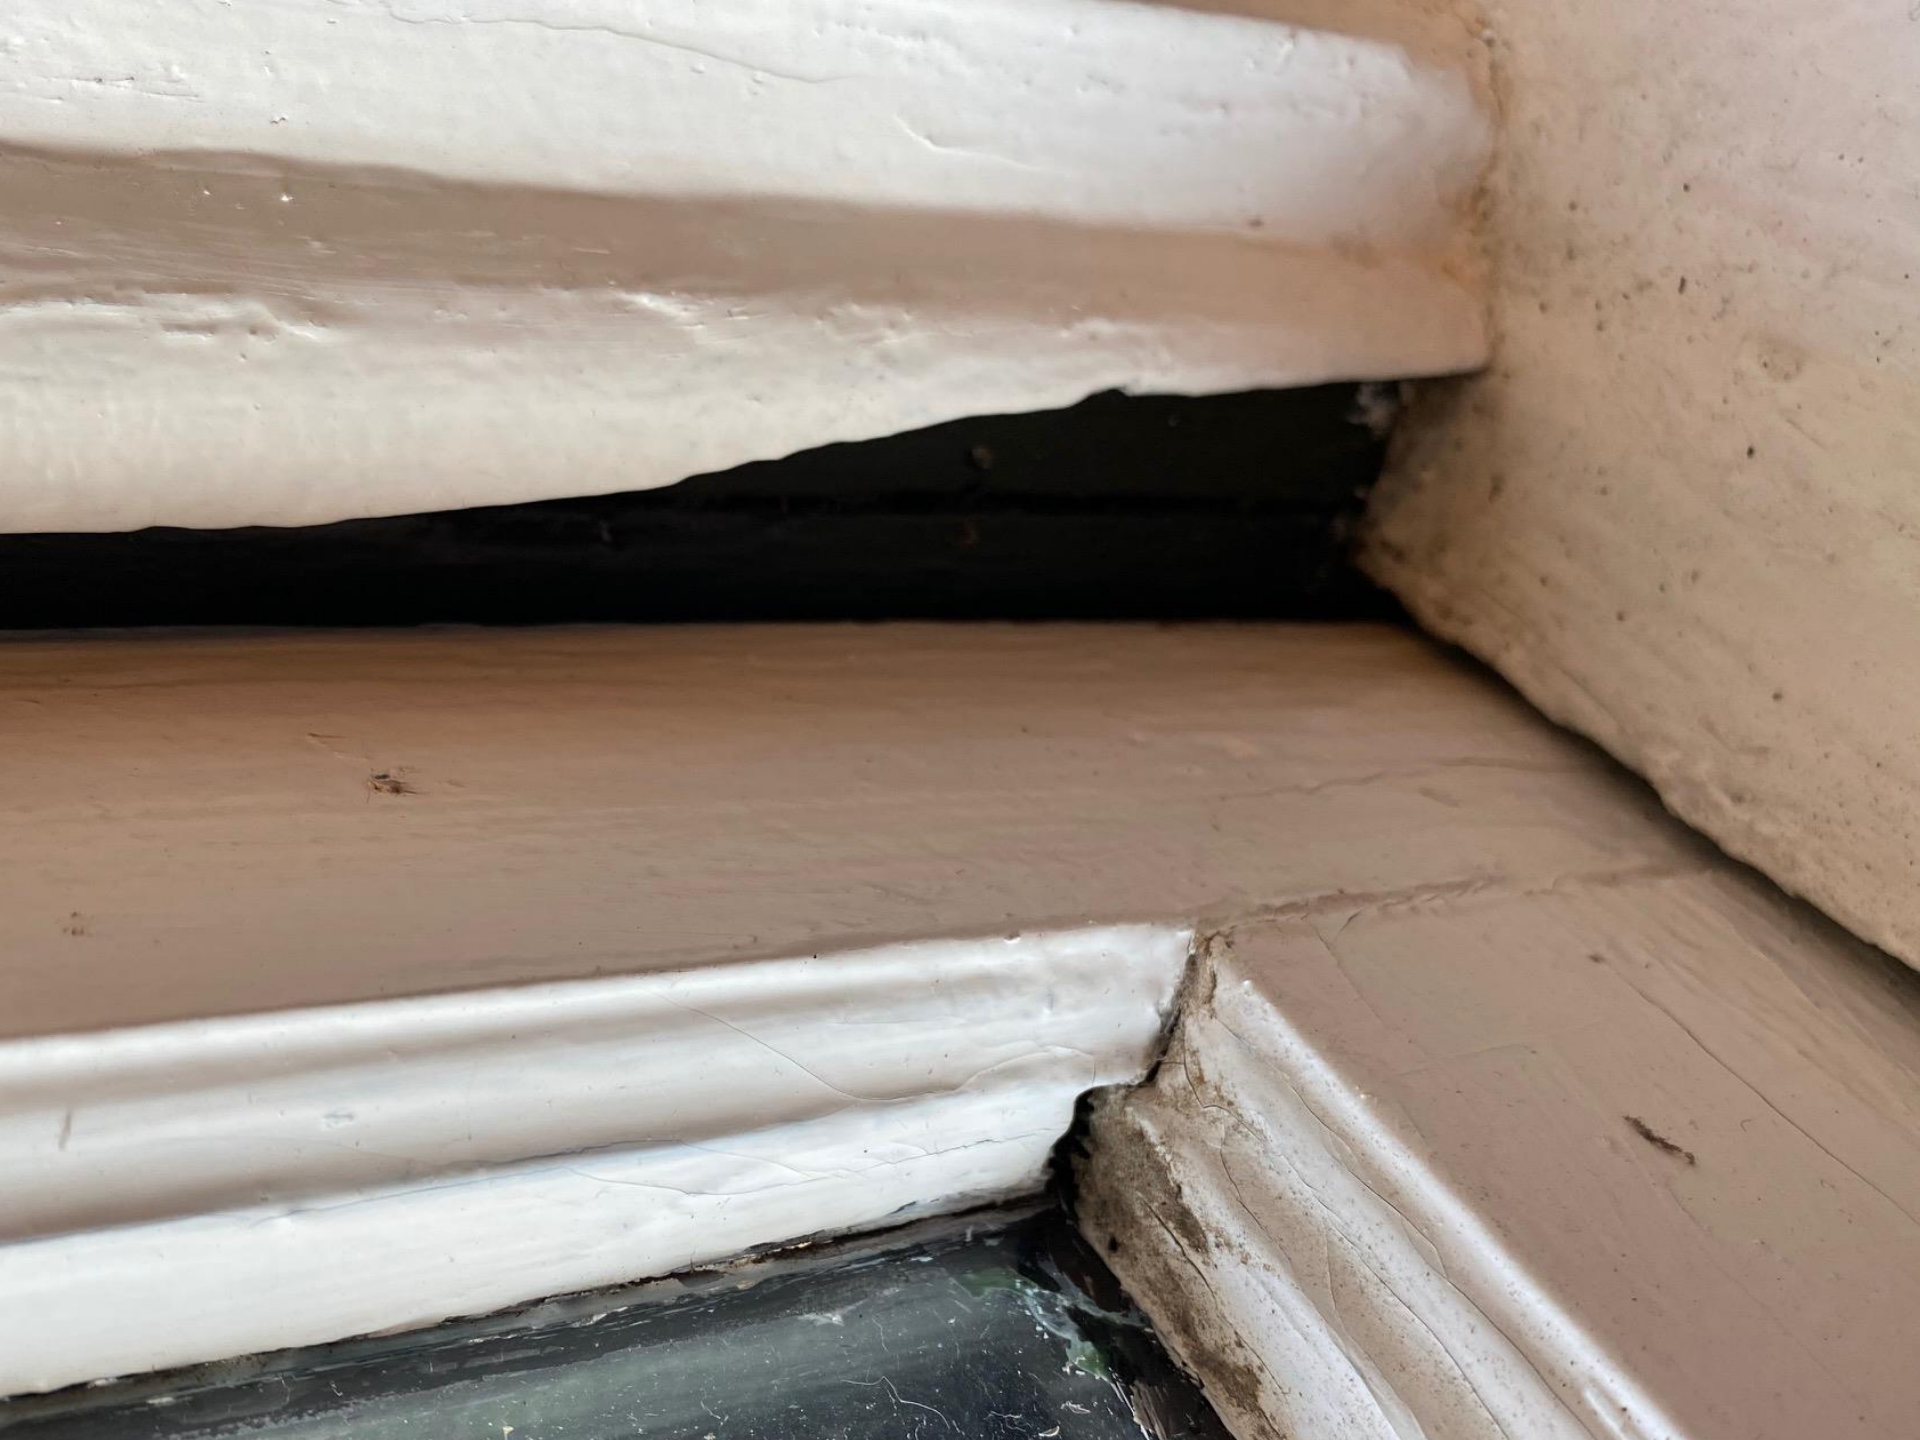
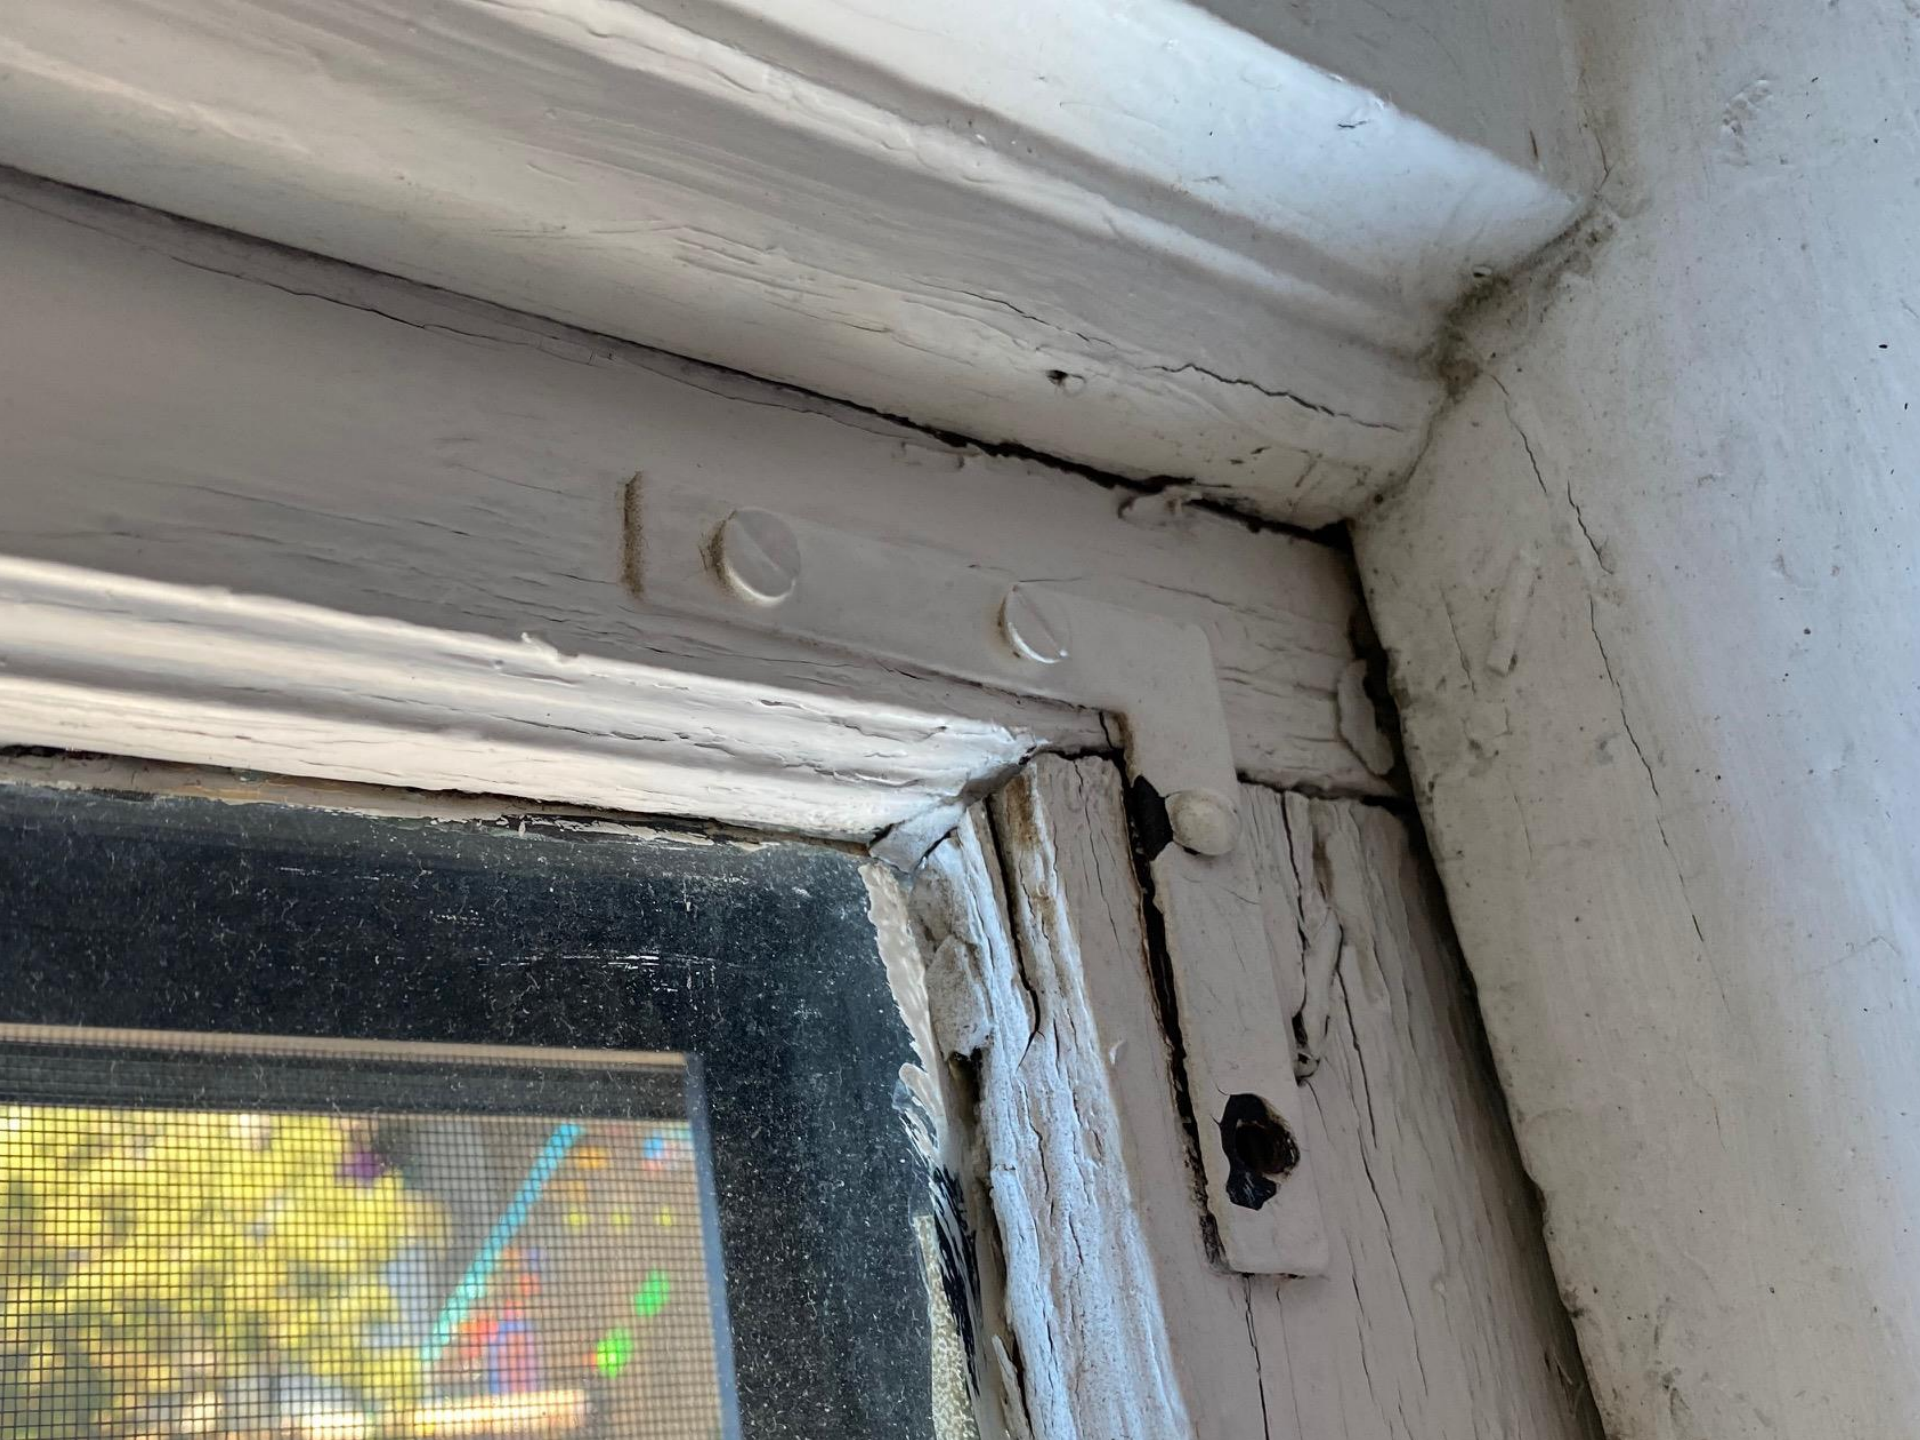
The proposed project does not meet the standard for replacement as described in **W1** for the **Window Design Guidelines** for the Cherokee Triangle Preservation District. Specifically, the windows were not found to meet guideline **W1** “severely deteriorated” for staff level approvable replacement. The existing front and rear facing dormer windows have already been repaired previously by former homeowners. There is some evidence of the repair with L-brackets on some of the sashes and there is some broken glass.

Storm windows are present, though they have some evidence of failure. Based on the photos provided, Staff determined the windows to fall between a condition 2 for “Stabilization” and 3 for “Partial Replacement” on the Historic Window Condition Checklist. Staff recommends that the front and rear facing dormer windows be repaired, and storms installed on the interior or exterior to assist with weatherization and energy efficiency.

On the basis of the information furnished by the applicant, staff recommends a Certificate of Appropriateness be **denied**.
