21-COA-0054
104 N. Keats Ave.

Clifton Architectural Review Committee
Public Hearing

Kat Groskreutz, Historic Preservation Specialist
April 28, 2021

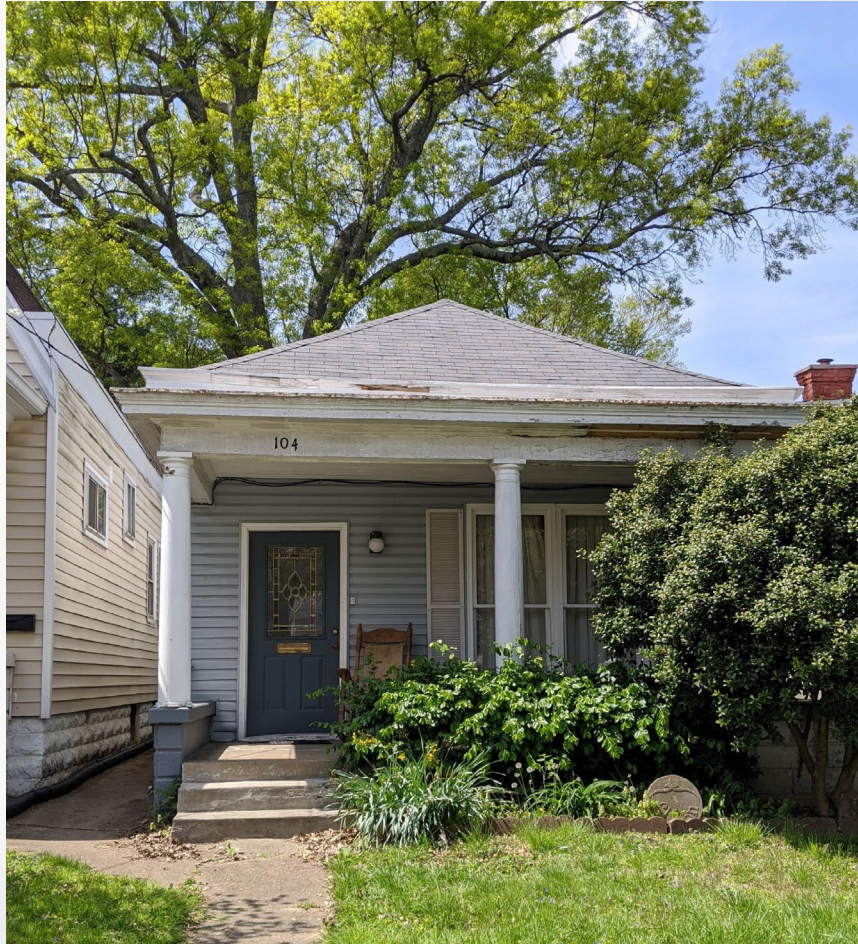
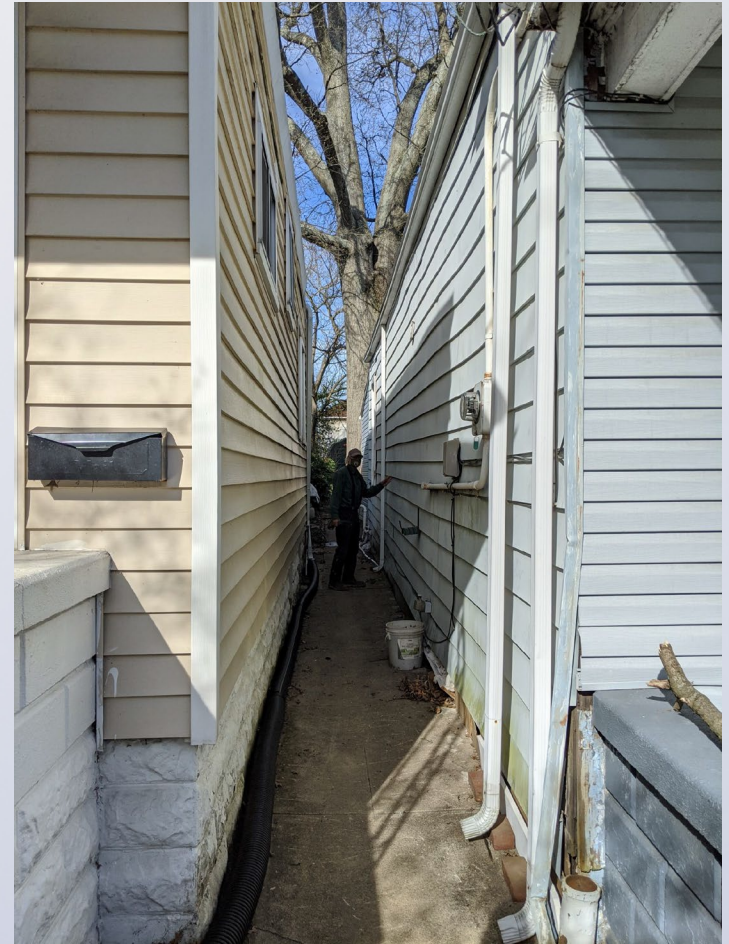
Subject Property Front & Demo Location

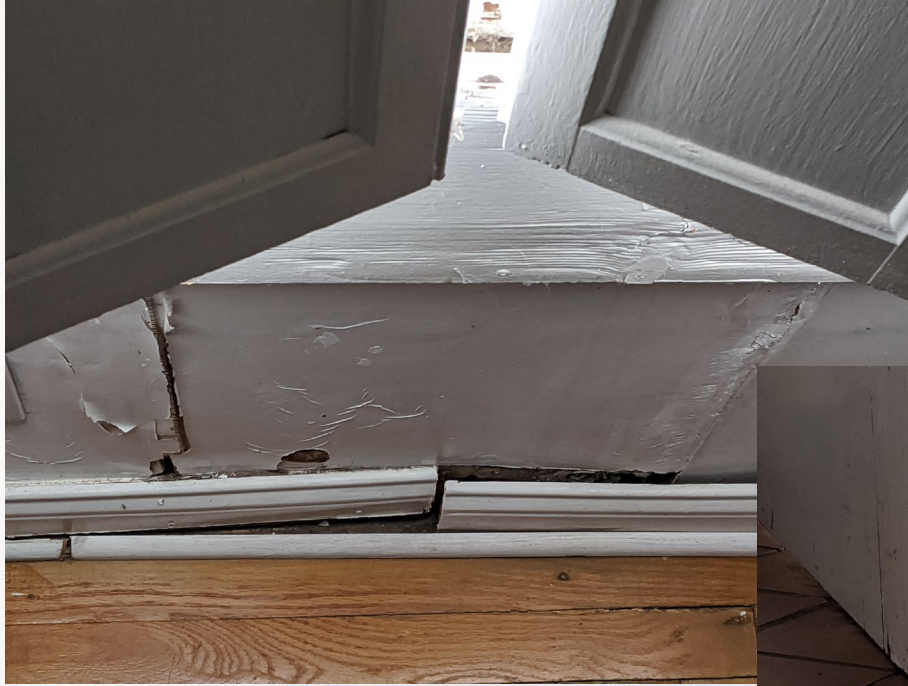
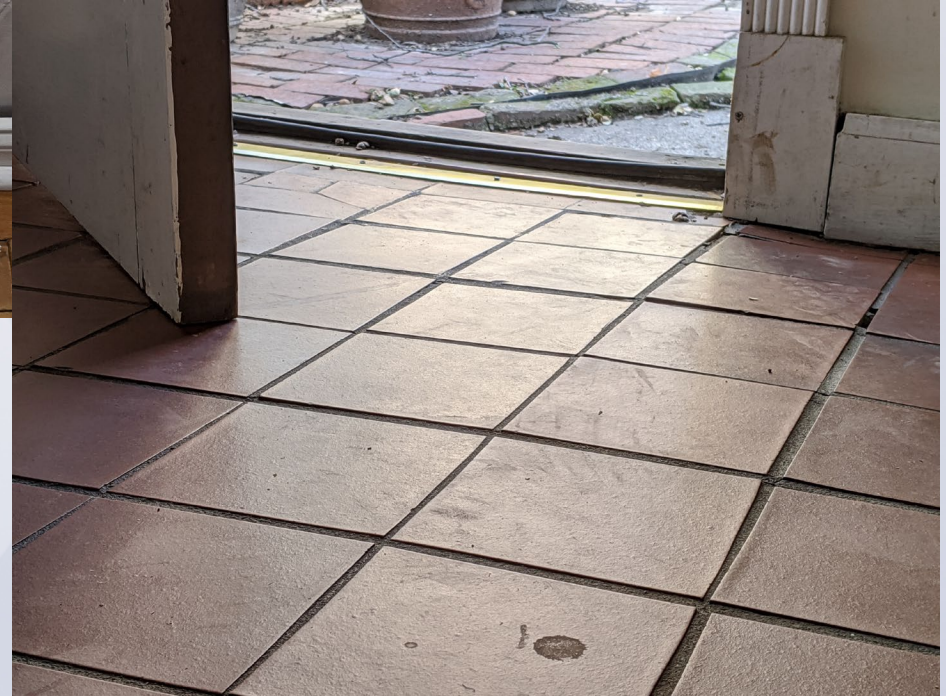
Hallway wall and rear addition floor buckling

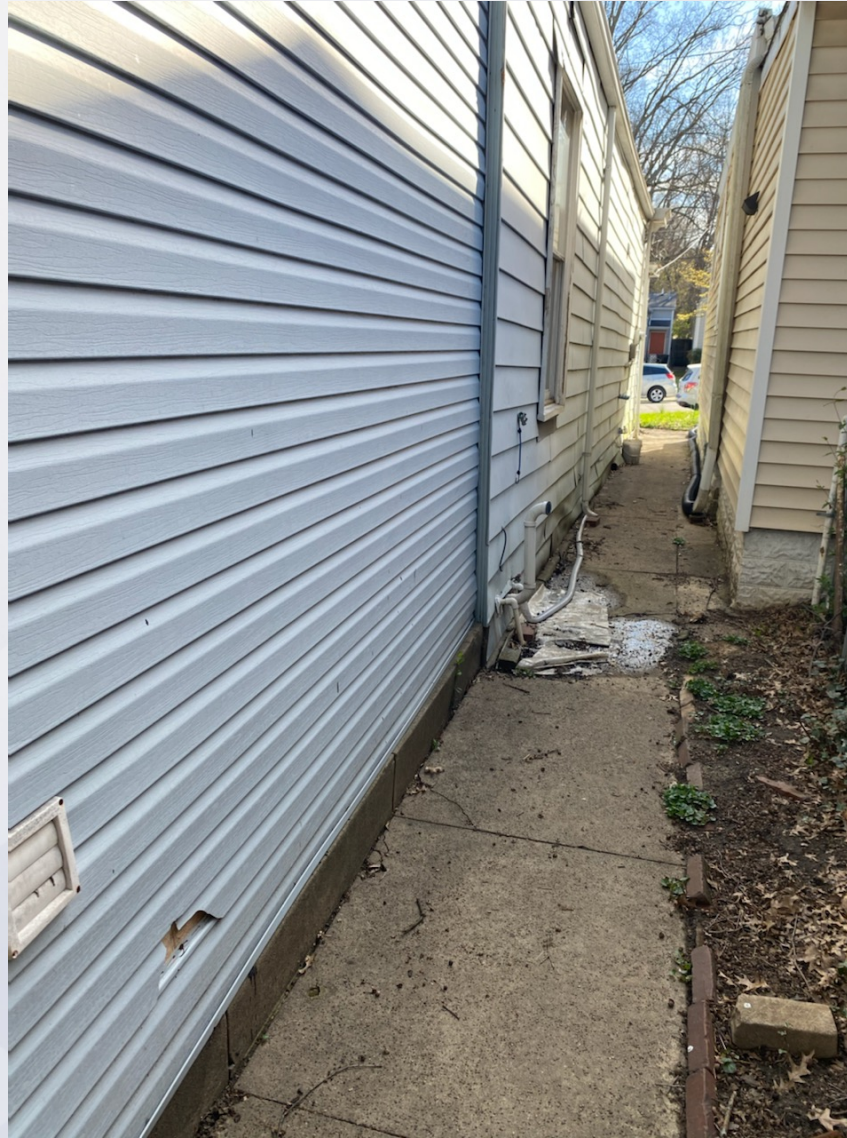
South side wall is wavy and bulging
