**21-COA-0074**  
**1451 S. 2nd St.**

**Old Louisville Architectural Review Committee**  
**Public Hearing**

**Bradley Fister, Historic Preservation Specialist**  
**May 12, 2021**

# Request

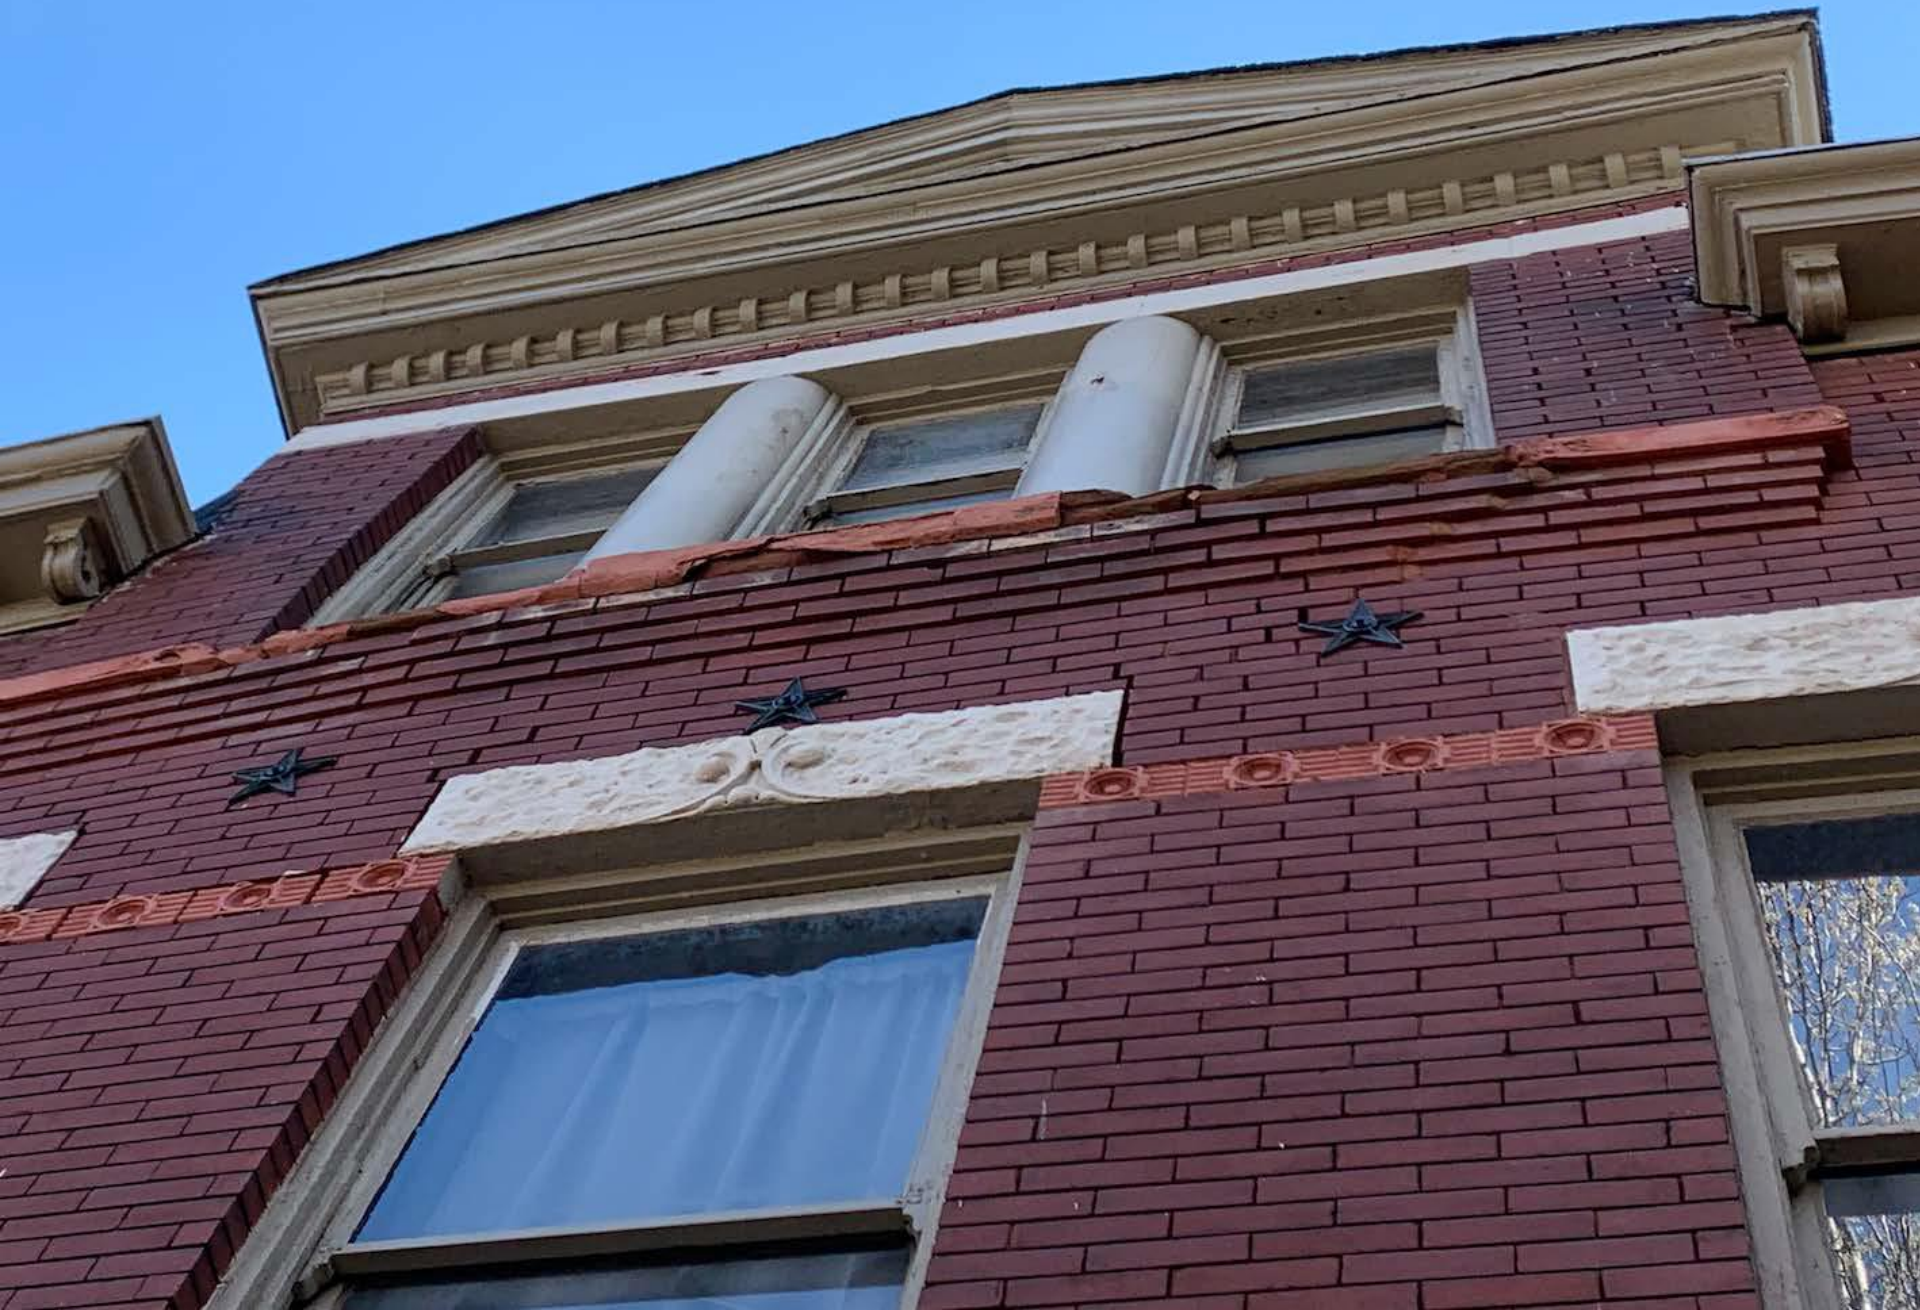
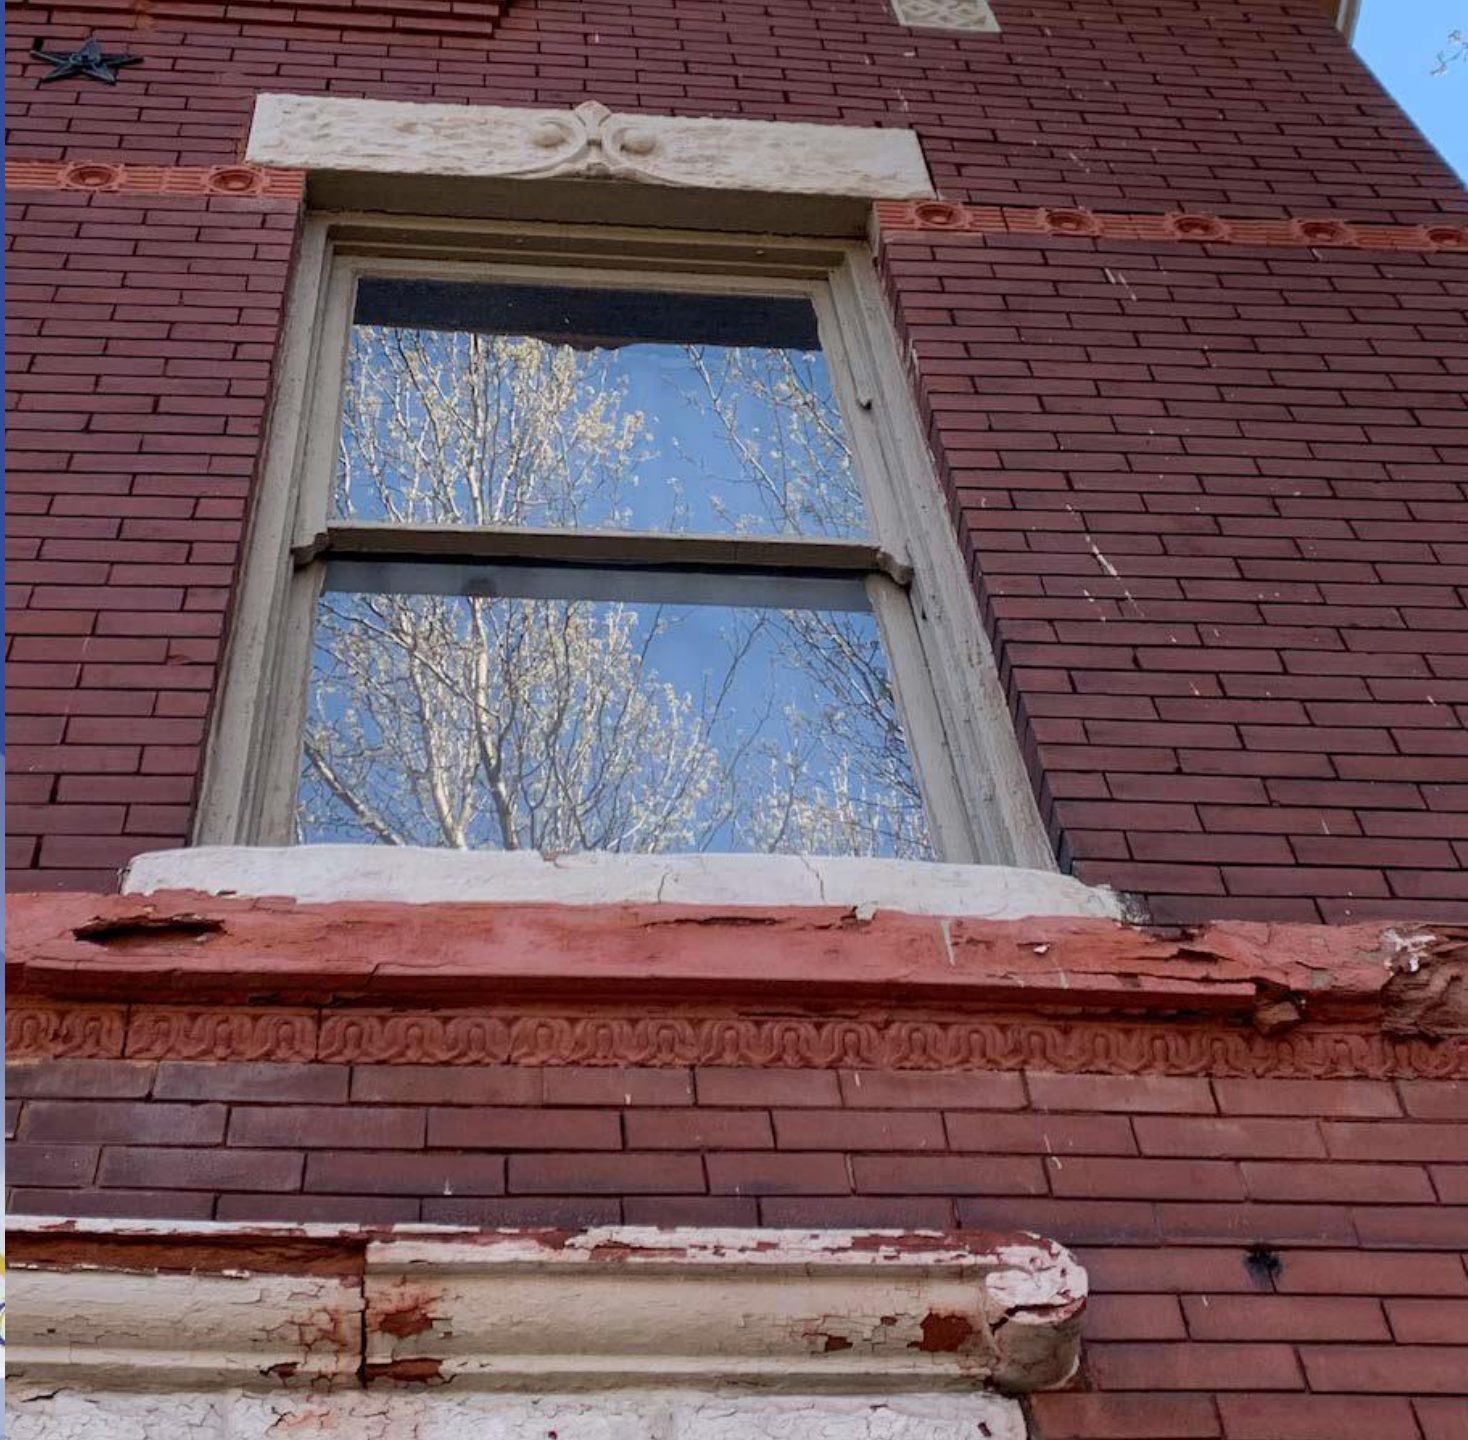
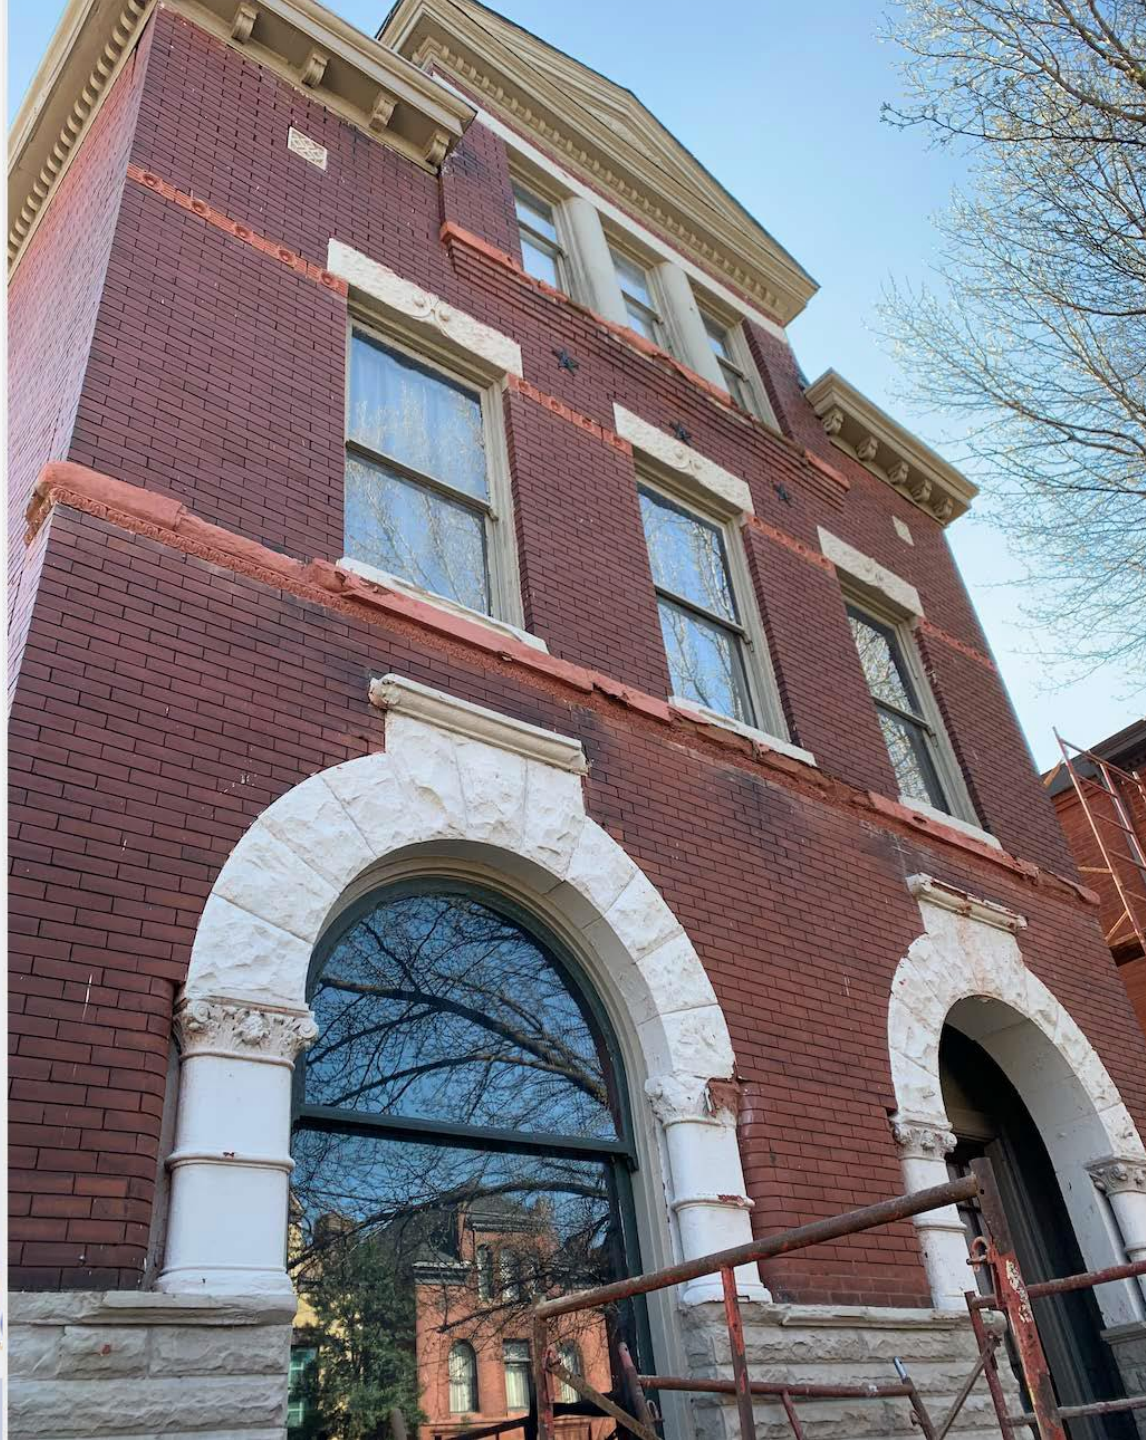
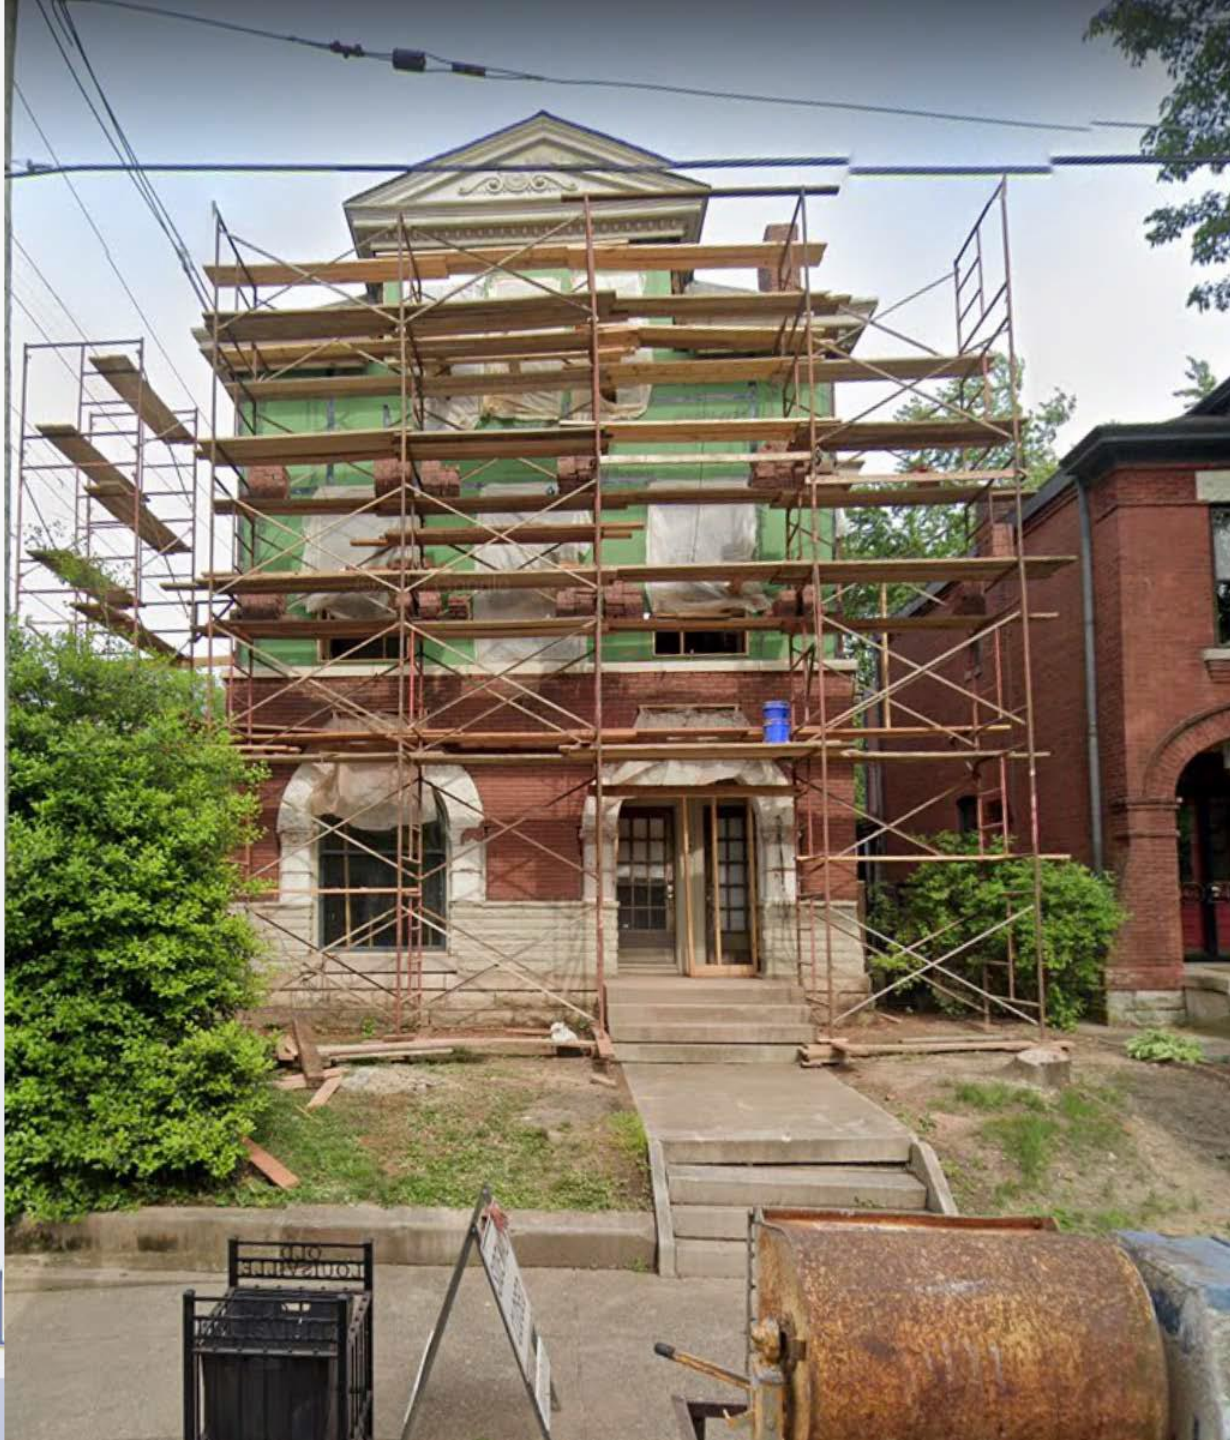
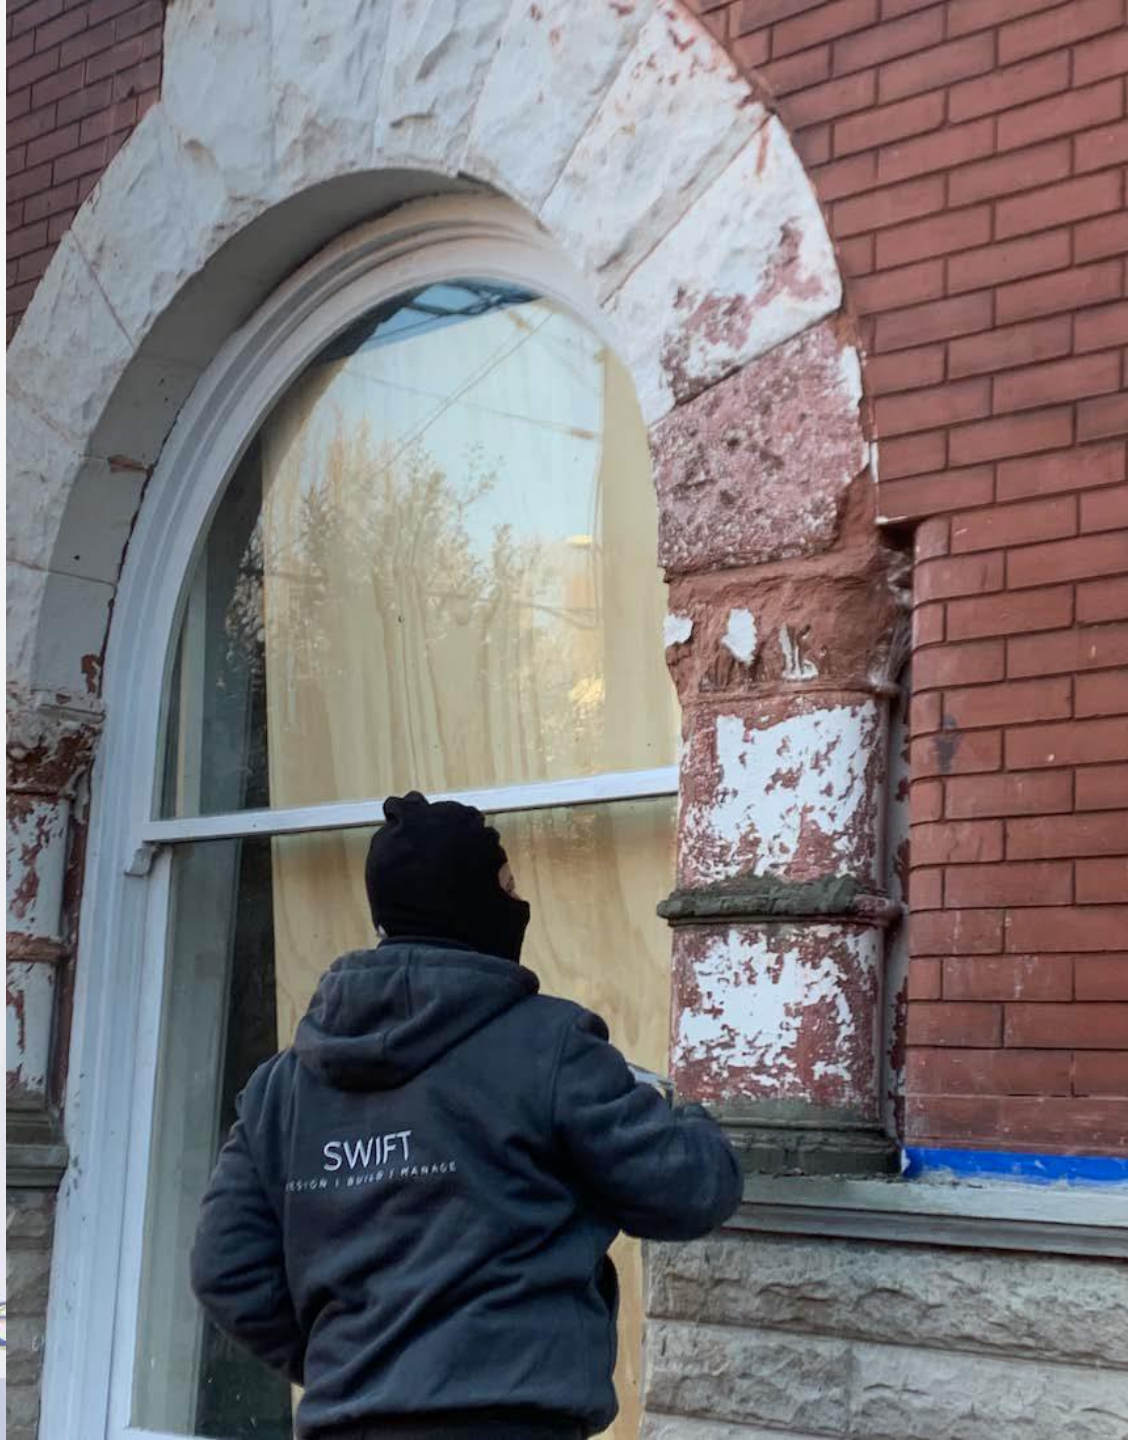
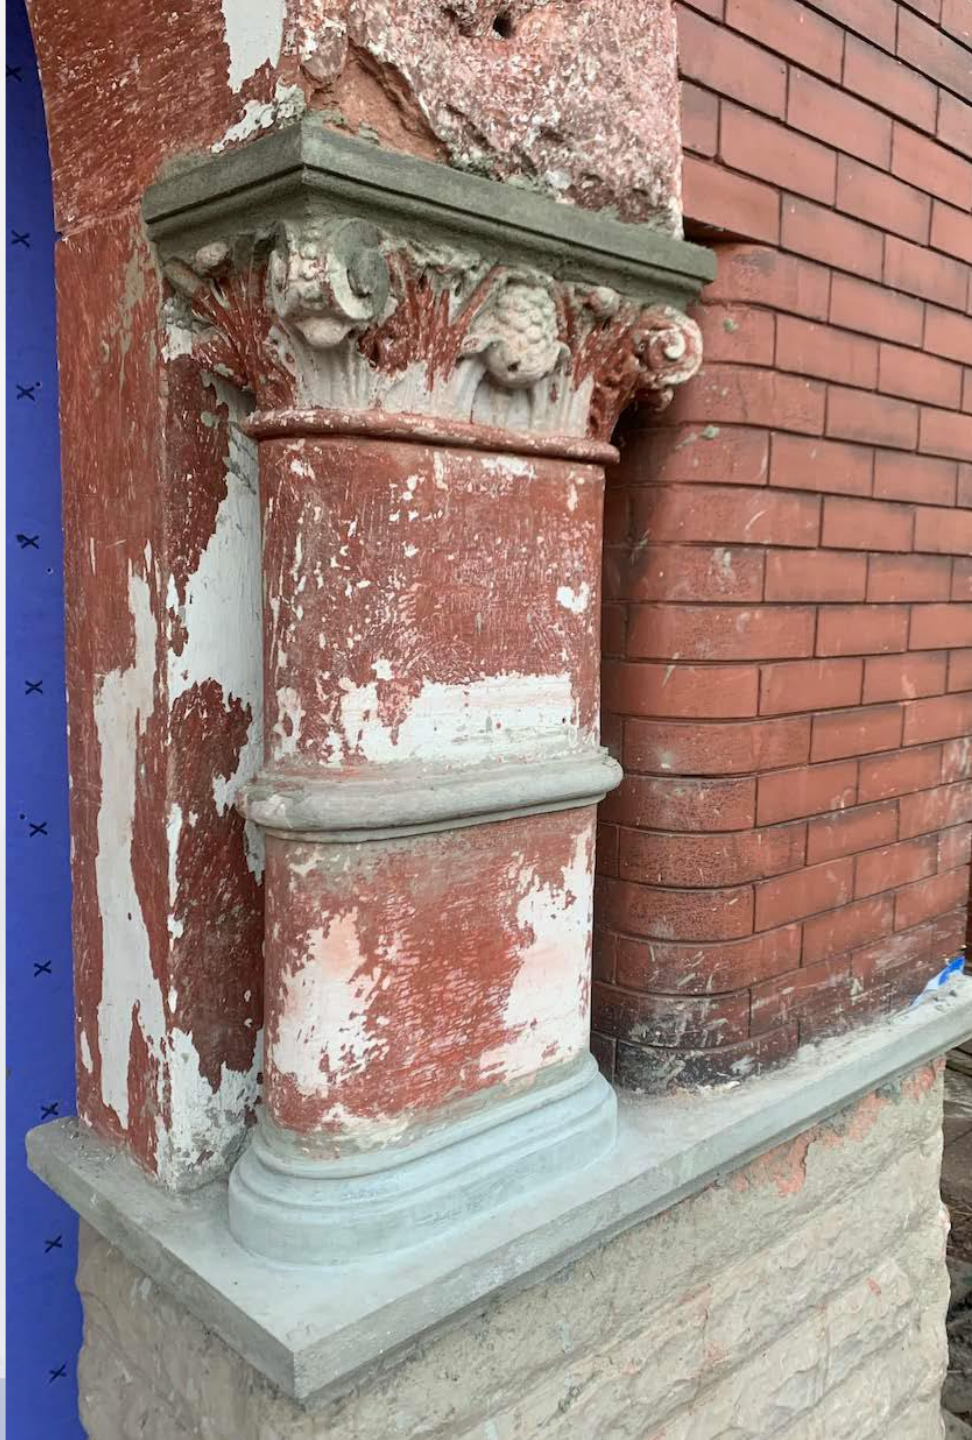
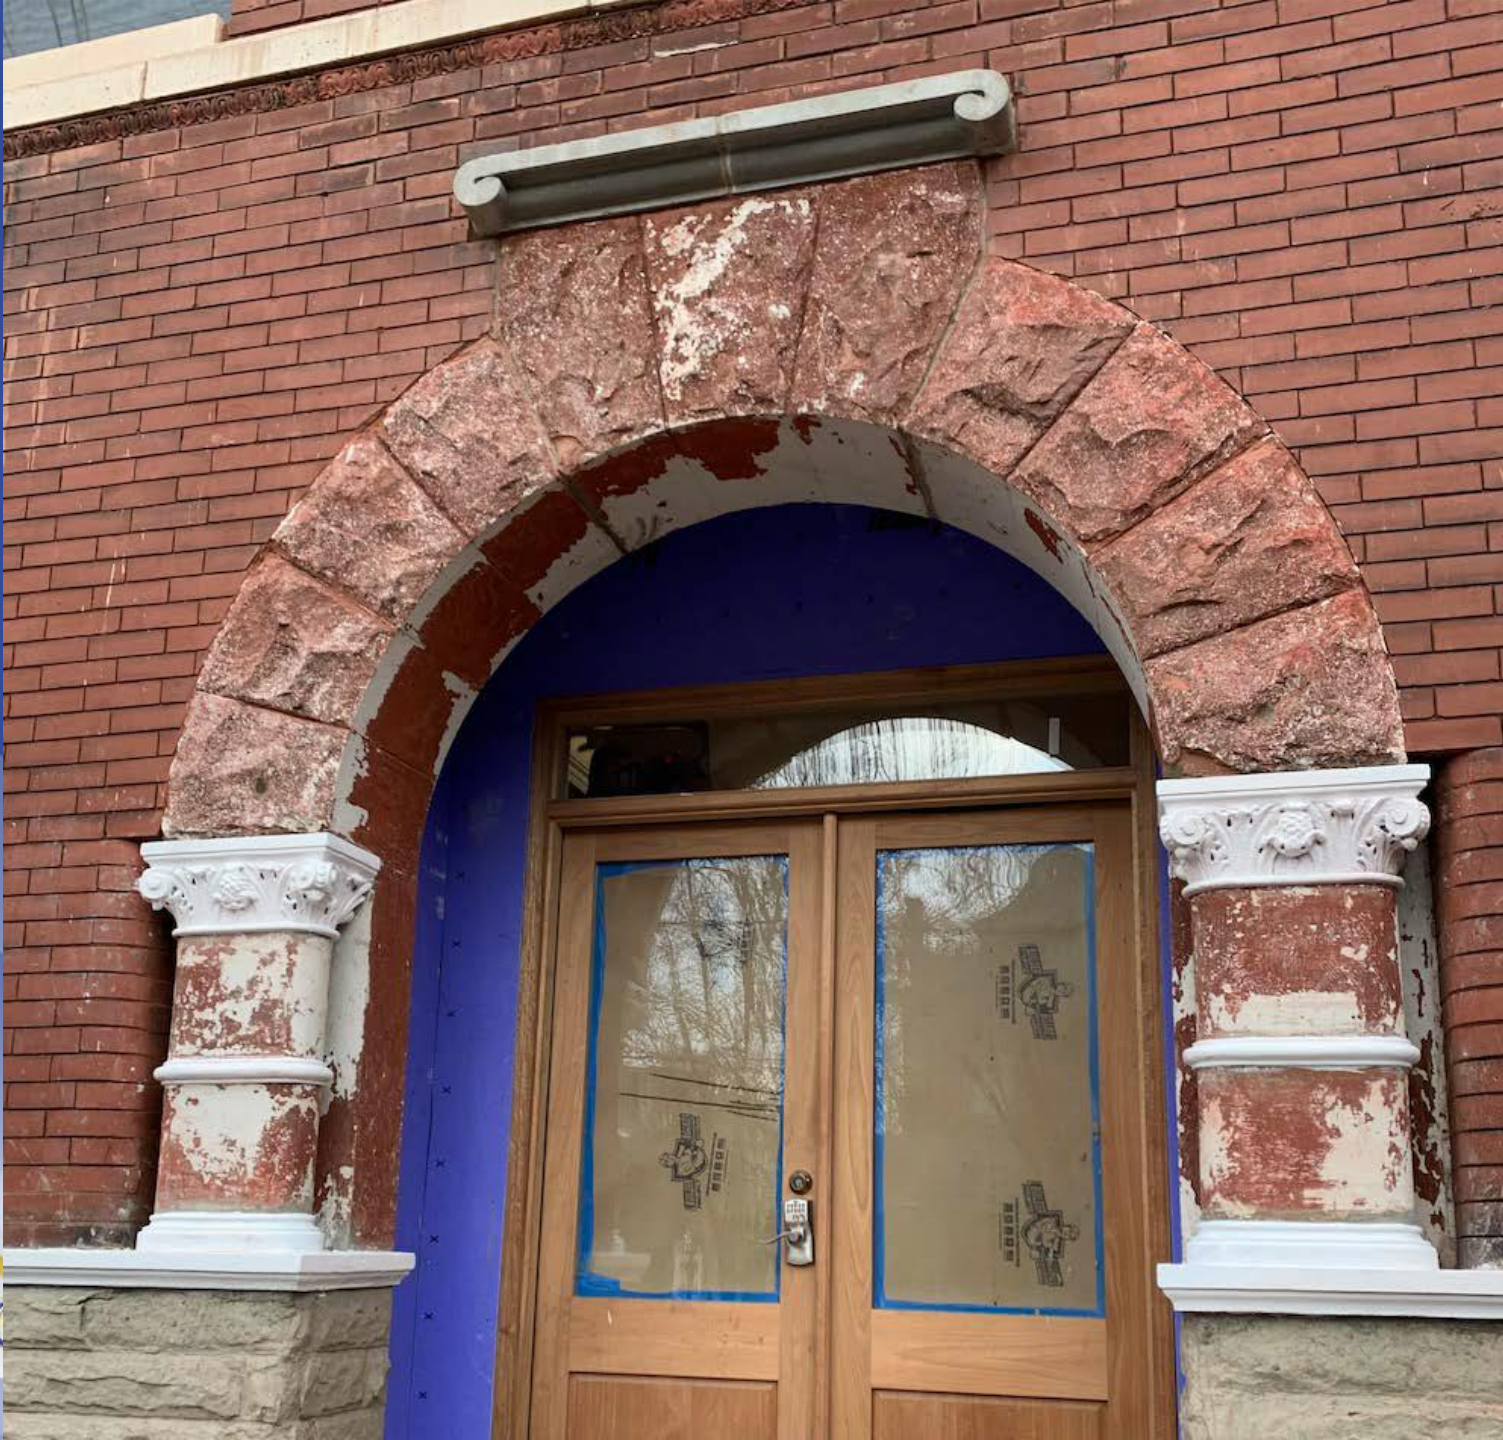
Upon removal of windows which was required to repair and restore the front façade, window sashes & frames were found to be compromised by years of neglect and continuous water damage.

The wood frame aluminum-clad replacement windows on the front façade generally meet the **Window Design Guidelines**. The applicant intended to originally repair the windows as done with the other windows, located on the sides and rear of the property. Once the masonry work began on the front façade it was discovered that the windows had been severely damaged by water. The box gutters were in disrepair and water had been running down the façade and pooling at the windows.

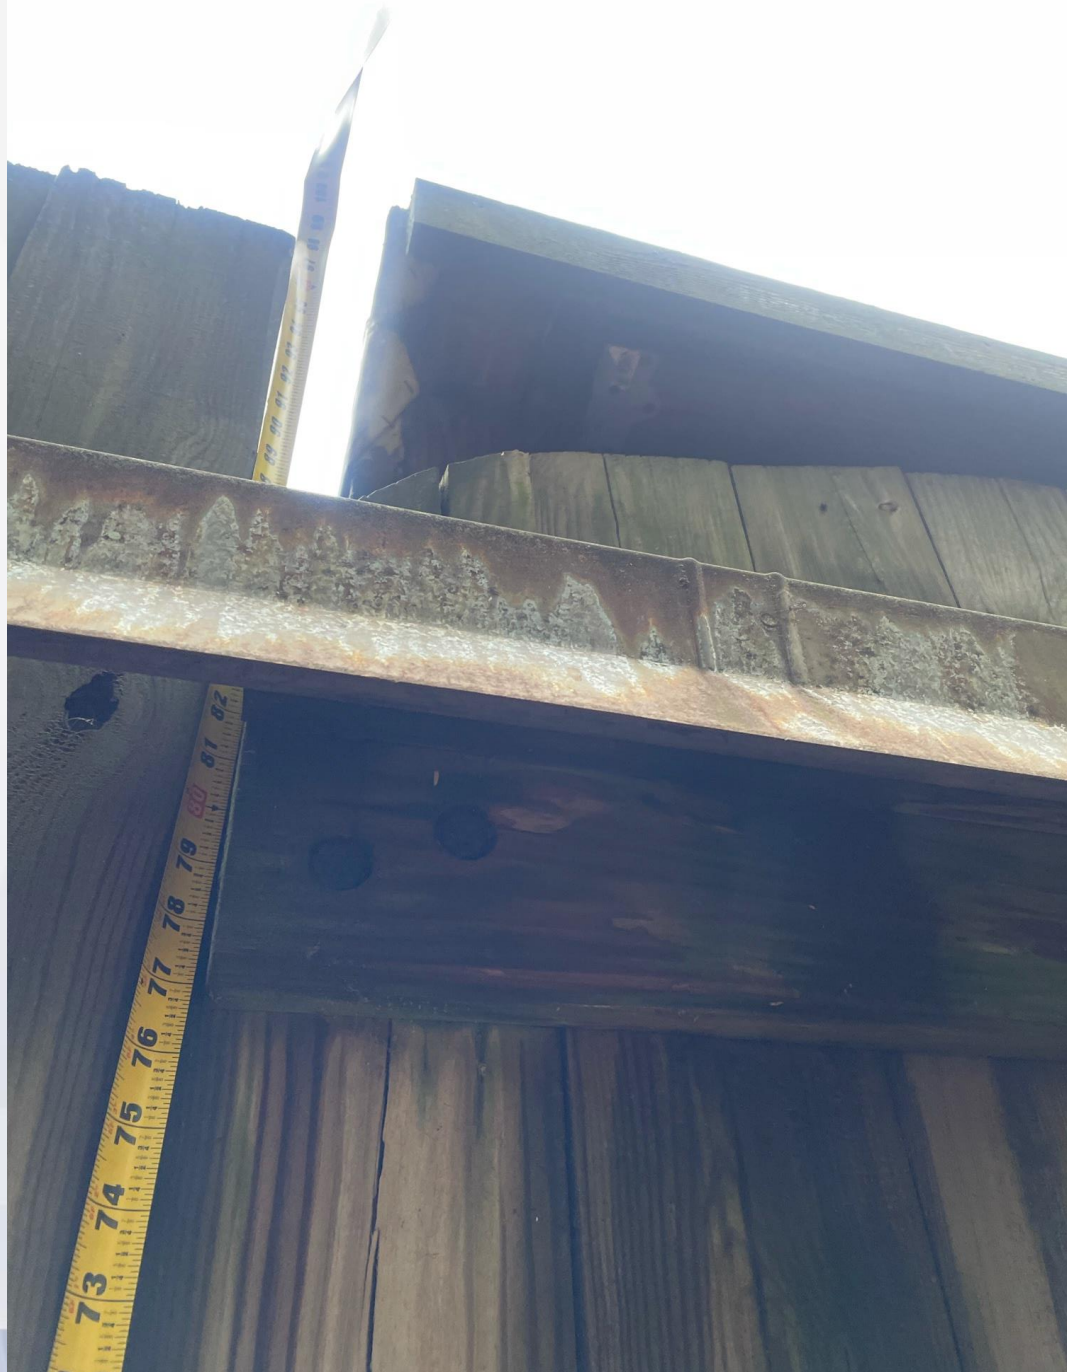
1453 S. 2<sup>nd</sup> St.  
Overall Height  
8'-4" +/-

The privacy fence, and gate located at the rear of the property would generally meet the design guidelines for **Site**, other than the height is above the 7' maximum height as stated in the Design Guidelines. Though staff cannot recommend the privacy fence based on the Design Guidelines, staff recognizes the height is in keeping with the condition of the neighboring privacy fences in the alley. The height of the fence was chosen to follow this existing site line to create a more cohesive continuous feel.

1. The applicant shall lower the height of the privacy fence and gate to a maximum of 7' above grade.
2. The applicant shall paint, stain or clear coat the privacy fence within six months of construction.
3. The applicant shall contact staff and apply for a COA prior to any further exterior changes.
