## Historic Landmarks and Preservation Districts Commission

### Report to Committee

**Case No:** 23-COA-0018  
**Classification:** Committee Review

**Property Address:** 285 Pope St.

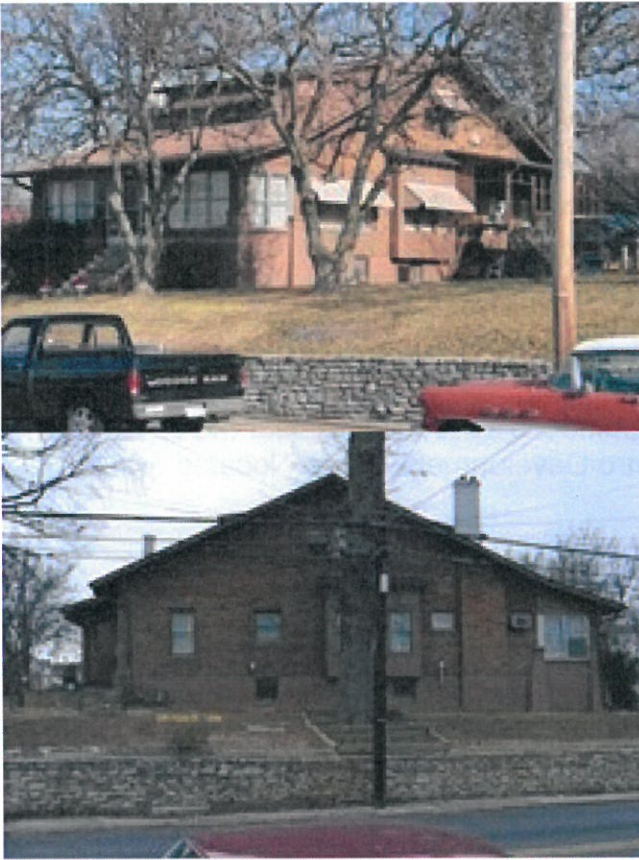
Figure 1 and 2. Designation Photos of 285 Pope St.

The project generally does not meet the Clifton Preservation District design guidelines for **Paint and Coatings** and **Masonry**. The brick on the house and garage had never been painted (**Figure 1 and 2 below**), with the exception of the porch parapet walls, porch columns, chimney, and first level bay projections. Thus its painting does not conform with guidelines **P1** and **M1 (Figure 3 below)**.

1. **The paint shall be removed from the bricks. The applicant shall test gentle treatments to remove the paint in an inconspicuous location.**
2. **Landmarks staff shall be consulted for recommended products. The applicant shall not sandblast, pressure wash or use acid-based cleaners to remove the paint. Solvent-based chemical strippers are preferred over sandblasting or pressure washing the masonry surface.**

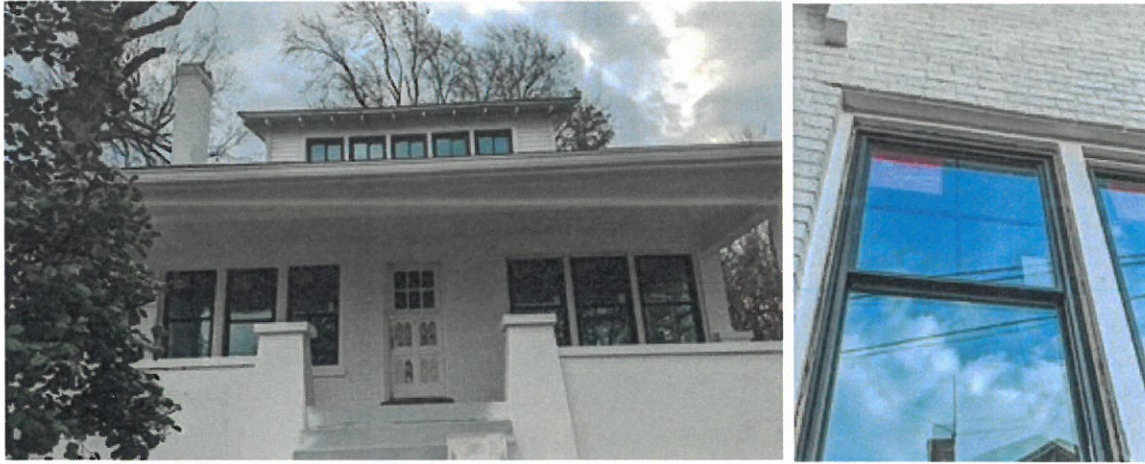
Figure 4 and 5. Replacement Windows.

The project generally does not meet the Clifton Preservation District design guidelines for **Windows**. Approximately 29 historic wood windows have been replaced without a COA, and of those approximately 18 are street facing. Their conditions were not able to be assessed by staff, or reviewed by the Clifton ARC prior to their replacement, which does not conform with **W1**. The vinyl replacement windows that have been installed do not convey the same visual appearance as the historic wood windows. Their glass is tinted, their muntins are internal instead of external, their muntin patterns do not match those of the historic wood windows, they have different reveal depths than the historic wood windows, and at least 8 of them do not function in the same way as the historic wood windows (**Figure 4 and 5 below**). They do not conform with guidelines **W2, W4, W5 or W7**.

3. **The windows facing Pope St. and Brownsboro Rd. shall be replaced with wood or wood clad windows that convey the same appearance and operate in the same way as the original historic wood windows that were removed.**

6. **The windows on the south side and east rear façades shall be replaced with windows that convey the same muntin configuration and operate in the same way as the original historic wood windows that were removed. Vinyl windows are acceptable on these façades.**
