Traffic Impact Study

Prospect Cove
6500 Forrest Cove Lane
Louisville, KY

April 22, 2022

Terracon Project No. 57225022

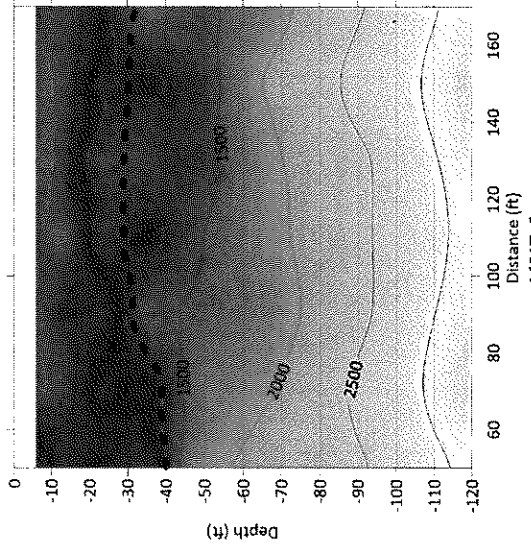
Shear-Wave Velocity (V_s) Model

Approximate Top of Bedrock

The shear wave velocity cross-sections are displayed on **Exploration Results**. The approximate top of bedrock was interpreted along the seismic lines based on velocity values and boring logs. The interpreted top of bedrock indicates a potential cutter/pinnacle profile commonly associated with karst terrain. In general, low velocity zones (blue to light green on the color scale) are indicative of overburden, clay seams, potential voids, and weathered/fractured rock. Higher velocity zones (dark green to red on the color scale) are indicative of competent bedrock.

As noted in the *Site Conditions*, the site is underlain by dolomite of the Laurel Dolomite formation which is reported to have a moderate karst potential. The MASW cross-sections include an interpreted top of bedrock based on the measured shear wave velocities, which indicates a variable cutter/pinnacle profile, weathered/fractured rock, and potential clay seams/voids commonly associated with karst terrain. We did not observe any surficial indications of sinkholes at the site during field reconnaissance and note that KGS has not mapped sinkholes within about a mile of the site West of US Highway 42 where the dolomite is overlain by glacial outwash and alluvium.
