## Historic Landmarks and Preservation Districts Commission

### Report to the Committee

**Case No:** 22-COA-0112  
**Classification:** Committee Review

**Property Address:** 141 Pope Street

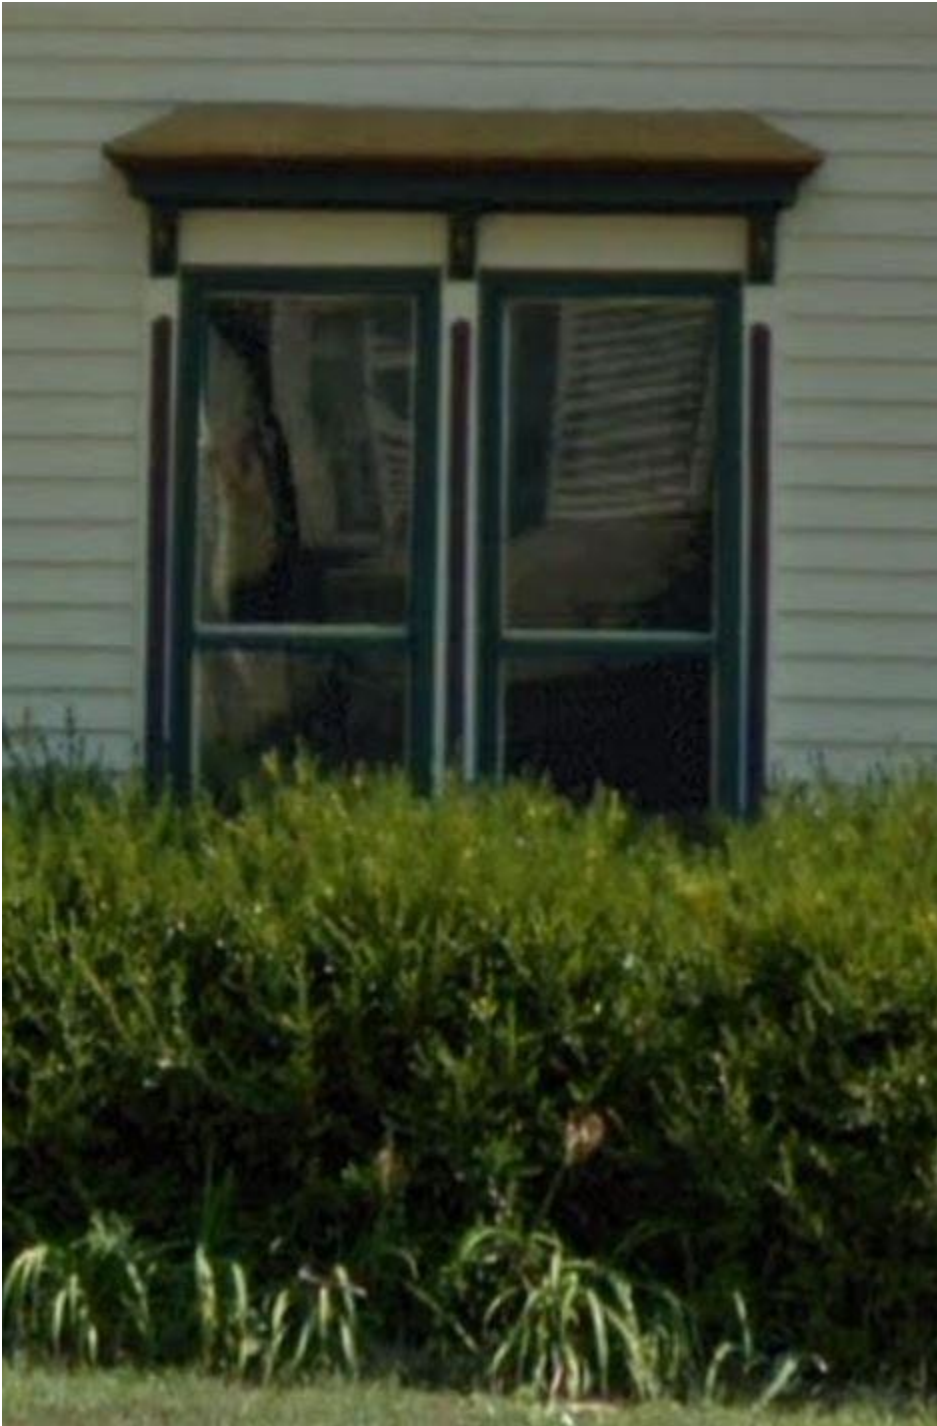
Staff cannot comment on the condition of the previous historic windows since they were removed prior to the site visit. The previous window sills did appear to have rot issues per the applicant provided photos. Staff did see the presence of rot around where the windows had been removed, and the siding was severely deteriorated to the point it all had to be removed and replaced.

West Elevation 1<sup>st</sup> level original front facing windows

1. The three after-the-fact replacement windows shall be replaced with one-over-one replacement windows that closely match the dimensions of the historic wood windows.
2. The replacement windows for the two front facing second-story windows shall be one-over-one and shall closely match the dimensions of the historic wood windows..
3. All glass shall be clear and non-reflective.
4. The applicant shall not wrap the window trim or sills with vinyl or aluminum.
5. The applicant shall take precautions to preserve any existing wood elements to be reapplied to the building and shall submit photographs of all elements proposed to be reconstructed.
6. The applicant shall take appropriate precautions with the handling of potential lead paint.

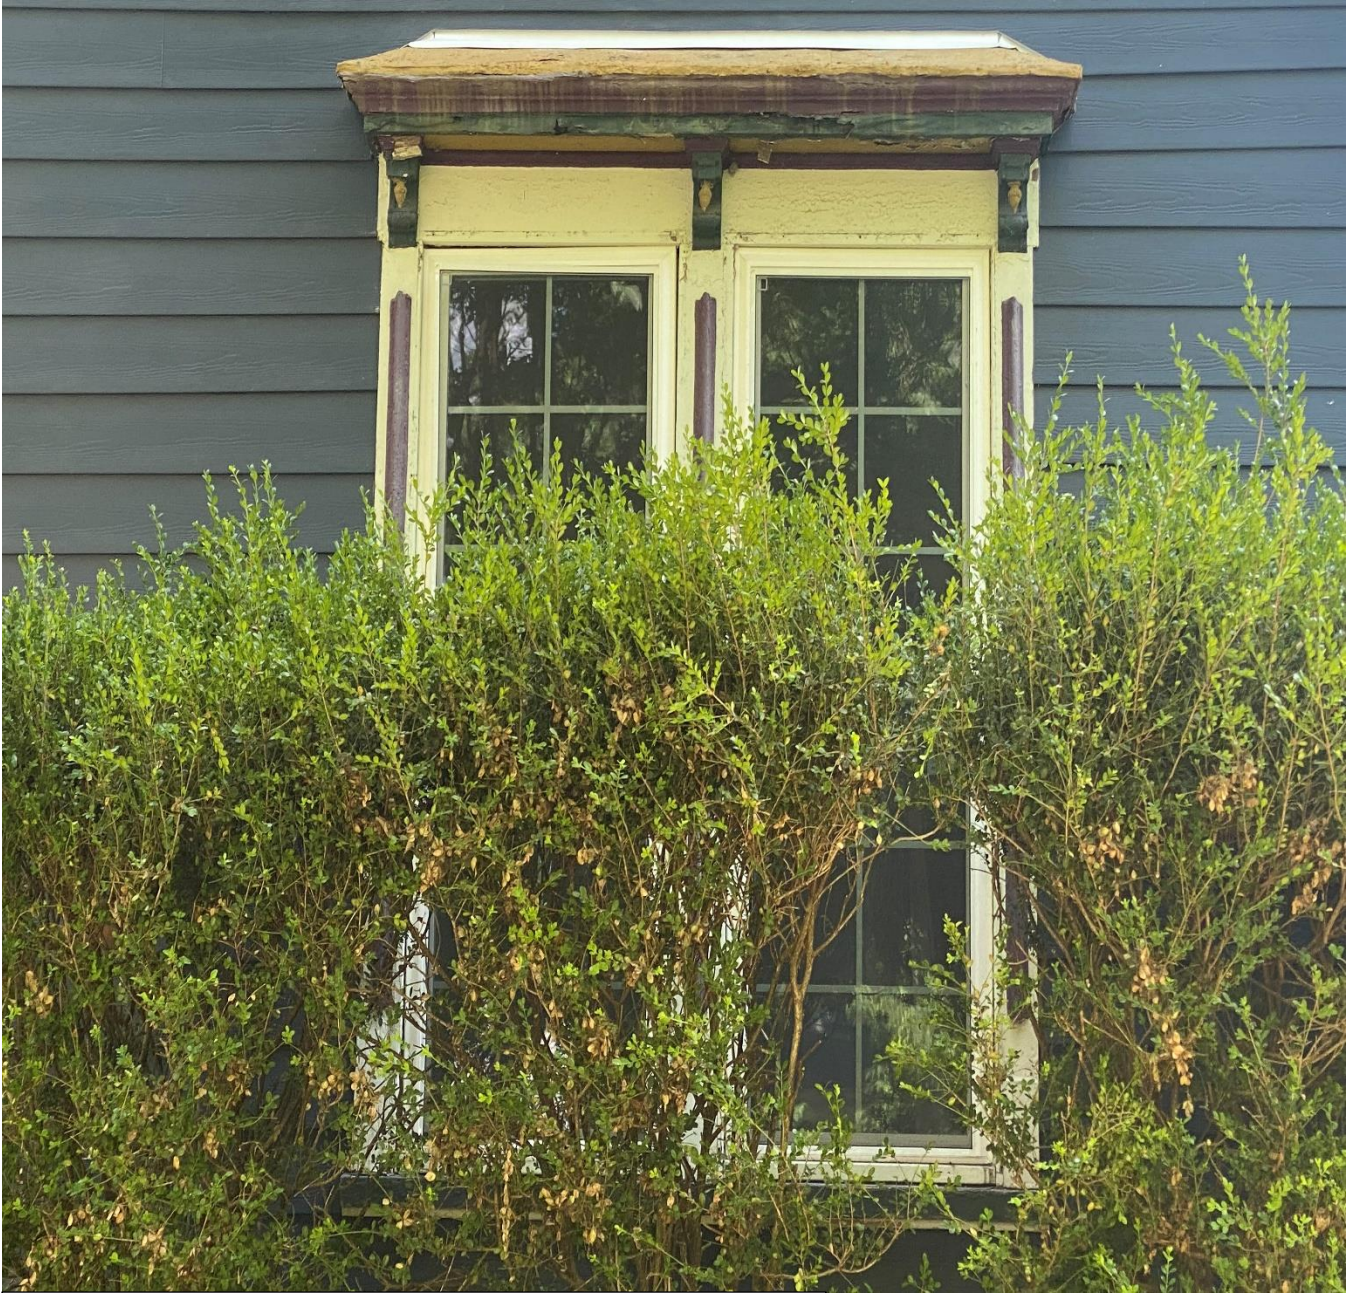
The proposed after-the-fact front facing windows generally do not meet the Clifton design guidelines for **Window**. Two of the three after-the-fact replacement windows no longer have the same one-over-one muntin pattern as the original windows did. They are now six-over-six, which does not meet W1 or W2. All three after-the-fact windows have been replaced with United 9600 Series vinyl composite replacement windows. Vinyl windows do not have the same profiles or dimensions as historic wood windows. While the design guidelines allow for synthetic, they do still have to match the historic windows. Staff recommends a different material than vinyl for the front window replacement. Furthermore, the windows should be replaced with new ones that are one-over-one to match the historic configuration.

West Elevation 1<sup>st</sup> level new front facing windows

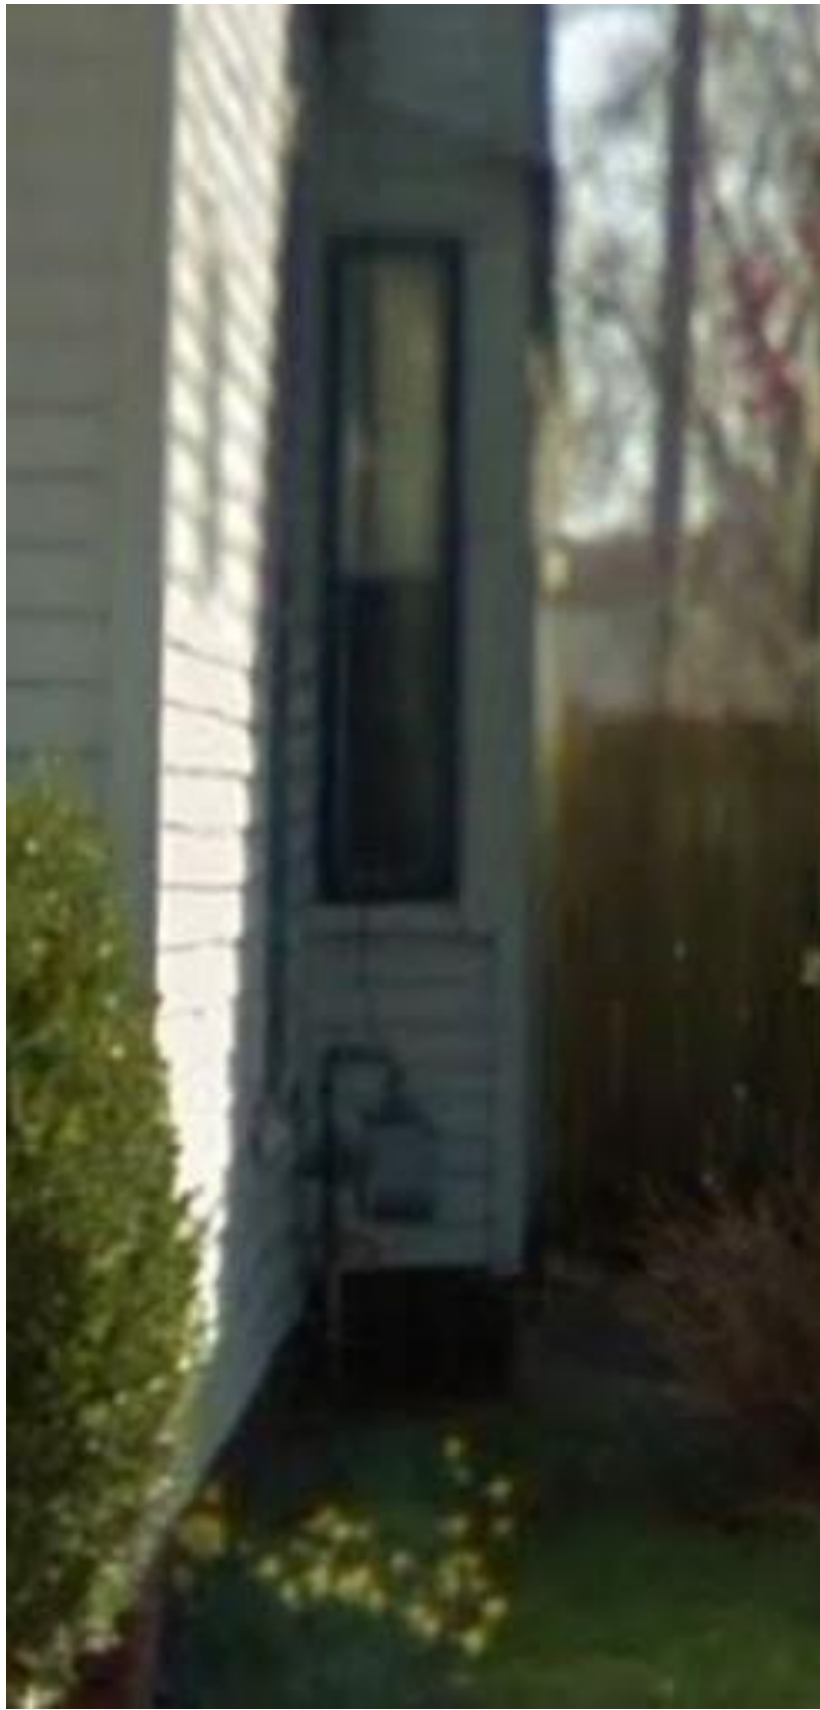
West Elevation 1<sup>st</sup> level original front facing side window

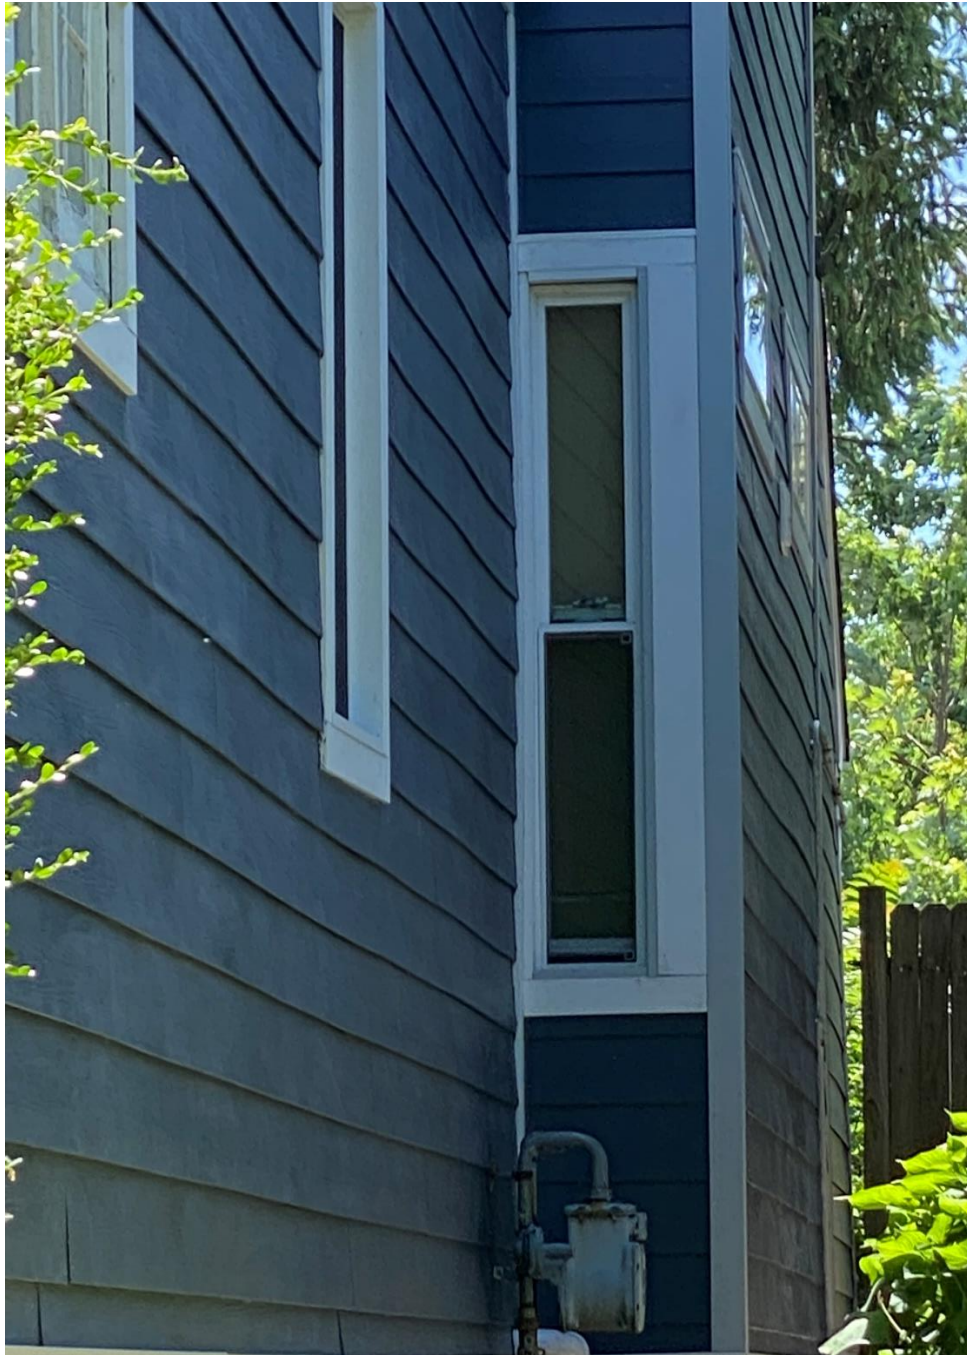
West Elevation 1<sup>st</sup> level new front facing side window

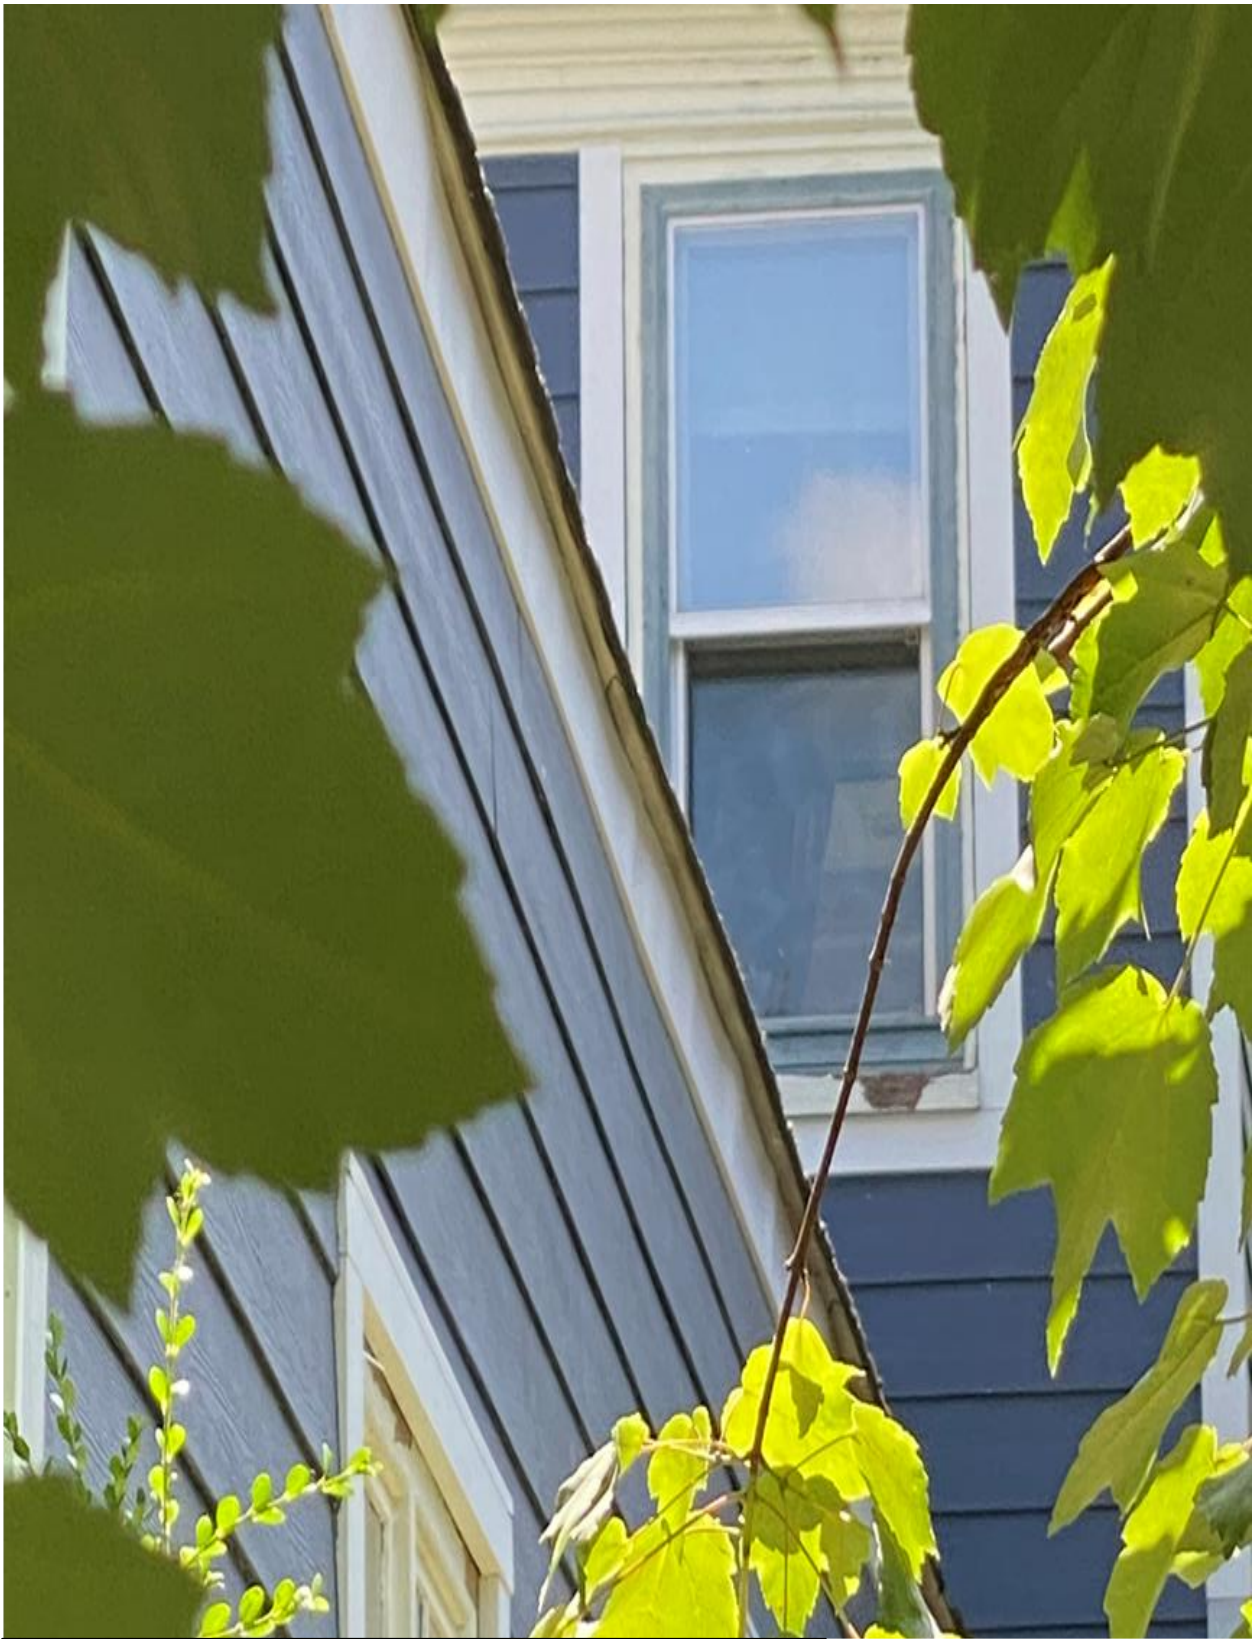
The proposed replacement of the two second-story front facing windows generally does not meet the **Window** design guidelines. The proposed replacement windows are United 9600 Series vinyl composite replacement windows. Vinyl

West Elevation 2nd level existing south side front facing window

windows do not have the same profiles or dimensions as historic wood windows. While the design guidelines allow for synthetic, they do still have to match the historic windows. Staff recommends a different material than vinyl for the front window replacement.

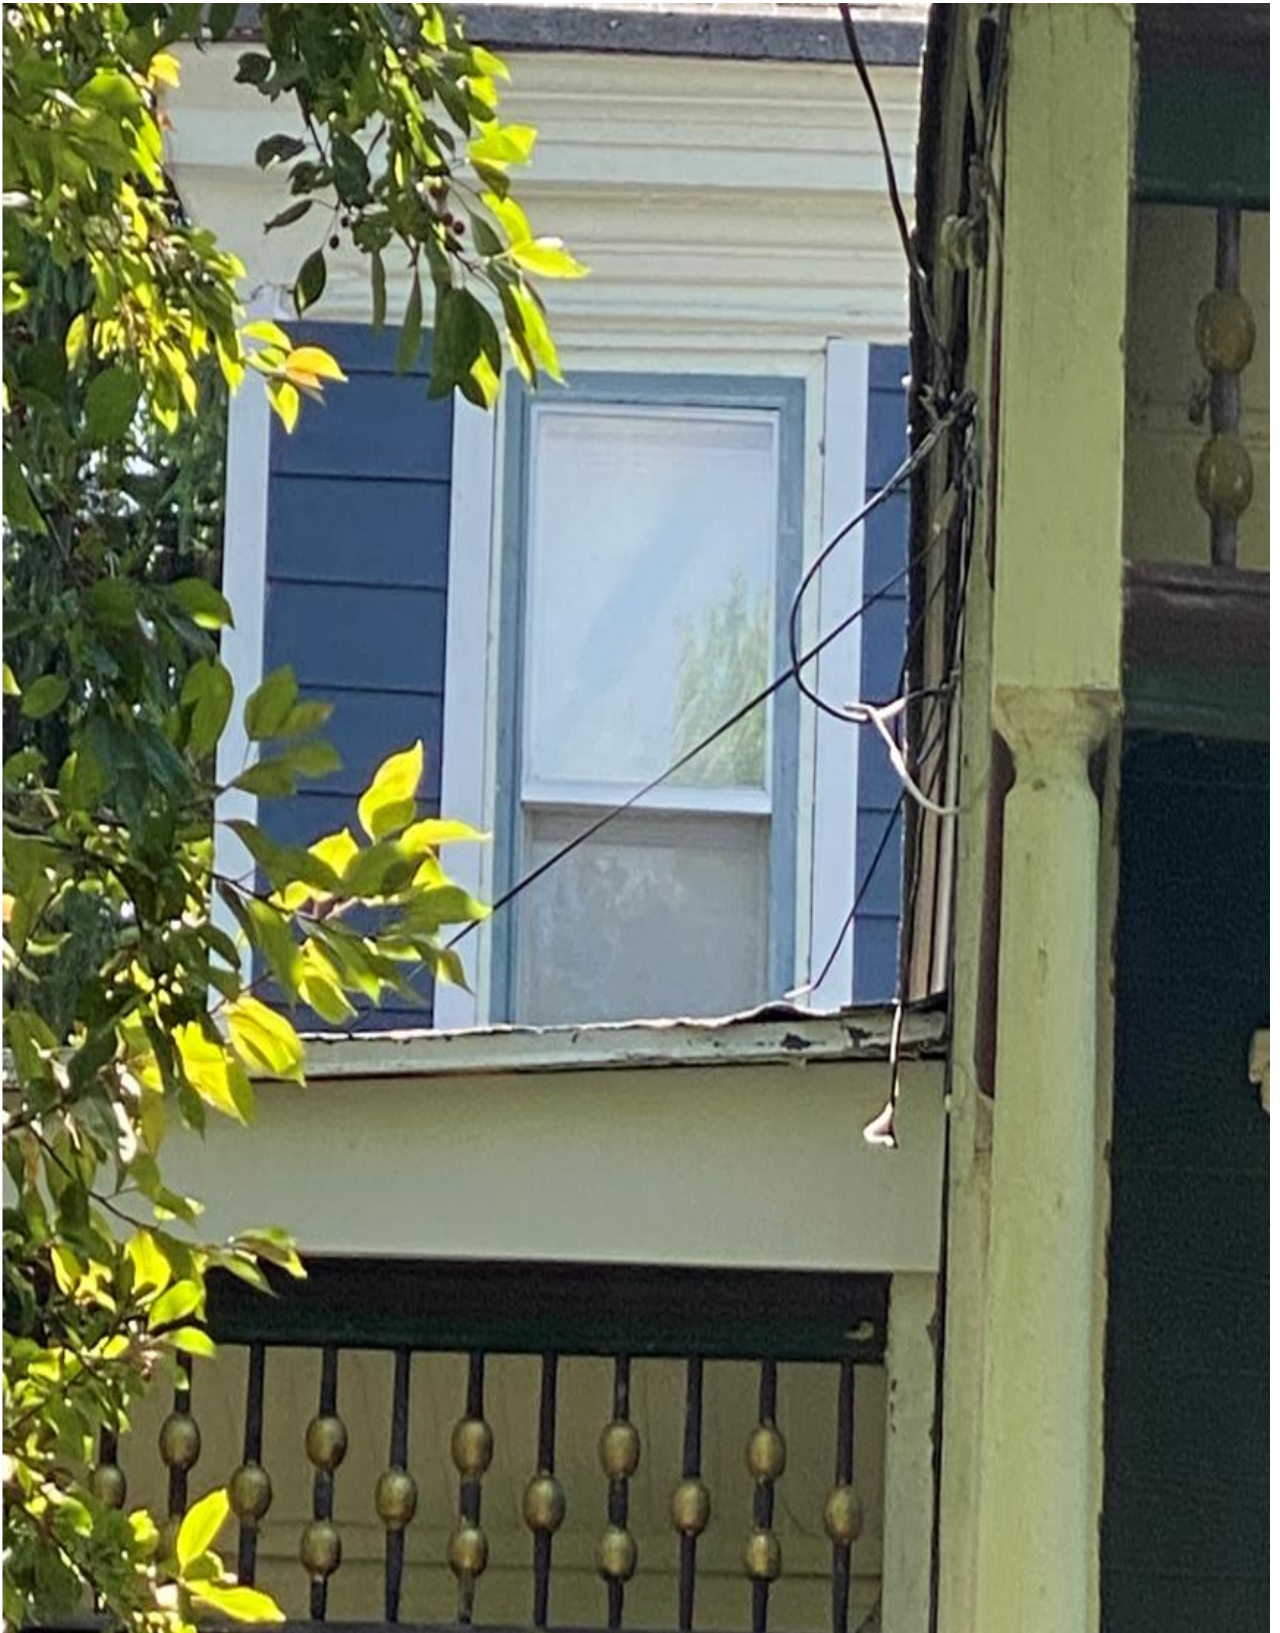
West Elevation 2nd level existing north side front facing window
