1. Historic Name(s) 103 W. Kentucky Street
 Original Owner _____
 2. Present Name 103 W. Kentucky Street
 3. Location 103 W. Kentucky Street

27. National Register District Name:
Old Louisville 0,5,1

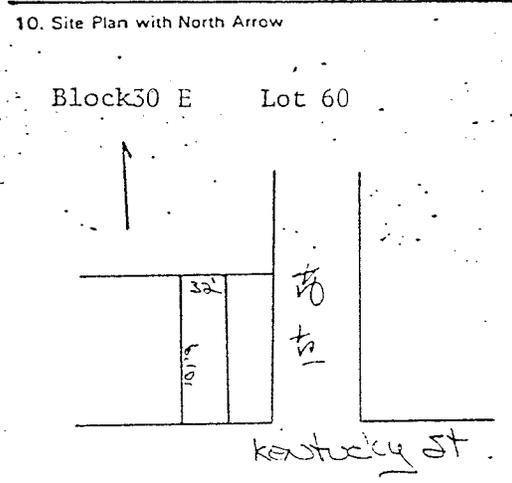
Roll No. 155
 Picture No. 18
 Direction _____
 34. Prepared by
Joanne Weeter
Researcher

18. Description
 This three story brick building has an ashlar masonry foundation and is two bays wide. The entry way is protected by a metal overhang (not original) which probably replaced a masonry porch. The entrance has two recessed doors (not original). On the left is a large window with wood framing above and below and topped with wood voussoirs. This framing
 (Continue on Back) (over)

This structure is typical of residences found in the Old Louisville Preservation District. The building's oriel window, the lattice-work found in the gable of
 (over)

18. was probably added to reduce the size of the original window that is now boarded. The second floor has a one-over-one window on the right with a rectangle of board and batten below and stone voussoirs above. To the left is an oriel window with four one-over-one lights and an art glass transom which has been aluminum sided. The third floor has a small, square casement window on the right and a four-over-four window on the left, flanked by two long narrow two-over-two windows. This window doesn't reach full height and is surmounted by a wide arch with brick voussoirs. A brick stringcourse cuts through the left bay of the third floor and is surmounted by a gable with lattice-work in its peak. An eyebrow vent is visible on the right side of the building's roof.
20. the third floor and the eyebrow vent on the building's roof give this building a unique character.
