**AN ARCHAEOLOGICAL INVESTIGATION OF  
THE VULCAN RUDY SITE (15Jf685)  
JEFFERSON COUNTY, KENTUCKY**

KAS REPORT 53

November 28, 2001

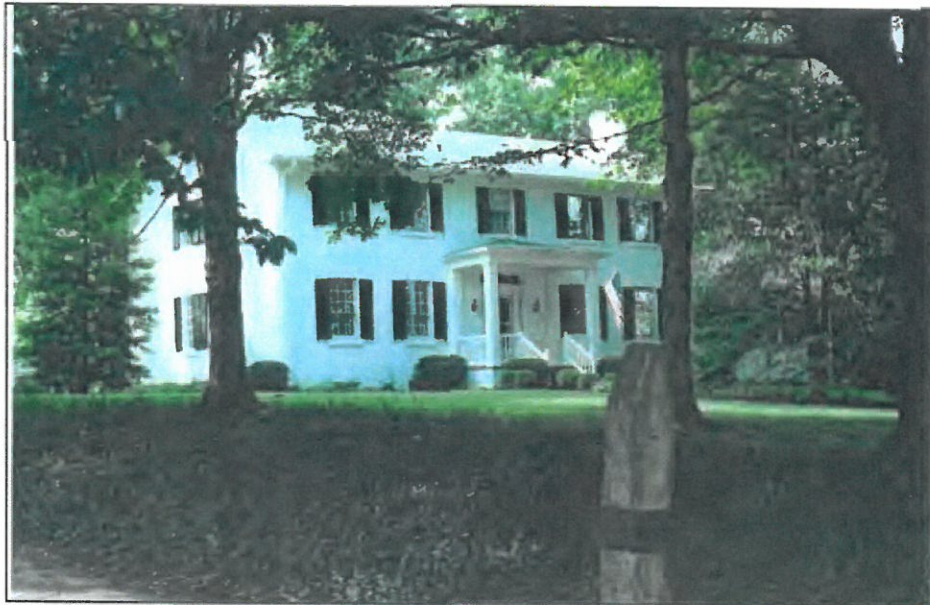
The Vulcan Rudy House was constructed ca. 1822 by George Vulcan Rudy. Additions were made to the structure in the 1850s. The house is currently a five-bay, two-story brick house laid in Flemish bond (Figure 3). Originally, it appears to have been a two-story one room deep house, with a two-room central hall plan (Oppel 1976).

Figure 3. Photograph of the Vulcan Rudy House Looking from the South.

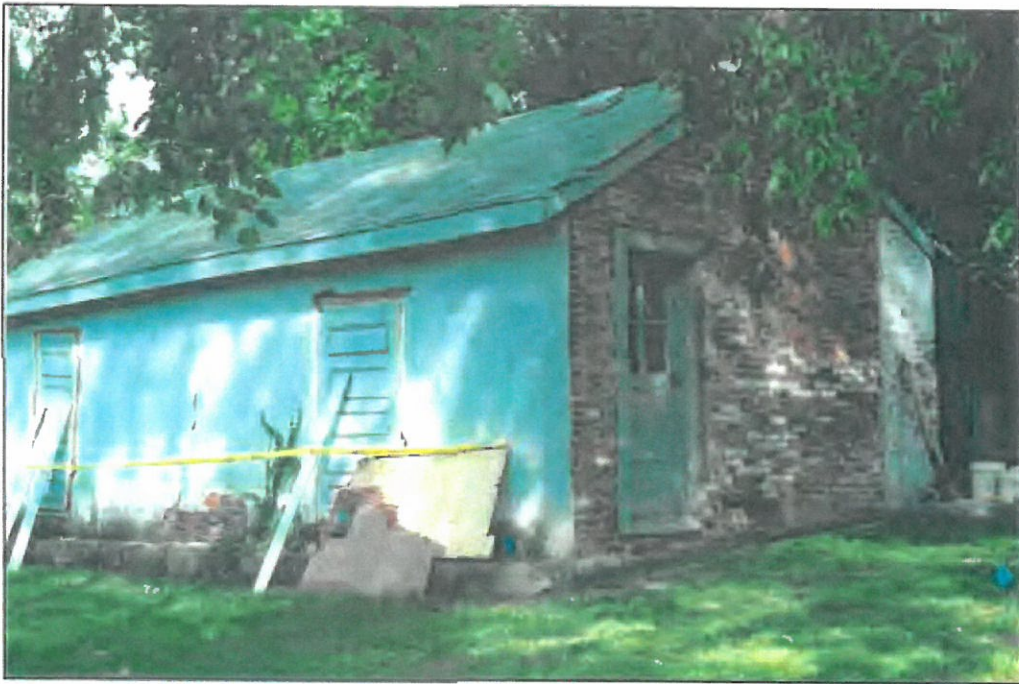
**Figure 7. Photograph of Slave House (North and West Sides).**

During the peak of the Vulcan Rudy plantation the property would have consisted of many outbuildings, such as a kitchen, smoke house, icehouse, barns, sheds, and slave houses. Many of these buildings survived into the early 1900s. However, all that remains of the original outbuildings is a slave house located approximately 30.5 m (100 ft.) behind the main house. The slave house is a two-room brick building with a chimney on each end and a stone foundation (Figures 7 and 8). An examination of the building by architectural historian Bill Macintire of the Kentucky Heritage Council indicates that the structure has been significantly modified over the years. The back windows had been cut into doors, mantles were replaced, floorboards were replaced, a door and window were cut into the gable ends, a screen porch had been constructed, and a large addition constructed (See Appendix A). Basically all that remains of the original structure is the brick shell (Bill Macintire, personal communication). The slave house underwent a major renovation during the 1940s by Mr. and Mrs. Crawford Arterburn, who used it as their home. The Arterburns added a kitchen, bathroom, and a concrete stone patio. The building has not been renovated since and has fallen into disrepair.

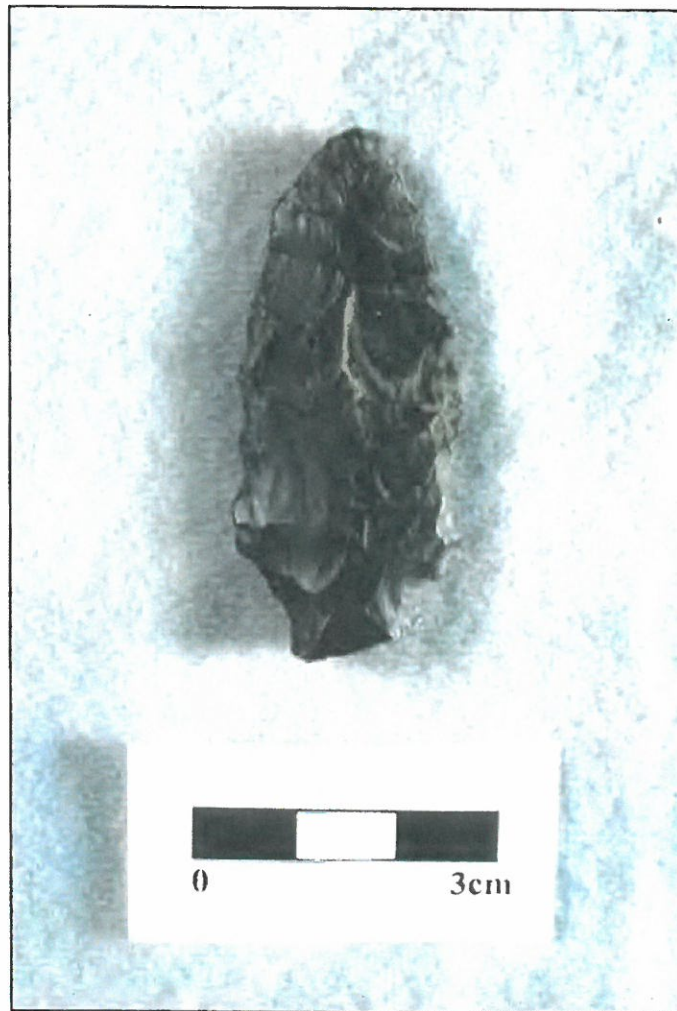
Other materials represented in the artifact assemblage include faunal remains and prehistoric artifacts. The faunal remains included bone (n=117) and snail shell (n=13). The prehistoric artifacts consisted of a chert flake and an Elk River Stemmed projectile point, dating from 3500 to 2000 B.C. (Figure 16) (Justice 1987). The projectile point was made of Sonora chert and was 5 cm long and 2.2 cm wide.

**Figure 16. Elk River Stemmed Projectile Point.**
