# Landmarks Certificate of Appropriateness & Overlay District Permit

Project Name: Conti Carriage House

Project Address / Parcel ID: 2026 Midland Ave 075F00280000 90241

RE: Existing Garage Structure  
2026 Midland Avenue Rear  
Louisville, Kentucky

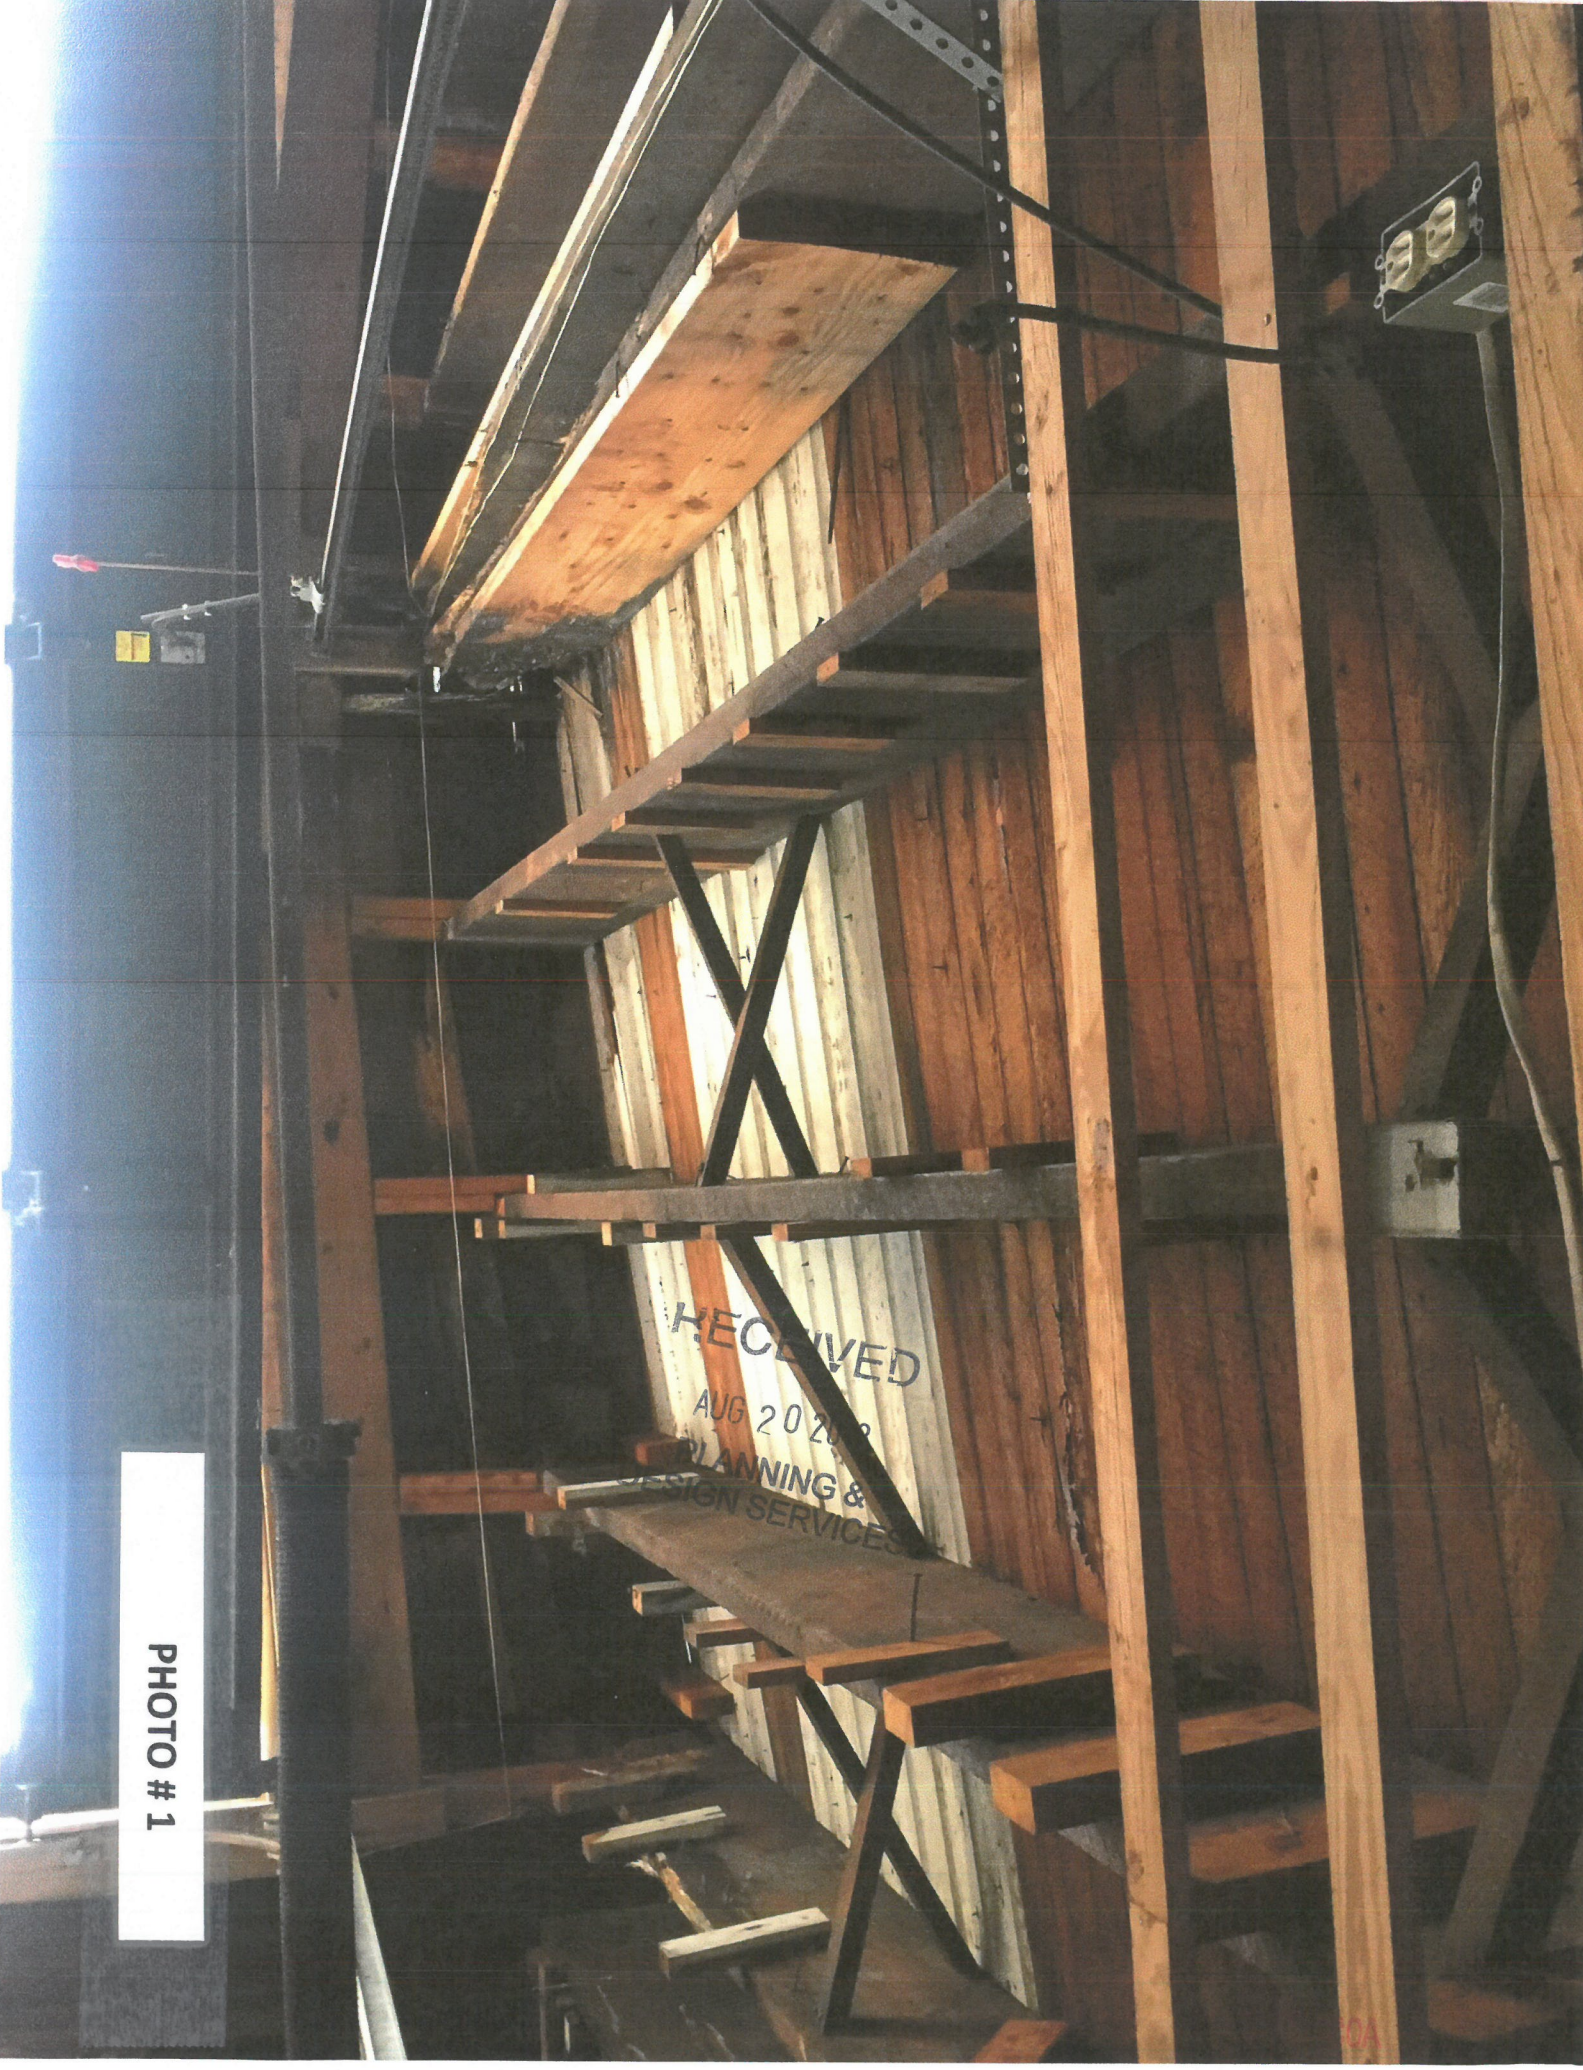
PHOTO # 1

2. The interior of the existing structure at the location of the overhead door (photos 1, 2, 3, & 4) has sustained fire damage that has resulted in a weakening of the roof and overhead door frame in this area.

It is our opinion that the structure in its present condition is unsafe for entry and use. The repair/rehabilitation of the structure is impractical due to the observed structural defects, lack of structural stability (current day shifting of the structure) and the overall deterioration of the existing building components. Our recommendation is that the entire structure be demolished.

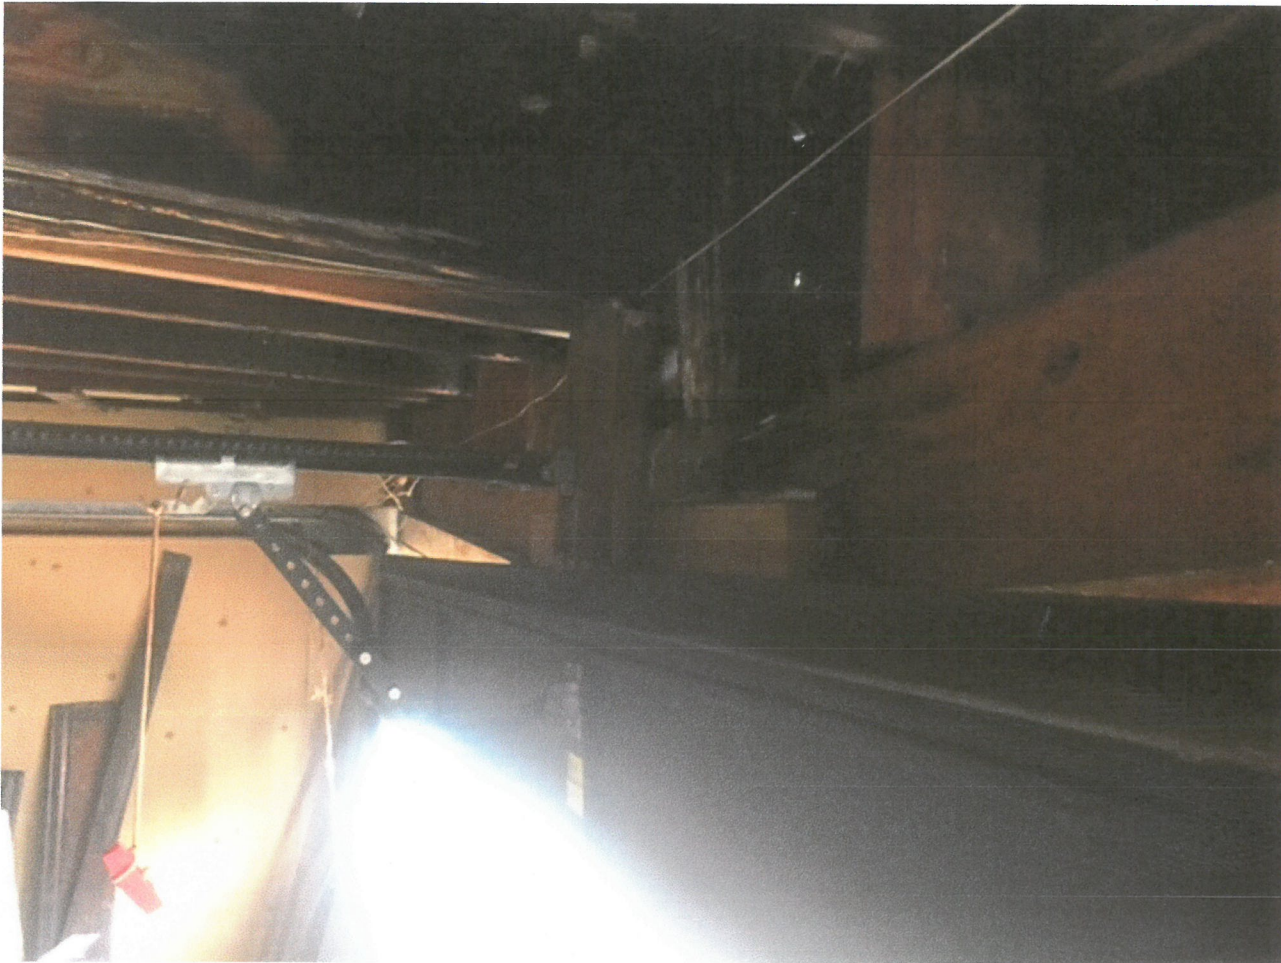
PHOTO # 5

Our second visit to the property confirmed that the framing for the overhead door and the roof structure within this area has experienced additional downward movement in the several weeks since our initial visit. Photo # 5 taken during our second visit shows the garage door header resting on the top of the garage door. Coincident with the failure of the garage door header and the sagging roof the corners of the structure now reflect a "Bow" inward.

This is a photo showing the header and roof now resting on the door if you need it. Can I get the letter tomorrow so I can schedule the city meeting?
