GREENBAUM ASSOCIATES, INC.
GEOTECHNICAL & MATERIALS ENGINEERS

Re: Karst Survey
5101 Bardstown Road
Louisville, Kentucky
Project Number 19-277G

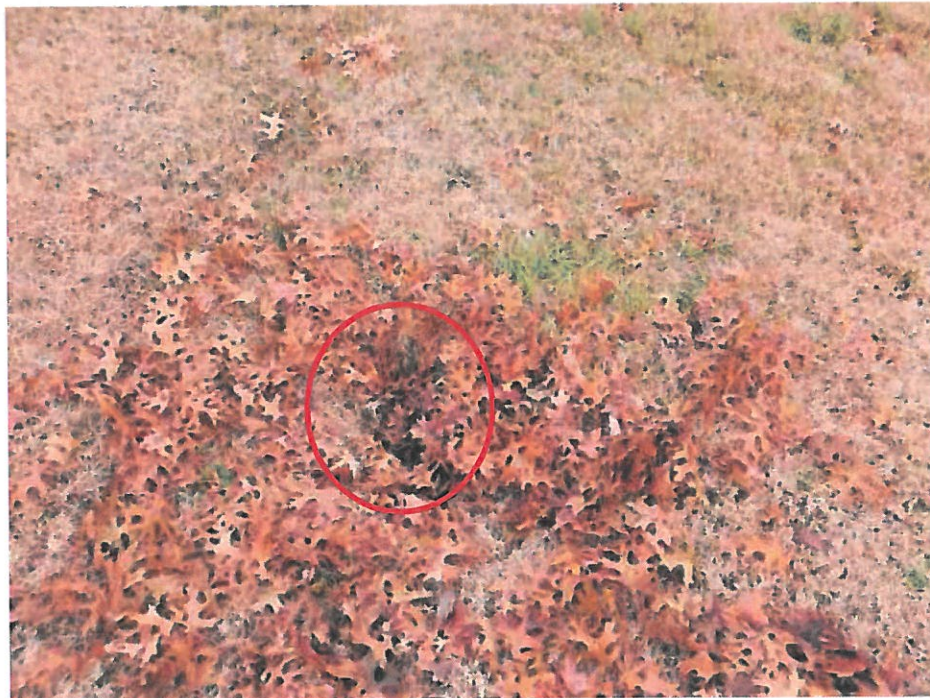
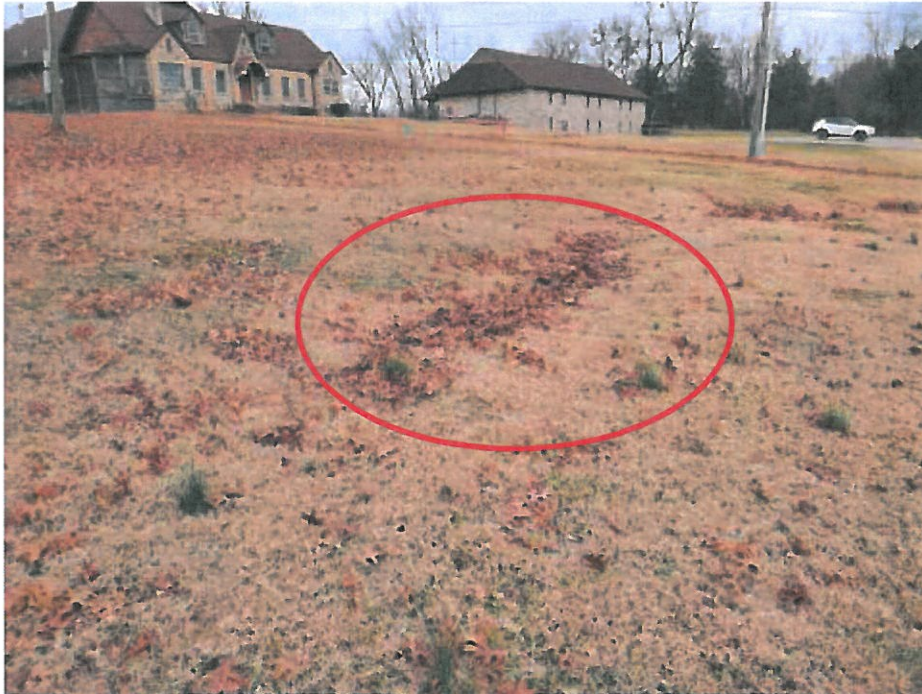
Yesterday I walked the above referenced site to discover any evidence of karst development. Rock appears to be very shallow at this site as evidenced by rock visible on the ground surface at a couple locations and large pieces of rock present in the material excavated and visible where a sewer was installed in the southwest portion of the property. In the northwest portion of the property, I found what appears to be a karst feature on the property. It forms a lineation across that portion of the property and an opening in the soil is visible at one point (see photographs below).

It is our understanding that there is to be no construction in the portion of the site in which the karst features mentioned previously are found. A building is proposed for the rear of the site in an area that has been filled. As far as we are aware, the nature and compaction of this fill is undocumented. This report does not address the condition of that fill since that is beyond the scope of this investigation.

There is no evidence of karst development at the rear of the site, nor is there evidence of karst development in the southeast portion of the site where a shallow detention basin is planned.

If construction is to take place in the portion of the site in which karst features are present, it will be necessary to expose the bedrock and install a filter in any crevices or openings in the bedrock. A diagram of a typical treatment of a karst feature using a filter is included with this letter for illustration.
