Traffic Impact Study

Garrett Bridwell
Old Heady Road
Louisville, KY

Louisville Metro Planning Commission

DIANE B. ZIMMERMAN
Traffic Engineering, LLC

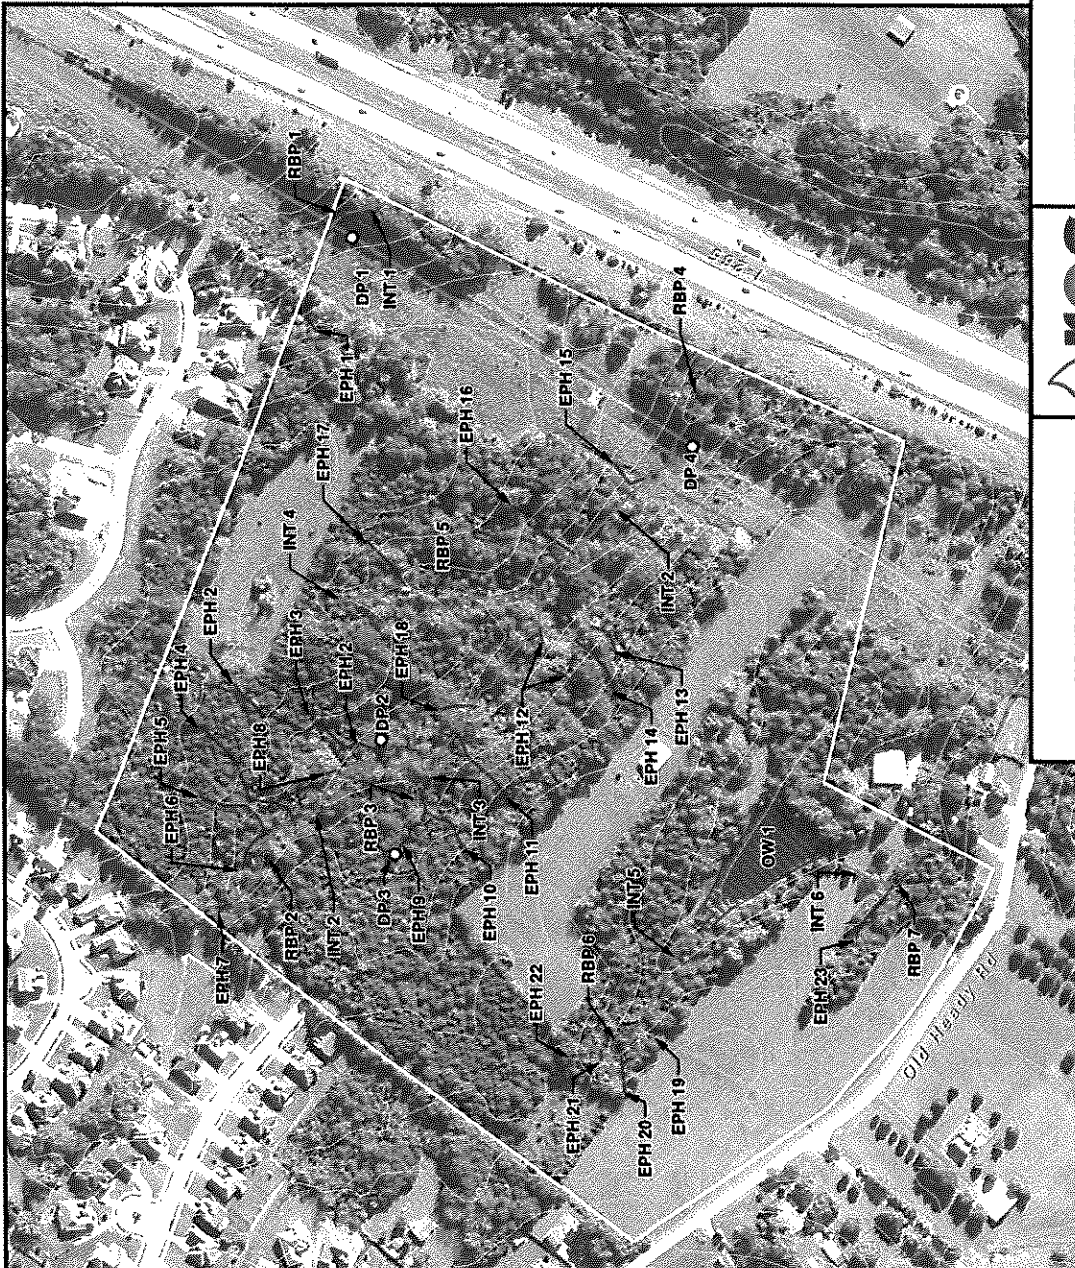
Water Wetland Location Map

Non-jurisdictional water/wetland features identified during the field assessment include 23 ephemeral streams totaling 2,611 linear feet (0.097 acre). No wetlands were present. Wetland determination data were formally collected at four data points within the project boundary (Figure 3) and are attached as Appendix A. The quality of intermittent streams was assessed using Rapid Bioassessment Protocol (RBP) methodology established by the U.S. Environmental Protection Agency (USEPA). The RBP forms are provided as Appendix B. An Approved Jurisdictional Determination Form is provided as Appendix C. The results of the water/wetland delineation are summarized in Table 1 (attached), depicted on Figure 3, and discussed below.

- Approximate Project Boundary
- Open Water Pond
- Intermittent Stream
- Ephemeral Stream
- Culvert
- Wetland Determination Data Point
- Rapid Bioassessment Protocol Point

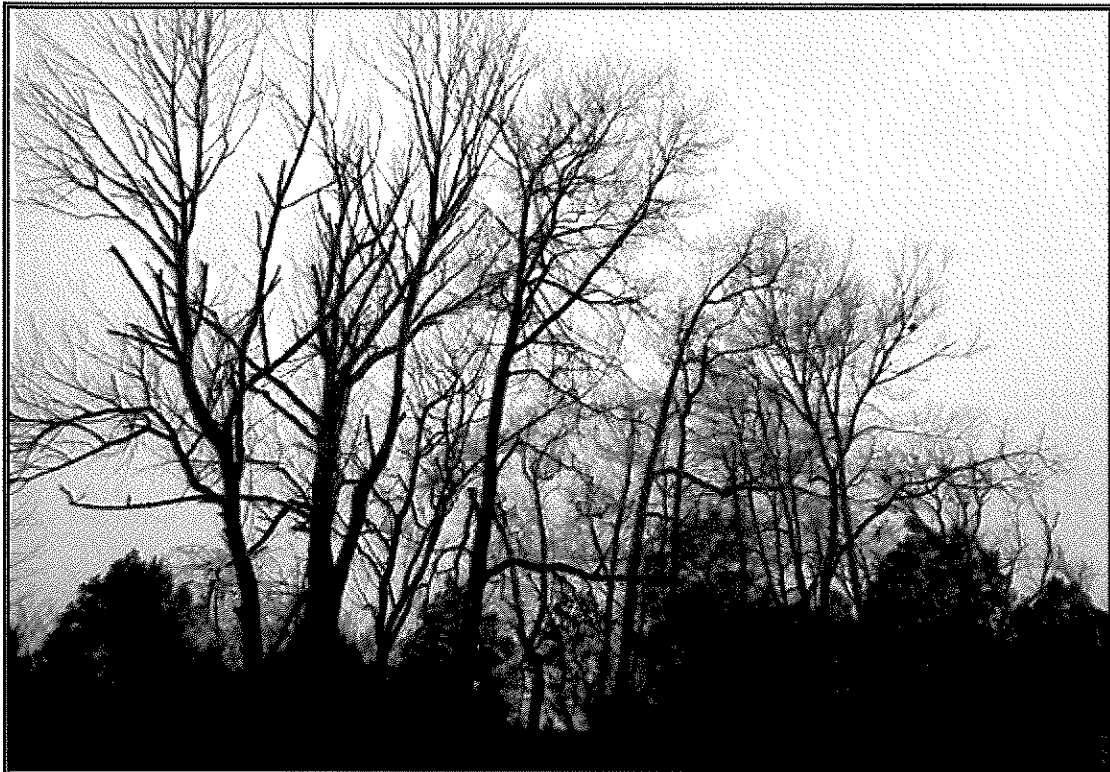
Photograph 1: General view of the upland mixed-age woods found throughout the site. This habitat is dominated by trees/shrubs such as white oak, bush honeysuckle, eastern red cedar. January 11, 2021.

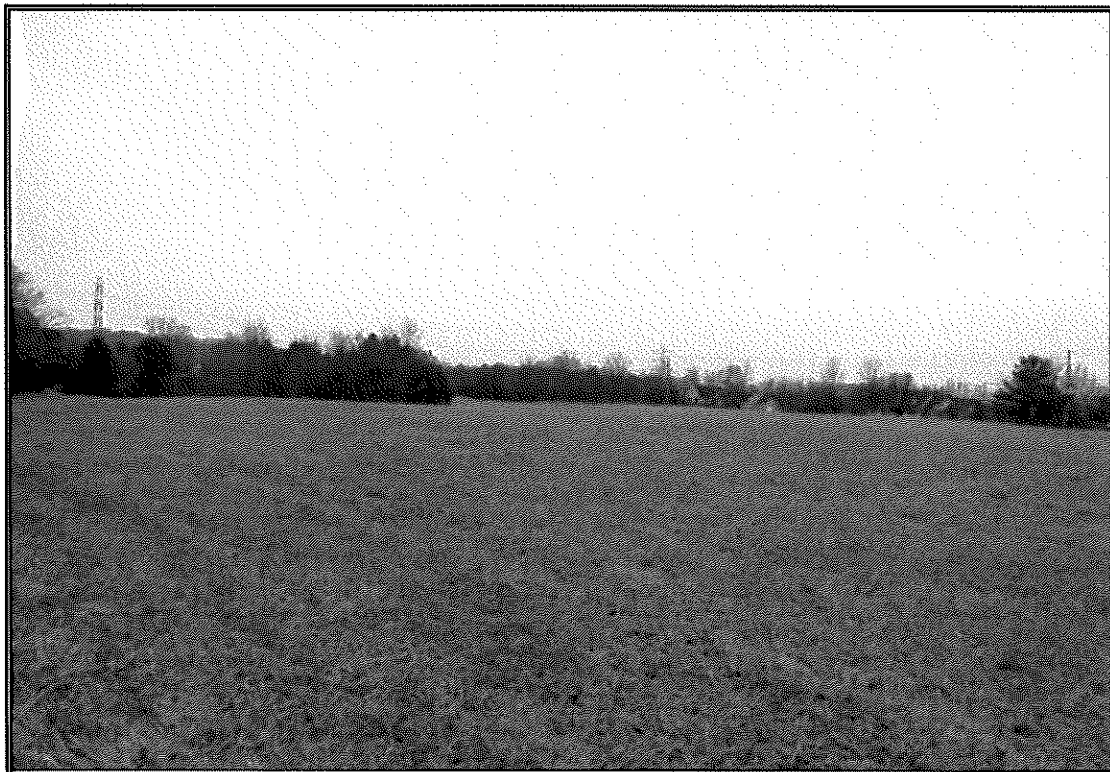
Photograph 2: General view of the maintained open field habitat located throughout the site. January 11, 2021.

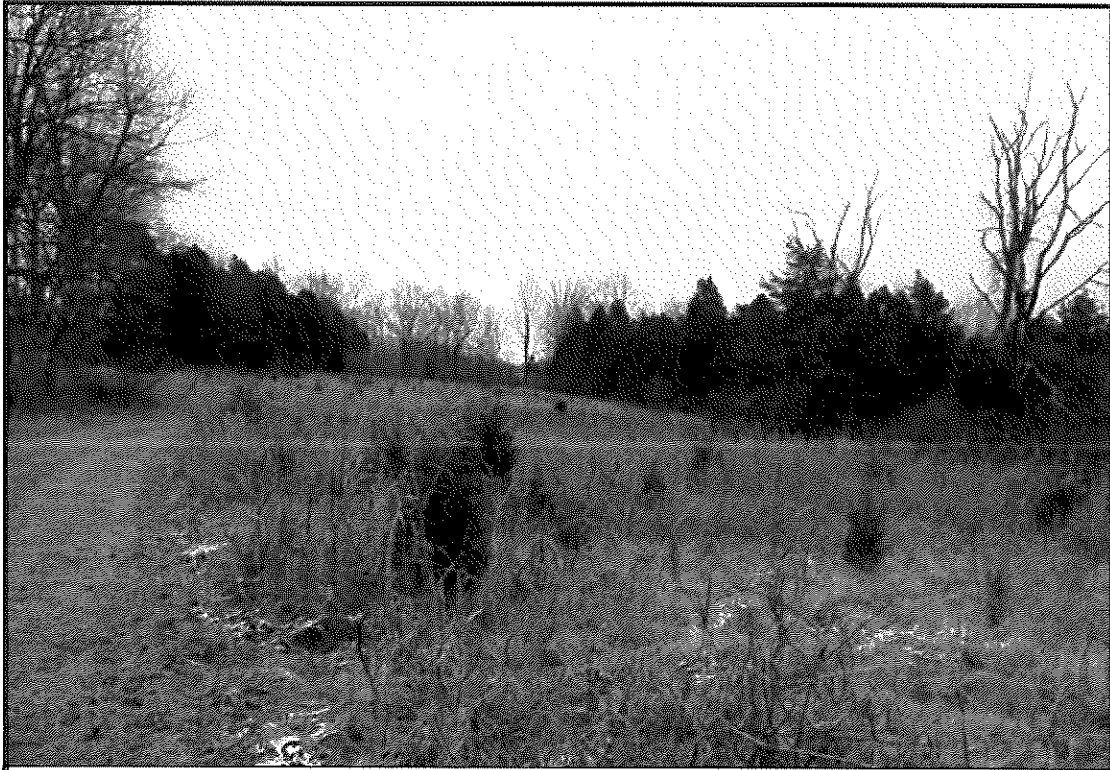
Photograph 3: General view of the old field habitat located throughout the site. January 11, 2021.

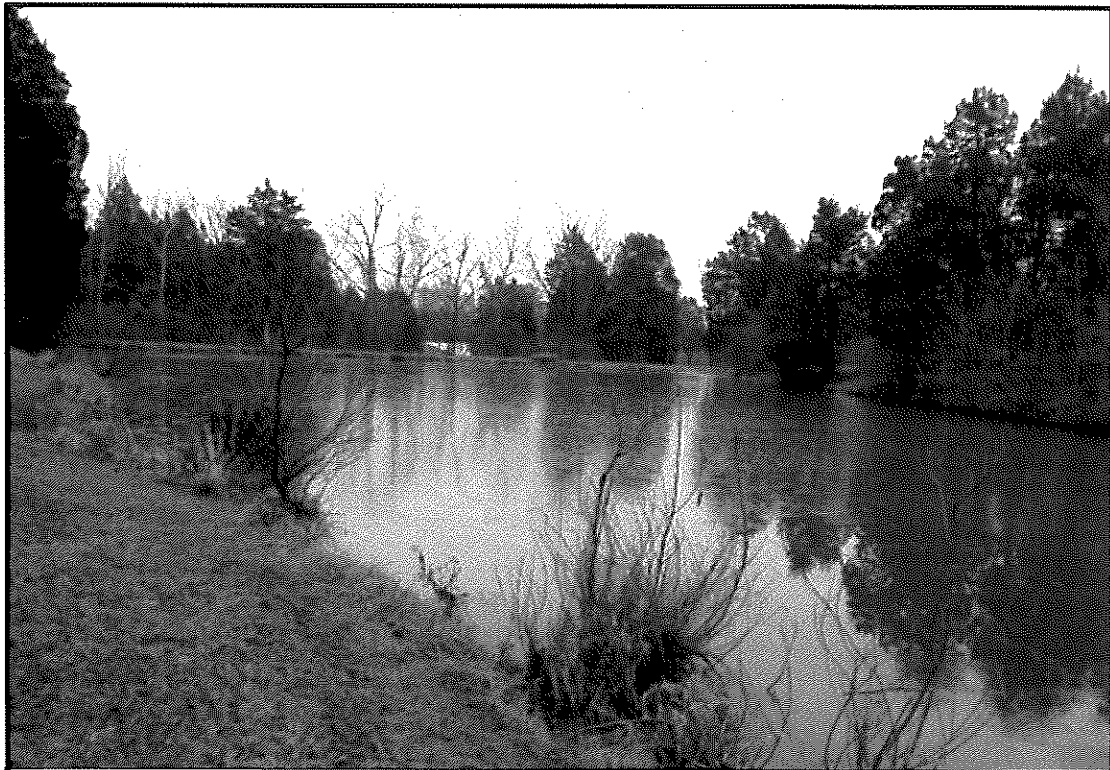
Photograph 4: Open Water Pond 1 is located in the south-central portion of the site. January 11, 2021.

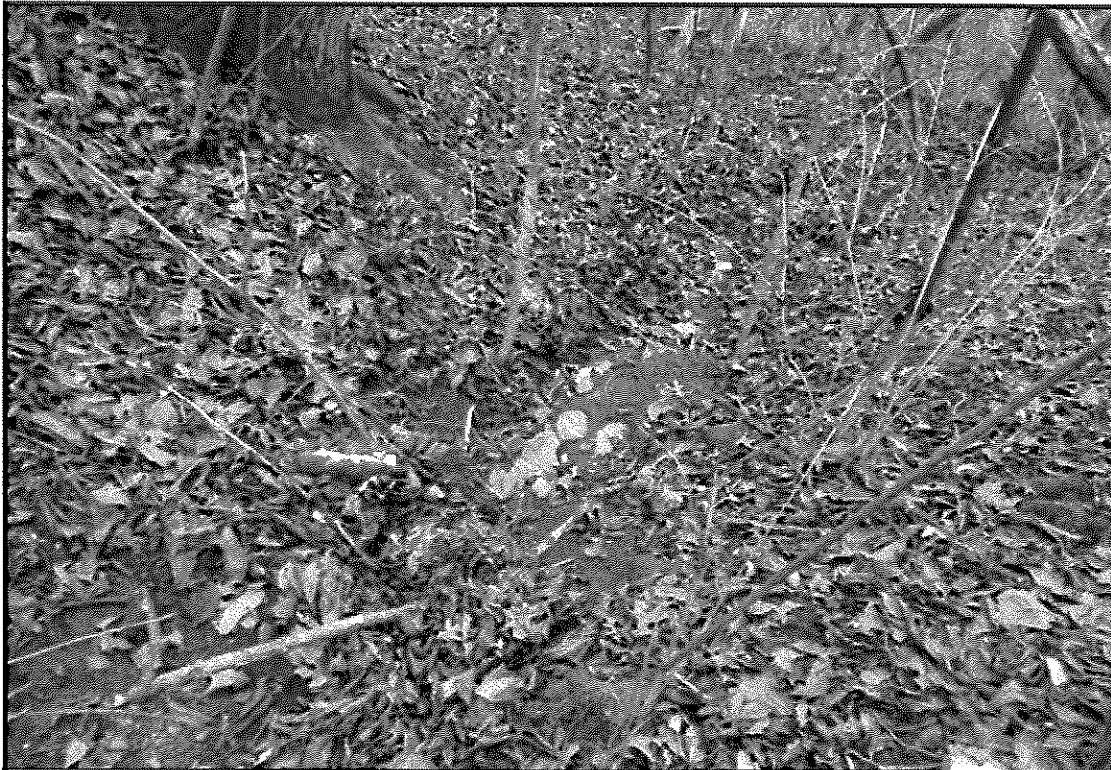
Photograph 5: Downstream view of Ephemeral Stream 11. This is a representative view of the on-site ephemeral streams. These streams did not have flowing water at the time of the field assessment. January 11, 2021.

Ephemeral Streams: A total of 23 ephemeral streams were identified within the project boundary. The ephemeral streams are approximately one to two feet wide with bank heights ranging from one to two feet. The substrates consist primarily of silt with scattered gravel and cobble. Only shallow isolated standing pools of water were observed within the banks of the ephemeral streams during the field assessment, confirming that they only flow in direct response to precipitation. Thus, they are considered non-jurisdictional features under the NWPR.

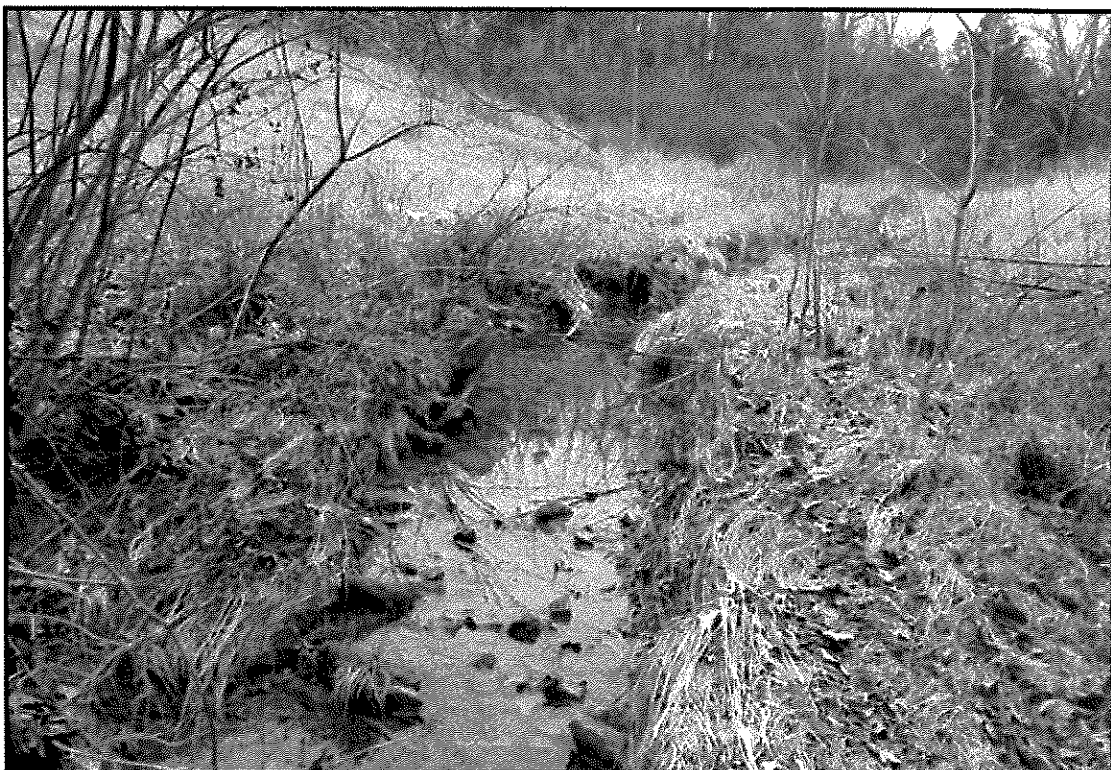
Photograph 6: Downstream view of Intermittent Stream 2 in the central portion of the site. Downstream waters continue off site and flow under I-265 and into Shinks Branch. January 11, 2021.

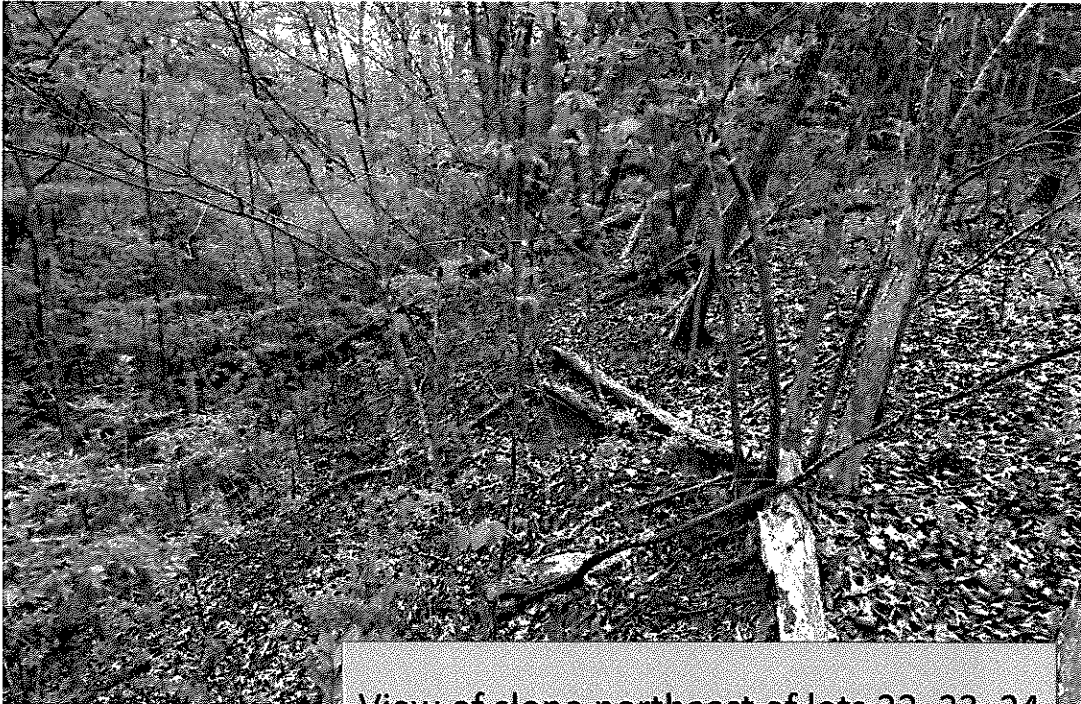
View of slope northeast of lots 22, 23, 24

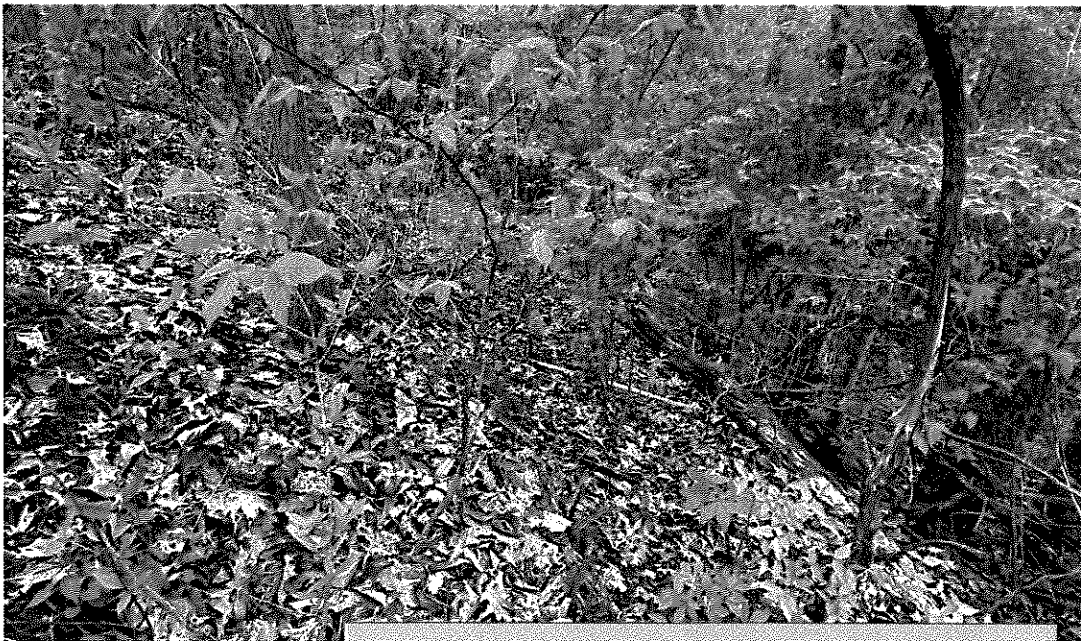
View of slope northeast of lot 24

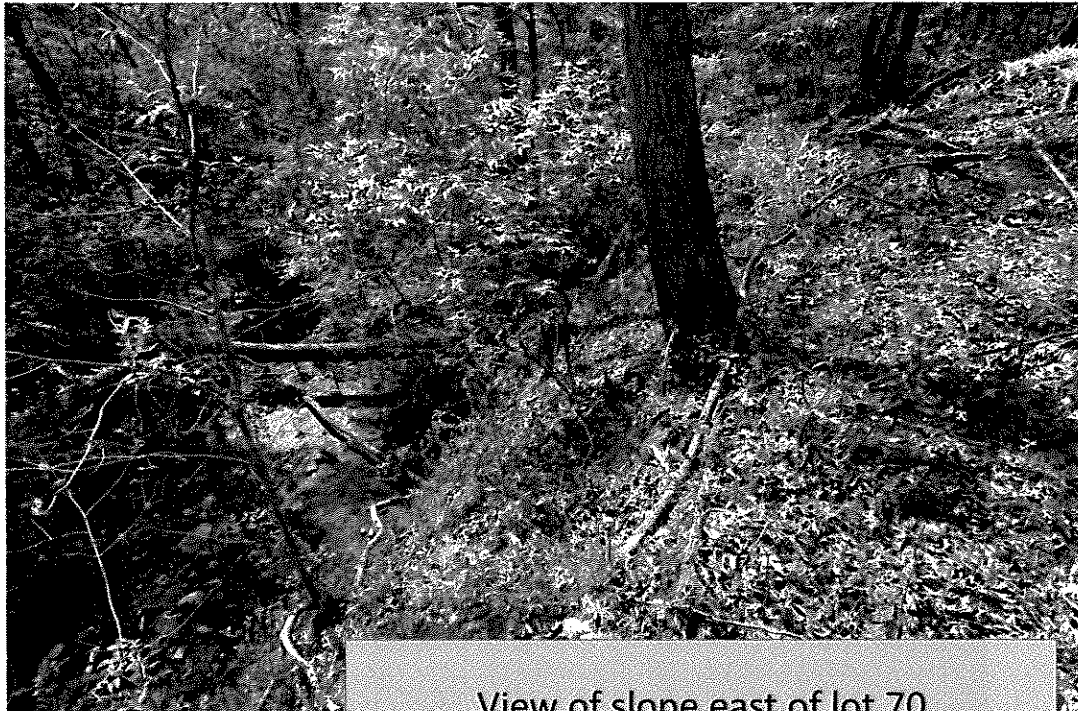
View of slope east of lot 70
