**Subject: Request for Jurisdictional Determination – DRAFT  
Old Heady Property  
Jefferson County, Kentucky  
Redwing Project No.: 20-236**

OLD HEADY PROPERTY  
JEFFERSON COUNTY, KENTUCKY

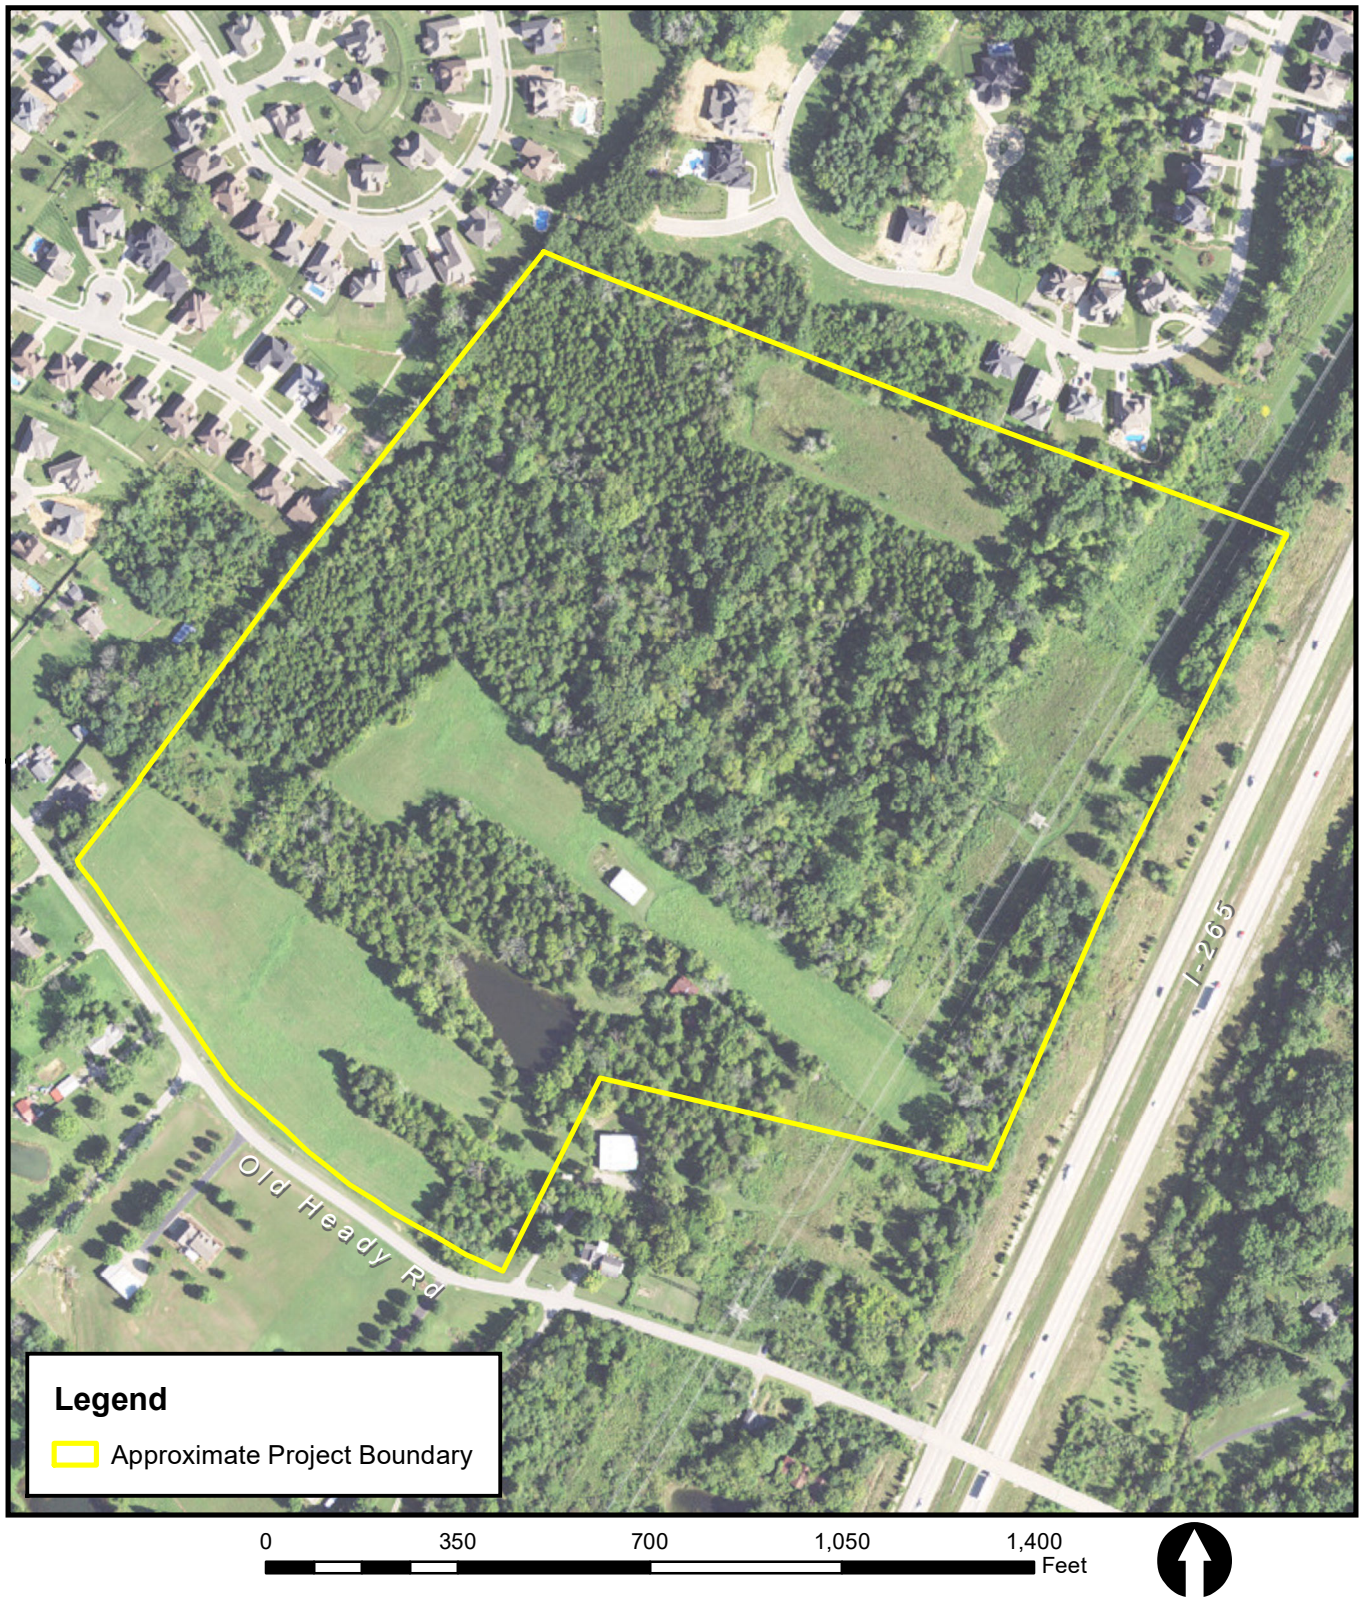
The project site consists primarily of upland mixed-age woods, maintained open field and old field habitat (Figure 2). Based on the water/wetland delineation, jurisdictional features on the site include six intermittent streams totaling 3,138 linear feet and one open water pond measuring 0.716 acre. The non-jurisdictional water/wetland features identified on site include 23 ephemeral streams totaling 2,611 linear feet (Figure 3). These ephemeral streams are considered non-jurisdictional features under the Navigable Waters Protection Rule (NWPR 2020). No wetlands were identified on site.

**Vegetation:** The project boundary consists primarily of mixed-age upland woods, maintained open field, and old field habitat (Figure 2). No wetland plant communities were observed.

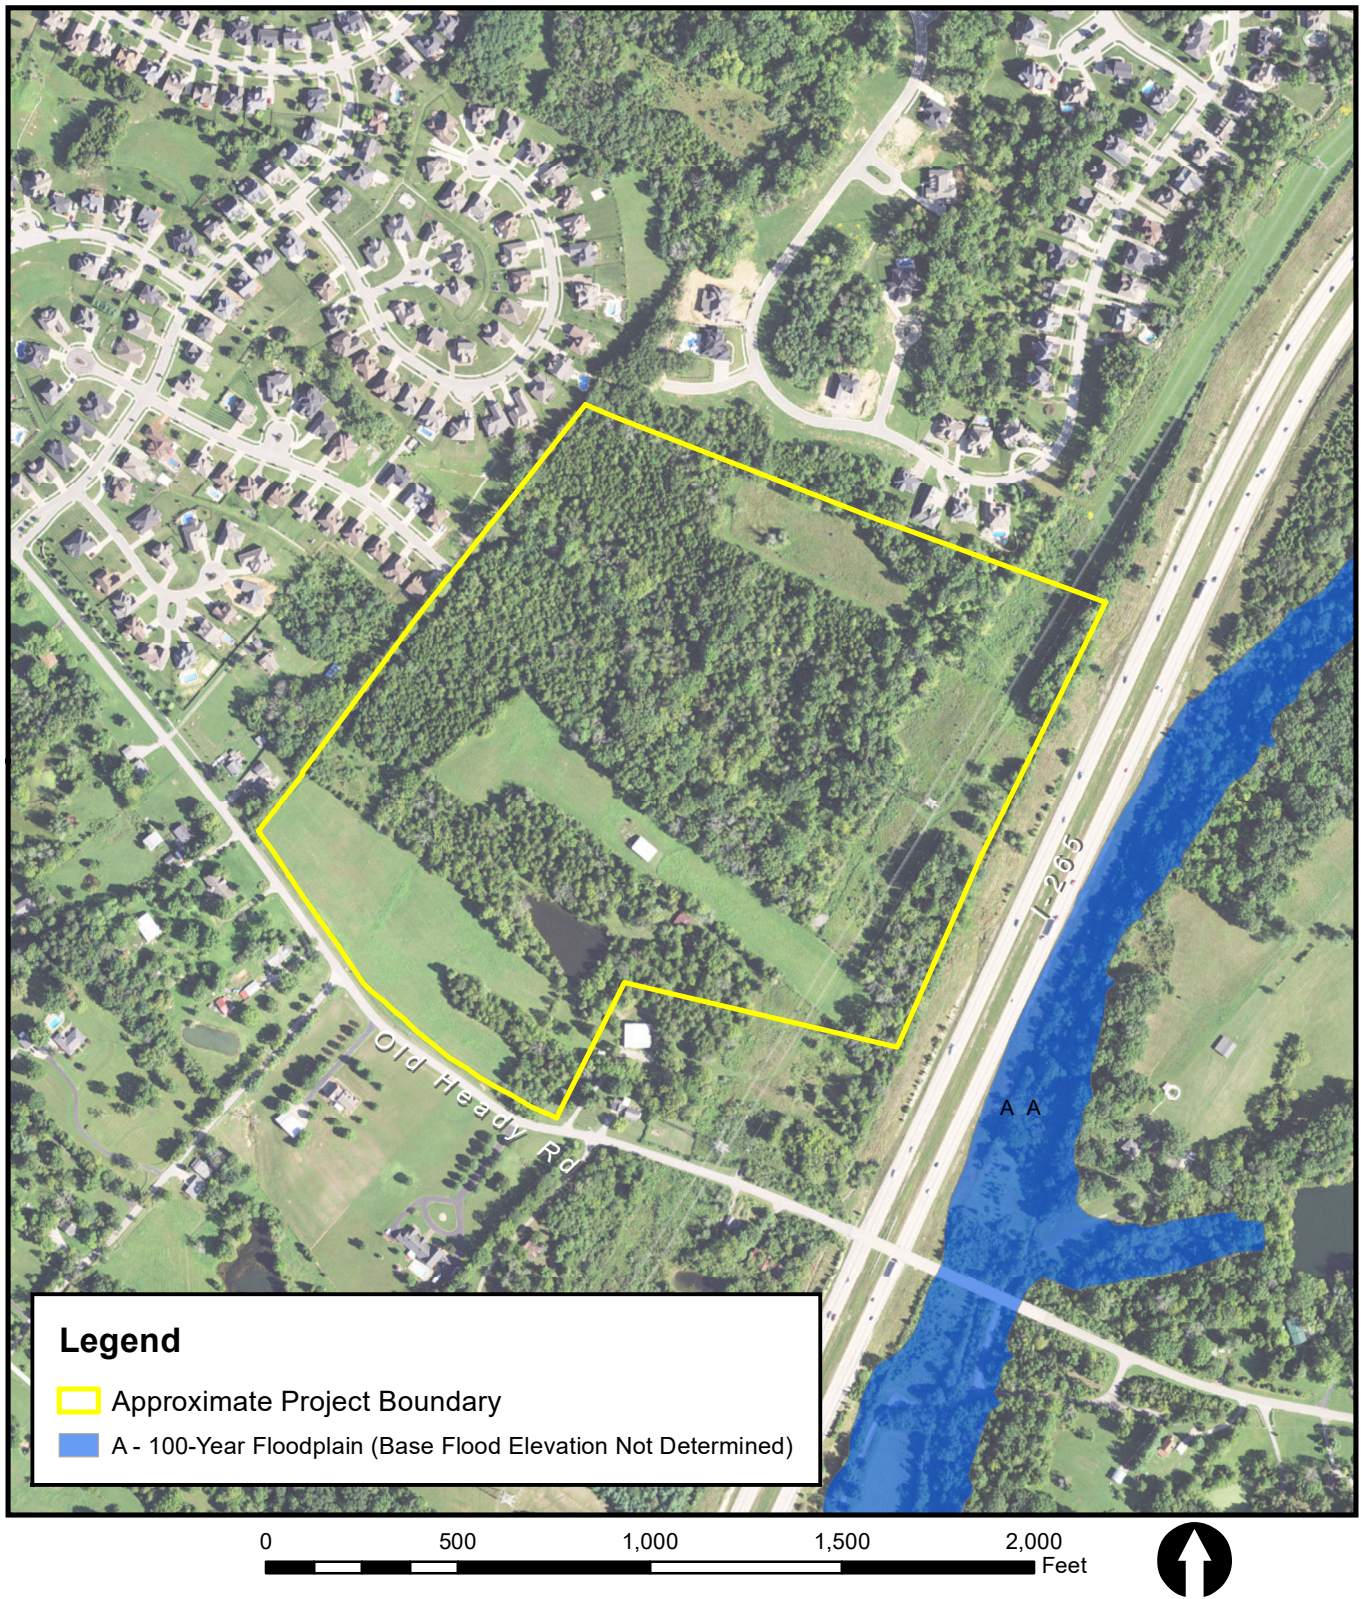
**Hydrology:** The main sources of hydrology to the site include direct precipitation and surface runoff from adjacent areas. The site is not located within the 100-year floodplain (Figure 5). No wetland hydrology indicators were observed at the four wetland data point locations.

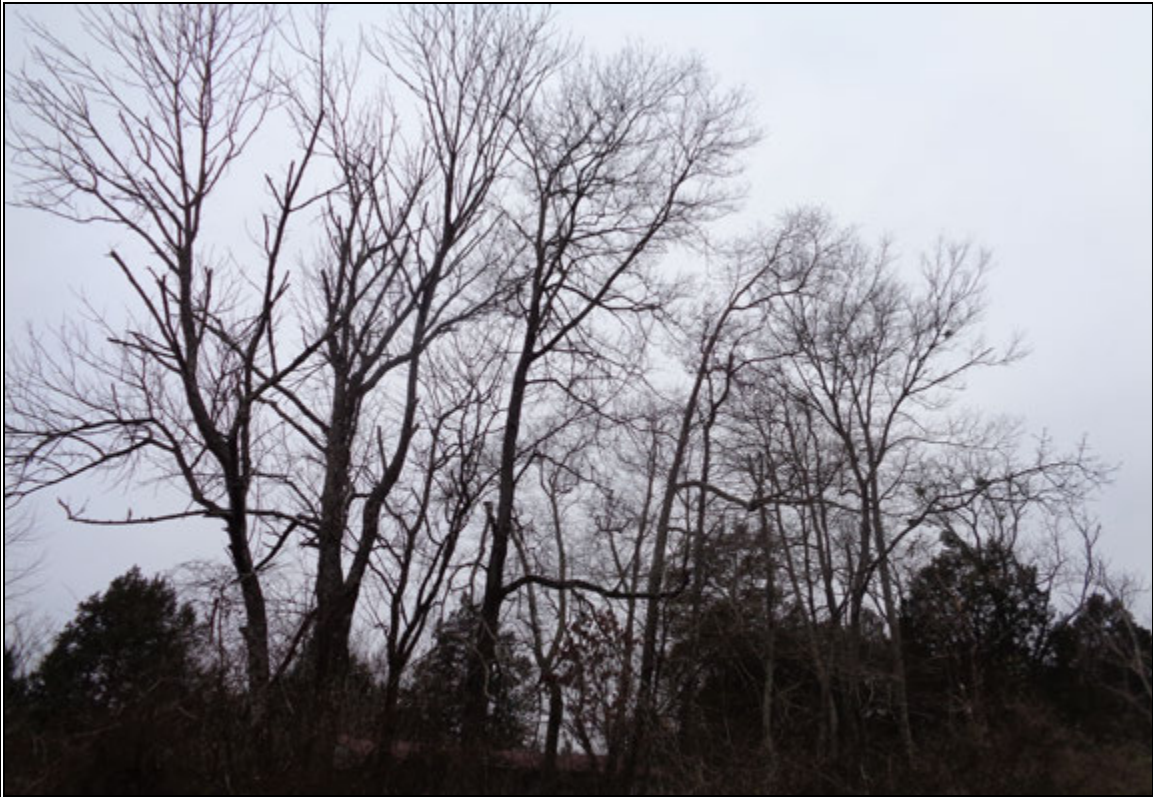
Common species in the upland woods habitat include: eastern red cedar (*Juniperus virginiana*), bush honeysuckle (*Lonicera maackii*), chinkapin oak (*Quercus muehlenbergii*), white oak (*Quercus alba*) and shagbark hickory (*Carya ovata*). These species are listed as upland (UPL) and facultative upland (FACU), in the *National Wetland Plant List: Eastern Mountain and Piedmont Final Regional Wetland Plant List – 2018, Version 3.4* (NWPL).

Photograph 1: General view of the upland mixed-age woods found throughout the site. This habitat is dominated by trees/shrubs such as white oak, bush honeysuckle, eastern red cedar. January 11, 2021.

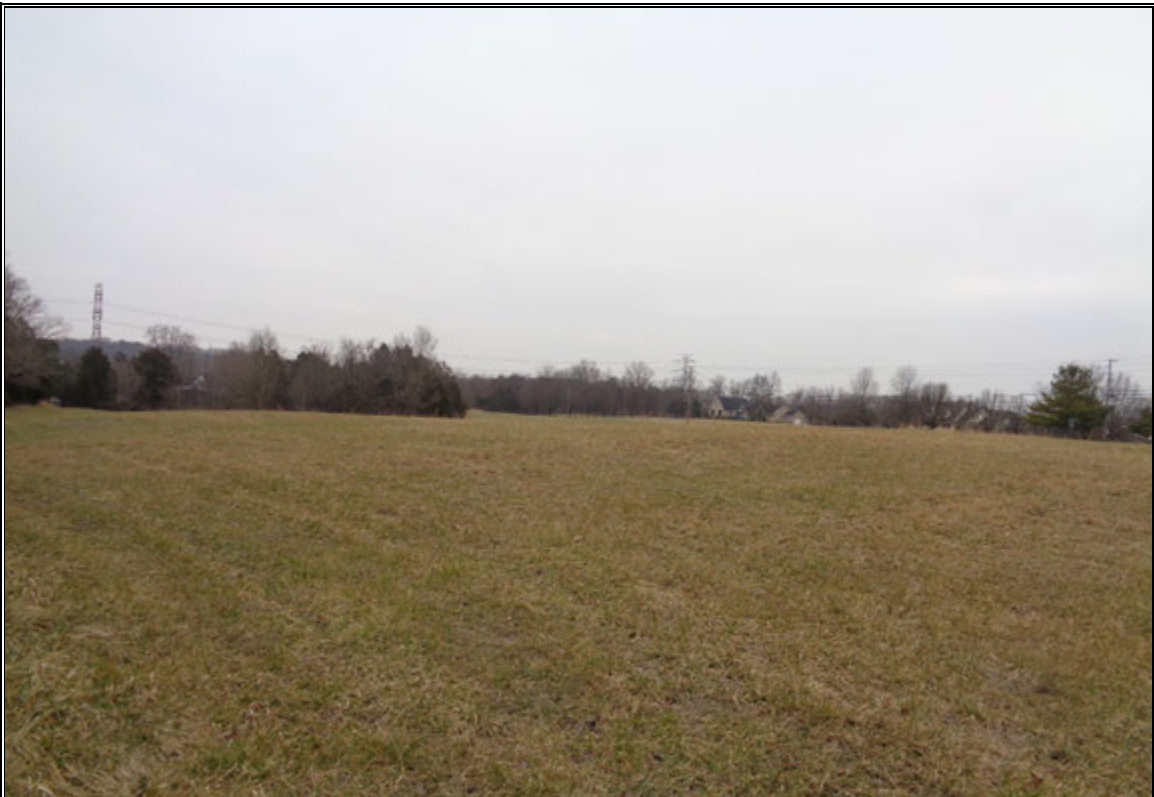
Common species in the maintained open field habitat include: tall fescue (*Schedonorus arundinaceus*), yellow foxtail (*Setaria pumila*), nodding foxtail (*Setaria faberi*), broomsedge (*Andropogon virginicus*), and white clover (*Trifolium repens*). These species are listed as UPL, FACU, and facultative (FAC) in the NWPL.

Photograph 2: General view of the maintained open field habitat located throughout the site. January 11, 2021.

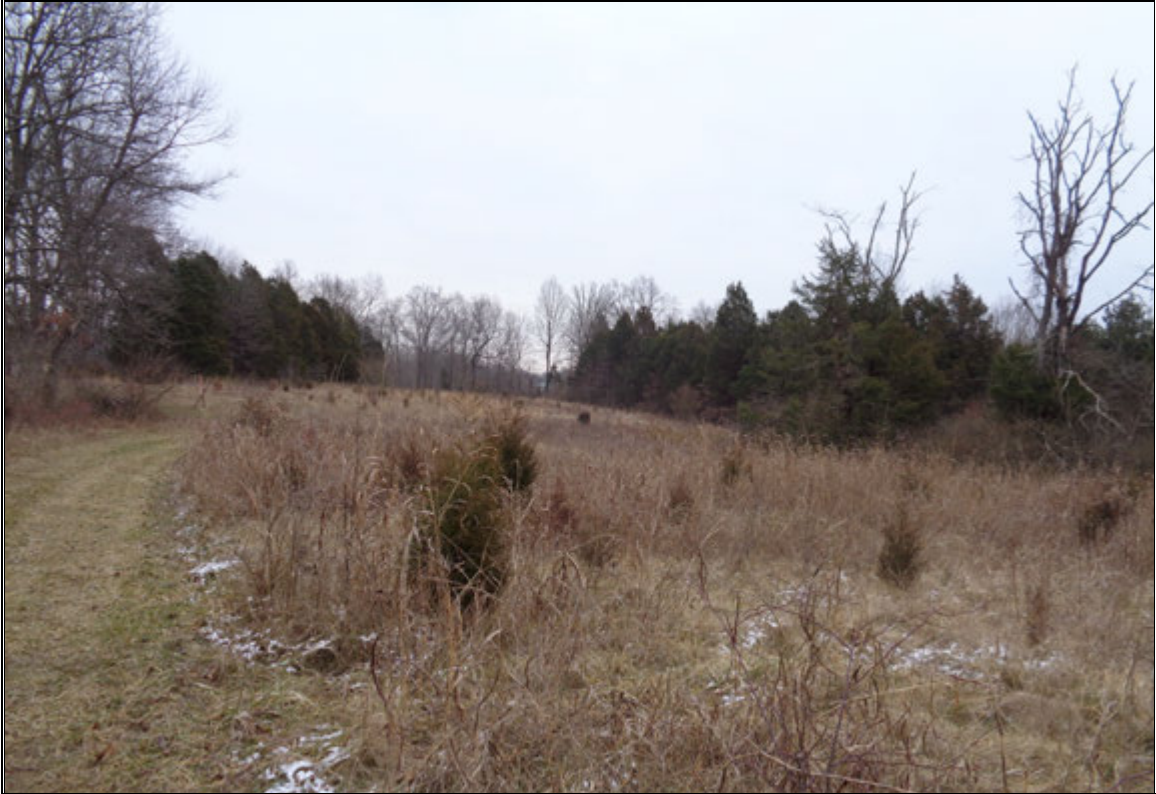
Photograph 3: General view of the old field habitat located throughout the site. January 11, 2021.

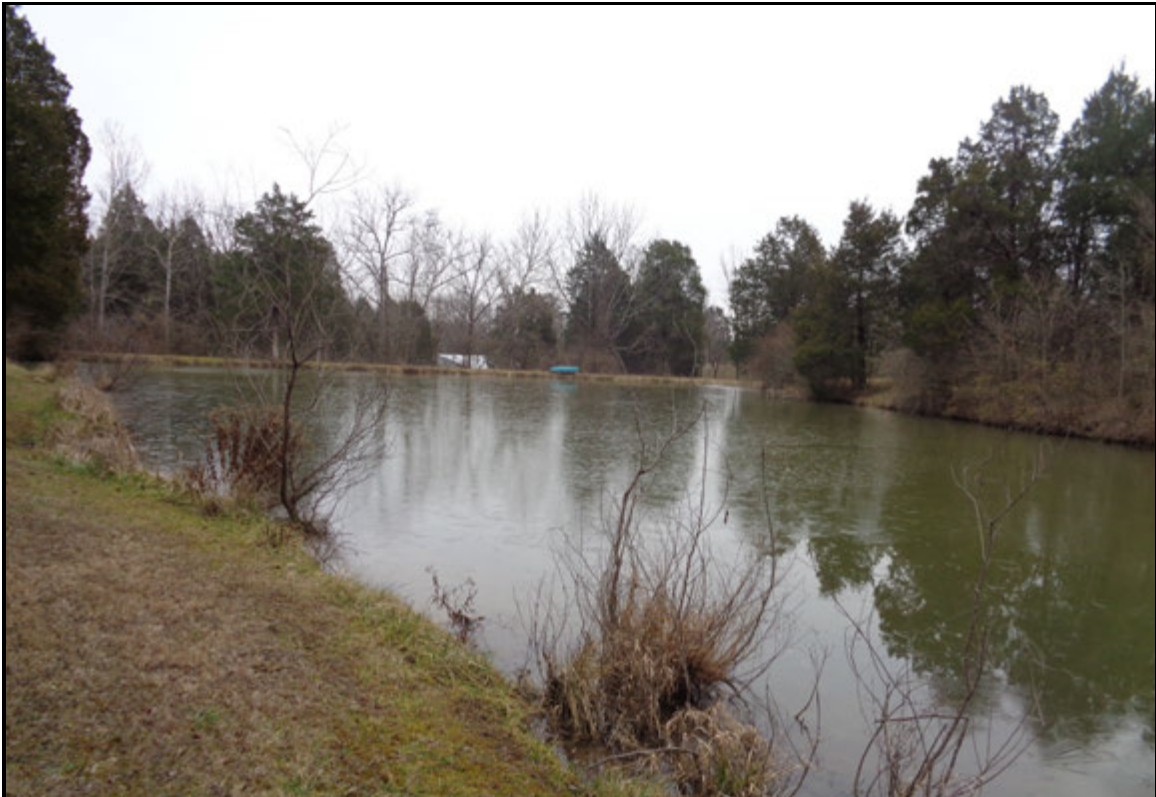
Photograph 4: Open Water Pond 1 is located in the south-central portion of the site. January 11, 2021.

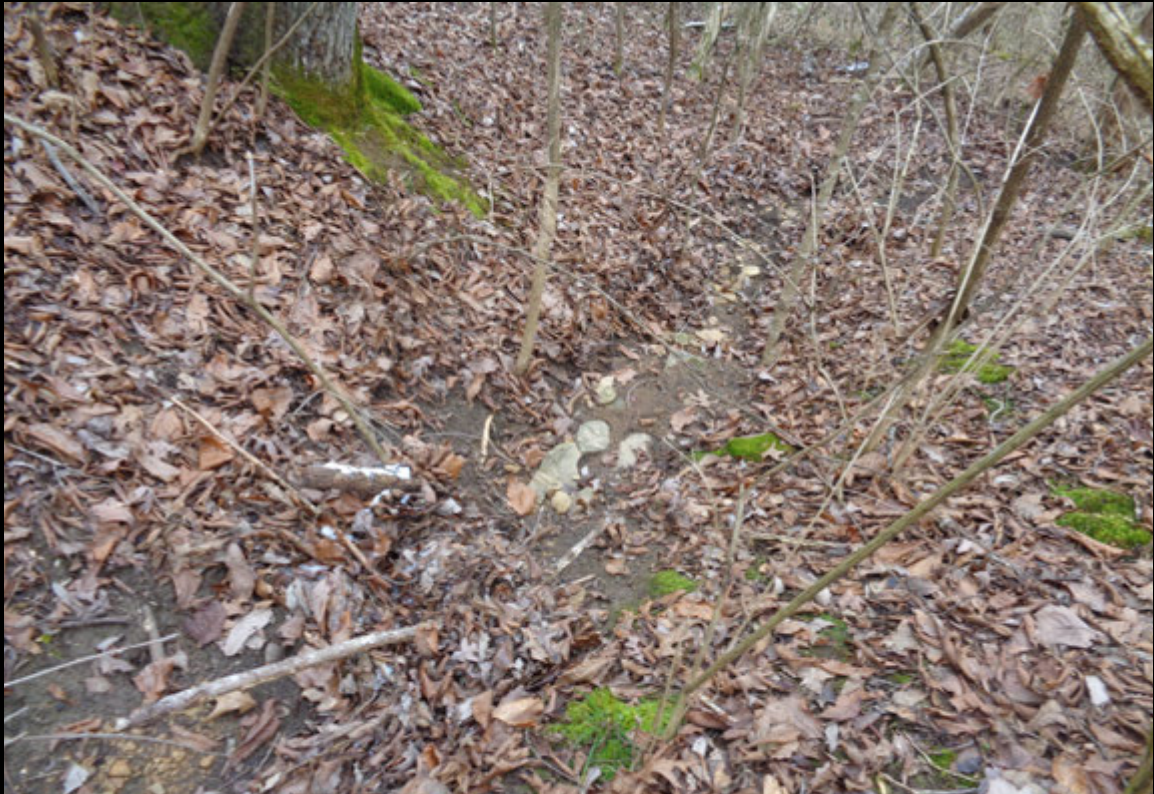
**Ephemeral Streams:** A total of 23 ephemeral streams were identified within the project boundary. The ephemeral streams are approximately one to two feet wide with bank heights ranging from one to two feet. The substrates consist primarily of silt with scattered gravel and cobble. Only shallow isolated standing pools of water were observed within the banks of the ephemeral streams during the field assessment, confirming that they only flow in direct response to precipitation. Thus, they are considered non-jurisdictional features under the NWPR.

Photograph 5: Downstream view of Ephemeral Stream 11. This is a representative view of the on-site ephemeral streams. These streams did not have flowing water at the time of the field assessment. January 11, 2021.

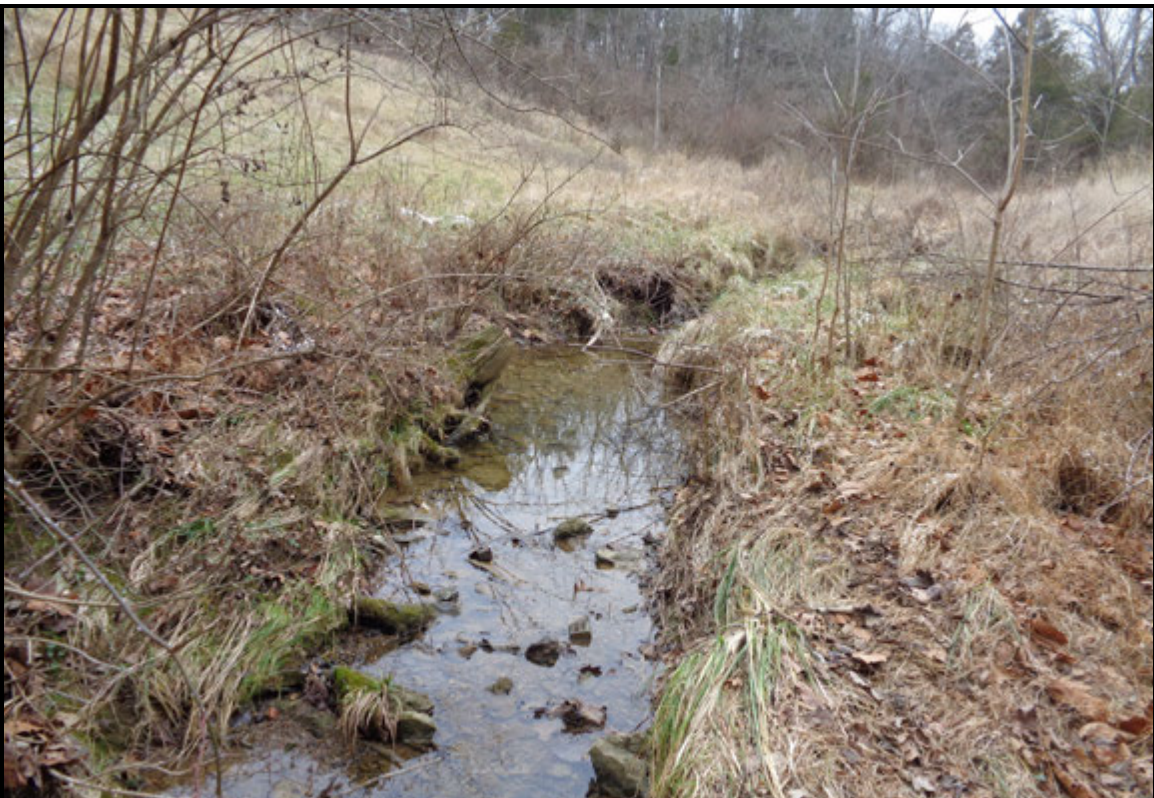
Intermittent Stream 2 is approximately seven feet wide with silt, sand, gravel, cobble, boulders and bedrock substrate. During the field assessment, Intermittent Stream 2 had flowing water at depths of up to six inches. Two RBP points were assessed along Intermittent Stream 2 with a score of 115 and 110 which characterizes it as "Poor" quality.

Photograph 6: Downstream view of Intermittent Stream 2 in the central portion of the site. Downstream waters continue off site and flow under I-265 and into Shinks Branch. January 11, 2021.

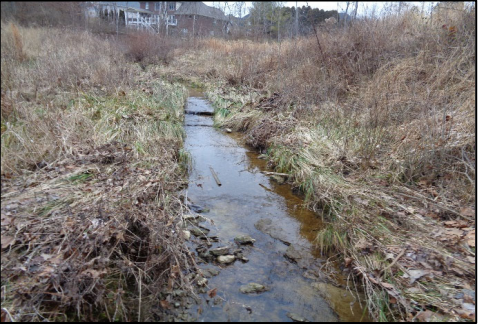
Substrate Characterization												
Substrate	Est.	P.C.	Riffle	15	%	Run	70	%	Pool	15	%	Reach Total
Silt/Clay (<0.06 mm/0.002 in)			X			X			X			
Sand (0.06–2 mm/0.002–0.08 in)			X			X			X			
Gravel (2–64 mm/0.08–2.52 in)			X			X			X			
Cobble (64–256 mm/2.52–10.08 in)			X			X			X			
Boulders (>256 mm/10.08 in)												
Bedrock			X			X			X

Project Name: Old Heady Property		Stream Name: Intermittent Stream 1																		
RBP High Gradient Habitat																				
Habitat Parameter	Condition Category																			
	Optimal					Suboptimal					Marginal					Poor				
SCORE	20	19	18	17	16	15	14	13	12	11	10	9	8	7	6	5	4	3	2	1

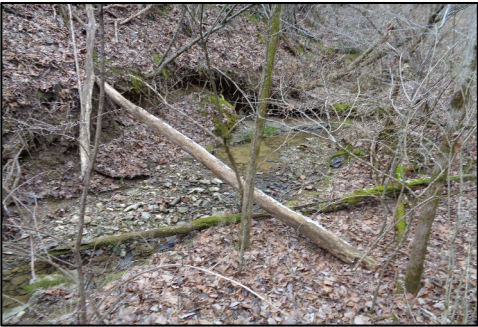
Substrate Characterization												
Substrate	Est.	P.C.	Riffle	20	%	Run	50	%	Pool	30	%	Reach Total
Silt/Clay (<0.06 mm/0.002 in)			X			X			X			
Sand (0.06–2 mm/0.002–0.08 in)			X			X			X			
Gravel (2–64 mm/0.08–2.52 in)			X			X			X			
Cobble (64–256 mm/2.52–10.08 in)			X			X			X			
Boulders (>256 mm/10.08 in)			X			X			X			
Bedrock			X			X			X

Project Name: Old Heady Property		Stream Name: Intermittent Stream 2																		
RBP High Gradient Habitat																				
Habitat Parameter	Condition Category																			
	Optimal					Suboptimal					Marginal			Poor						
SCORE	20	19	18	17	16	15	14	13	12	11	10	9	8	7	6	5	4	3	2	1

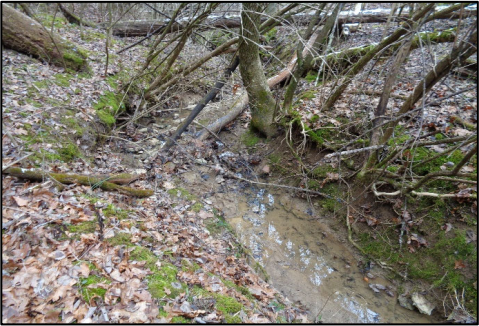
Substrate Characterization												
Substrate	Est.	P.C.	Riffle	10	%	Run	80	%	Pool	10	%	Reach Total
Silt/Clay (<0.06 mm/0.002 in)			X			X			X			
Sand (0.06–2 mm/0.002–0.08 in)			X			X			X			
Gravel (2–64 mm/0.08–2.52 in)			X			X			X			
Cobble (64–256 mm/2.52–10.08 in)			X			X			X			
Boulders (>256 mm/10.08 in)												
Bedrock

Project Name: Old Heady Property		Stream Name: Intermittent Stream 3																		
RBP High Gradient Habitat																				
Habitat Parameter	Condition Category																			
	Optimal					Suboptimal					Marginal			Poor						
SCORE	20	19	18	17	16	15	14	13	12	11	10	9	8	7	6	5	4	3	2	1

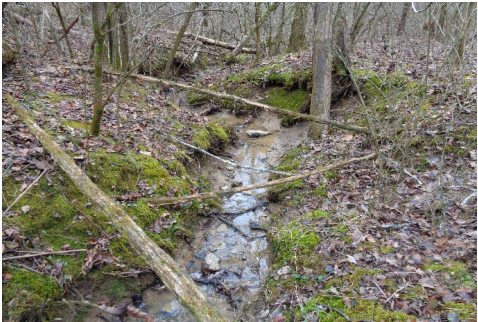
Substrate Characterization												
Substrate	Est.	P.C.	Riffle	20	%	Run	70	%	Pool	10	%	Reach Total
Silt/Clay (<0.06 mm/0.002 in)			X			X			X			
Sand (0.06–2 mm/0.002–0.08 in)			X			X			X			
Gravel (2–64 mm/0.08–2.52 in)			X			X			X			
Cobble (64–256 mm/2.52–10.08 in)			X			X			X			
Boulders (>256 mm/10.08 in)												
Bedrock

Project Name: Old Heady Property		Stream Name: Intermittent Stream 4																		
RBP High Gradient Habitat																				
Habitat Parameter	Condition Category																			
	Optimal					Suboptimal					Marginal			Poor						
SCORE	20	19	18	17	16	15	14	13	12	11	10	9	8	7	6	5	4	3	2	1

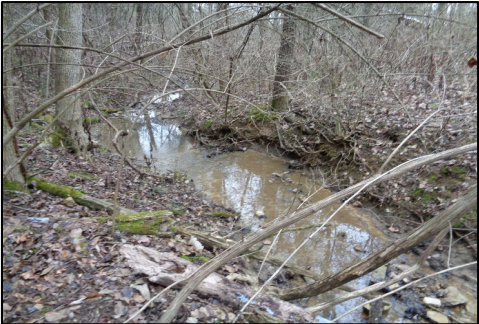
Substrate Characterization												
Substrate	Est.	P.C.	Riffle	10	%	Run	80	%	Pool	10	%	Reach Total
Silt/Clay (<0.06 mm/0.002 in)			X			X			X			
Sand (0.06–2 mm/0.002–0.08 in)			X			X			X			
Gravel (2–64 mm/0.08–2.52 in)			X			X			X			
Cobble (64–256 mm/2.52–10.08 in)			X			X			X			
Boulders (>256 mm/10.08 in)												
Bedrock			X			X			X

Project Name: Old Heady Property		Stream Name: Intermittent Stream 5																		
RBP High Gradient Habitat																				
Habitat Parameter	Condition Category																			
	Optimal					Suboptimal					Marginal					Poor				
SCORE	20	19	18	17	16	15	14	13	12	11	10	9	8	7	6	5	4	3	2	1

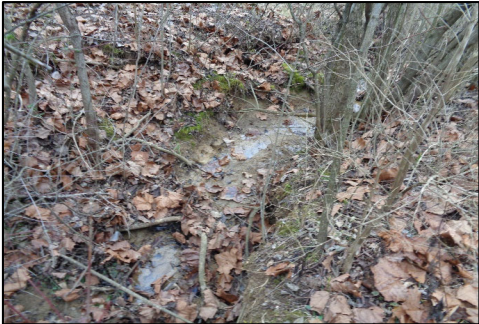
Substrate Characterization												
Substrate	Est.	P.C.	Riffle	10	%	Run	80	%	Pool	10	%	Reach Total
Silt/Clay (<0.06 mm/0.002 in)				X			X			X		
Sand (0.06–2 mm/0.002–0.08 in)				X			X			X		
Gravel (2–64 mm/0.08–2.52 in)				X			X			X		
Cobble (64–256 mm/2.52–10.08 in)				X			X			X		
Boulders (>256 mm/10.08 in)												
Bedrock

Project Name: Old Heady Property		Stream Name: Intermittent Stream 6																		
RBP High Gradient Habitat																				
Habitat Parameter	Condition Category																			
	Optimal					Suboptimal					Marginal			Poor						
SCORE	20	19	18	17	16	15	14	13	12	11	10	9	8	7	6	5	4	3	2	1
