# Landmarks Certificate of Appropriateness & Overlay District Permit

DEMO HOUSE THAT IS UNSAFE TO  
OCCUPY.

Re: Structural Review  
1737 Payne St.  
Louisville, KY 40206

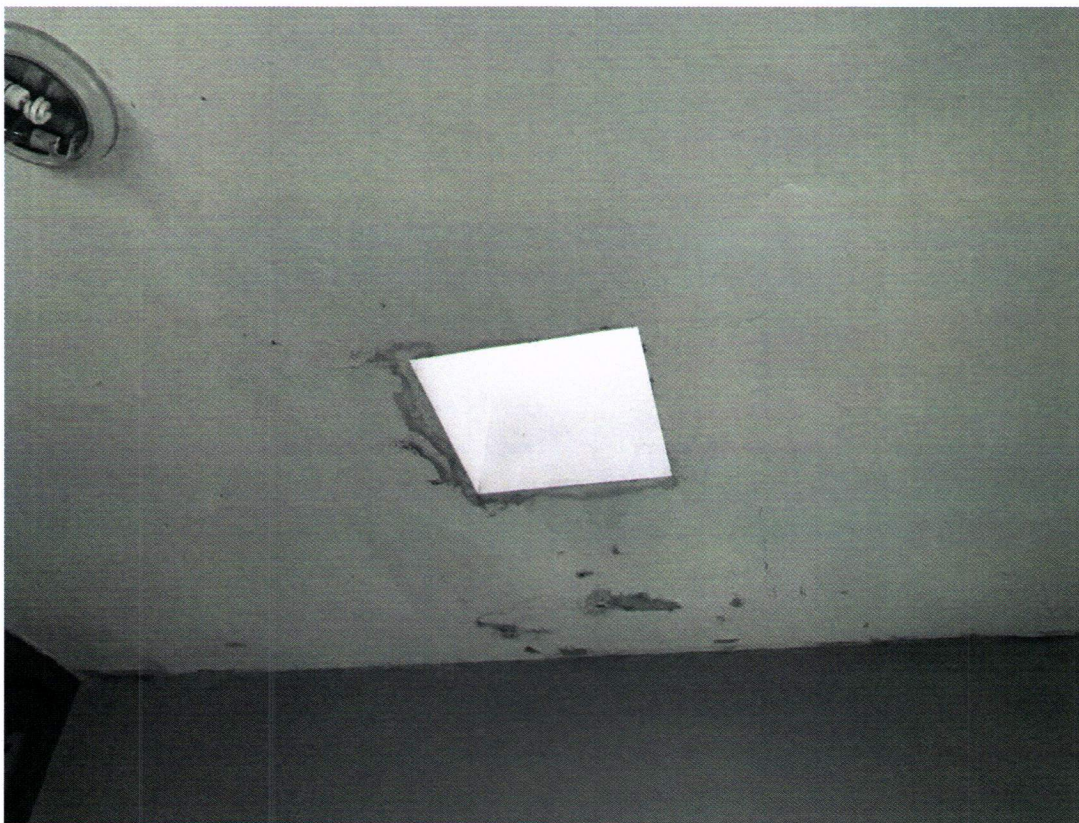
While the majority of wall and roof framing was not visible during our inspection it should be noted that there was evidence of water infiltration as seen in the water staining in ceiling. Roof framing located above the side door was not framed in accordance with current building codes and showed signs of disrepair. With the evidence of termites in the floor framing it should be noted that there is a good possibility of other hidden areas of termite damage.

Water staining and damage to existing ceiling.

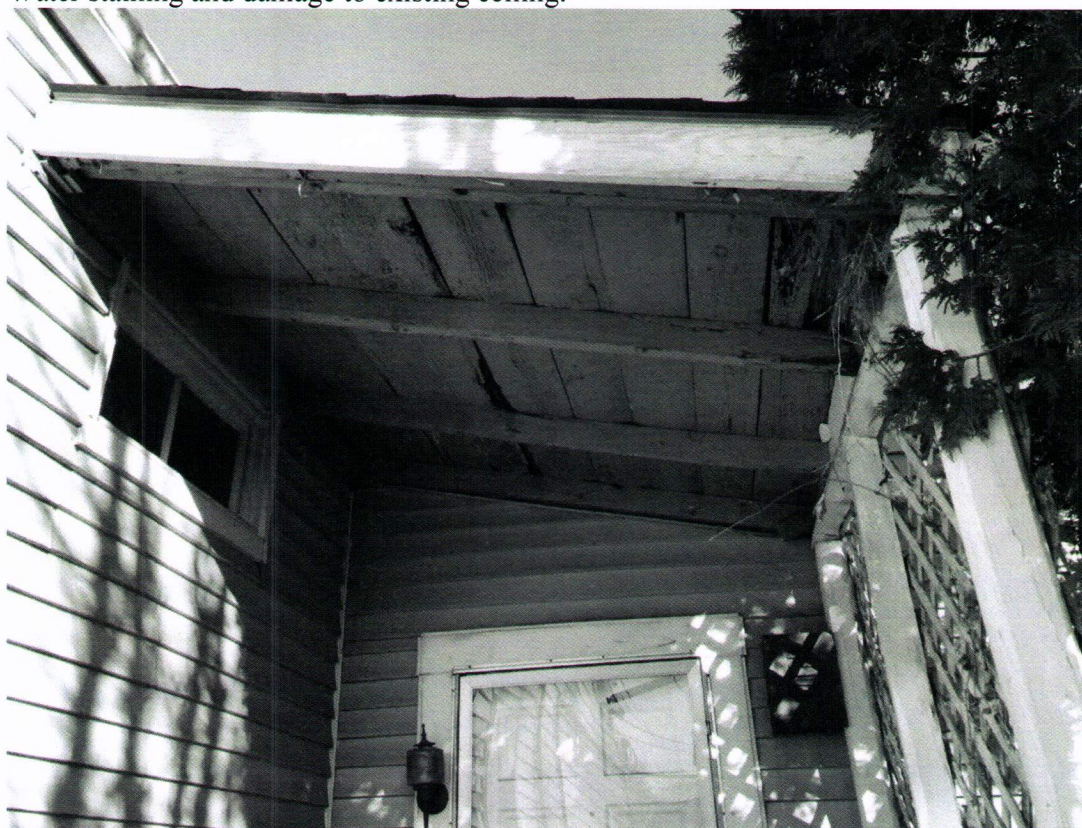
Side door porch roof framing.

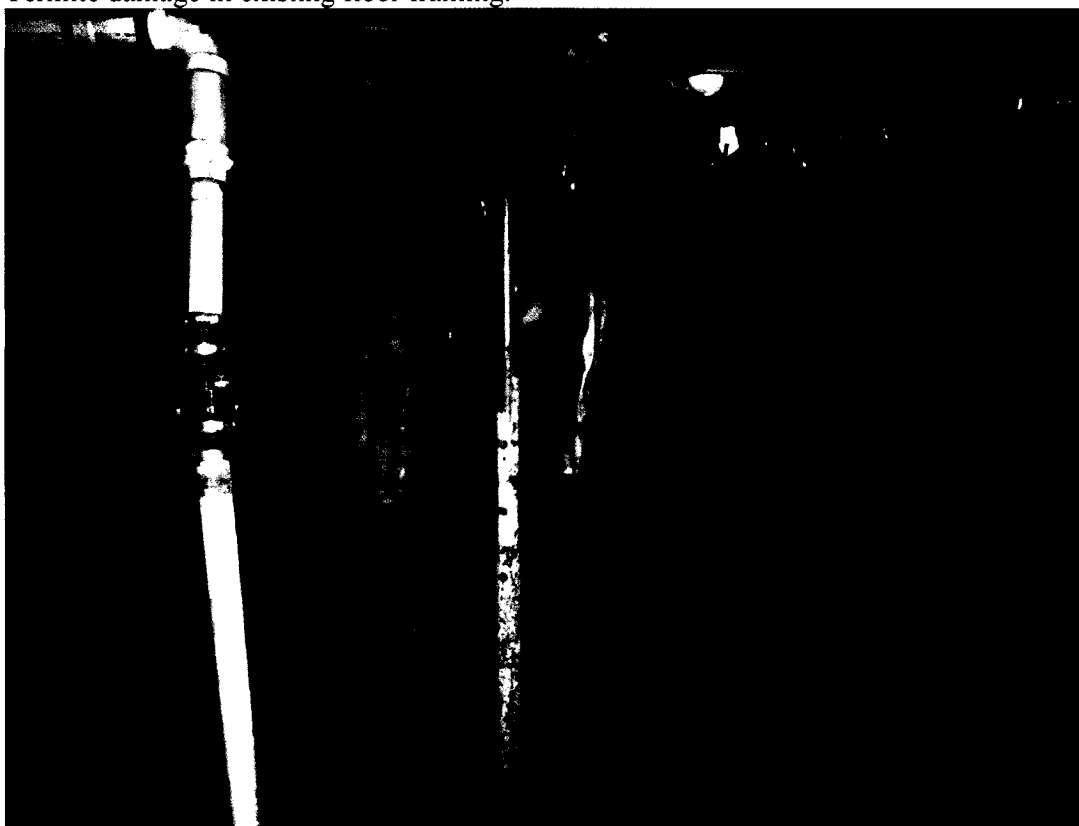
Upon review the main level floor structure was severely out of level in several areas of the house. This was due to the deteriorated condition of the framing. Upon entering the basement the moisture levels were extremely high. The floor framing was moist to the touch. In several areas there was damage due to the past presence of termites. There were several locations where steel posts were added to shore the existing structure. It should be noted that most of the attempted repairs do not meet Kentucky Building Code requirements.

Steel posts placed to shore the existing floor framing.
