# **1829 & 1831 Brownsboro Road Houses**

## **Draft Report on the Proposal for Designation as an Individual Landmark**

**(22-LANDMARK-0001)**

**Metro Historic Landmarks and  
Preservation Districts Commission**

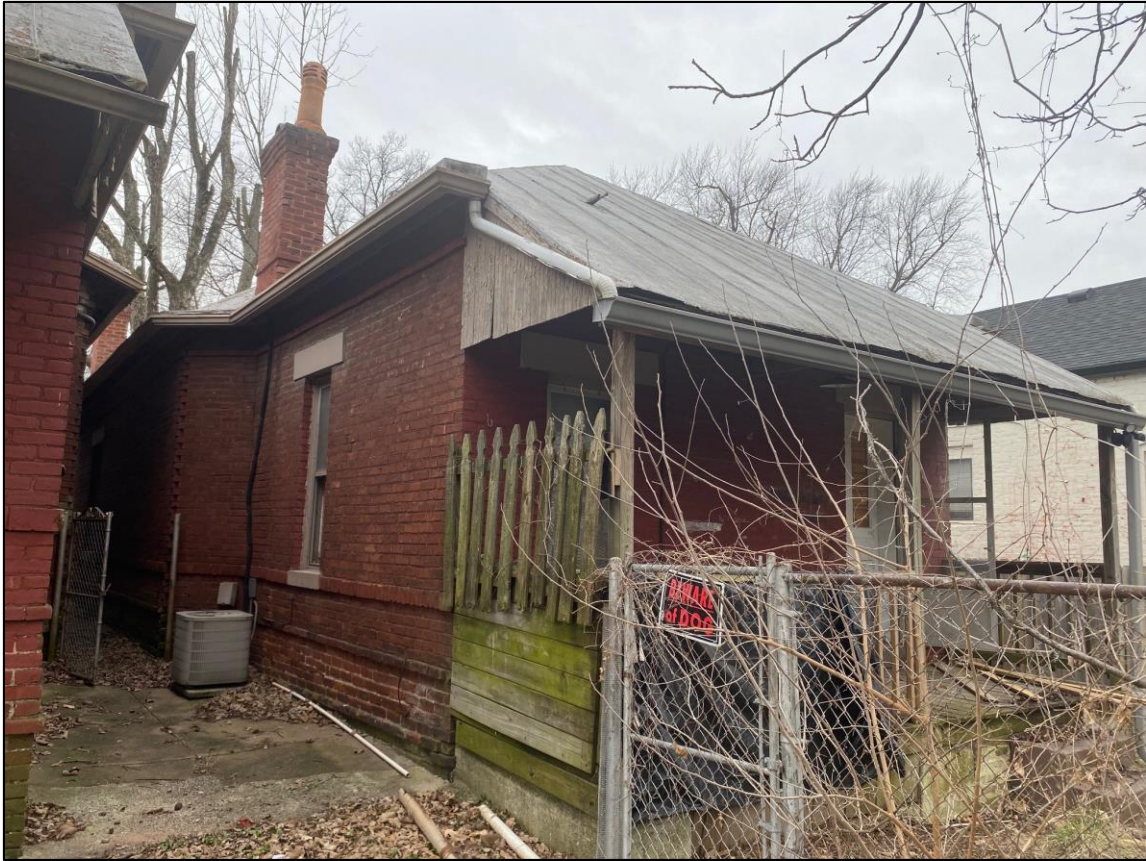
**Figure 11. Rear (north) elevation, looking southwest.**

The north, or rear, elevation contains one 1/1 double-hung wood window on the east side and a 1/2 lite entry door with a storm door on the east side. The rear portion of the roof extends down to become cover for the rear porch with wood posts. The porch has concrete foundation with wood floor boards (Figure 11).

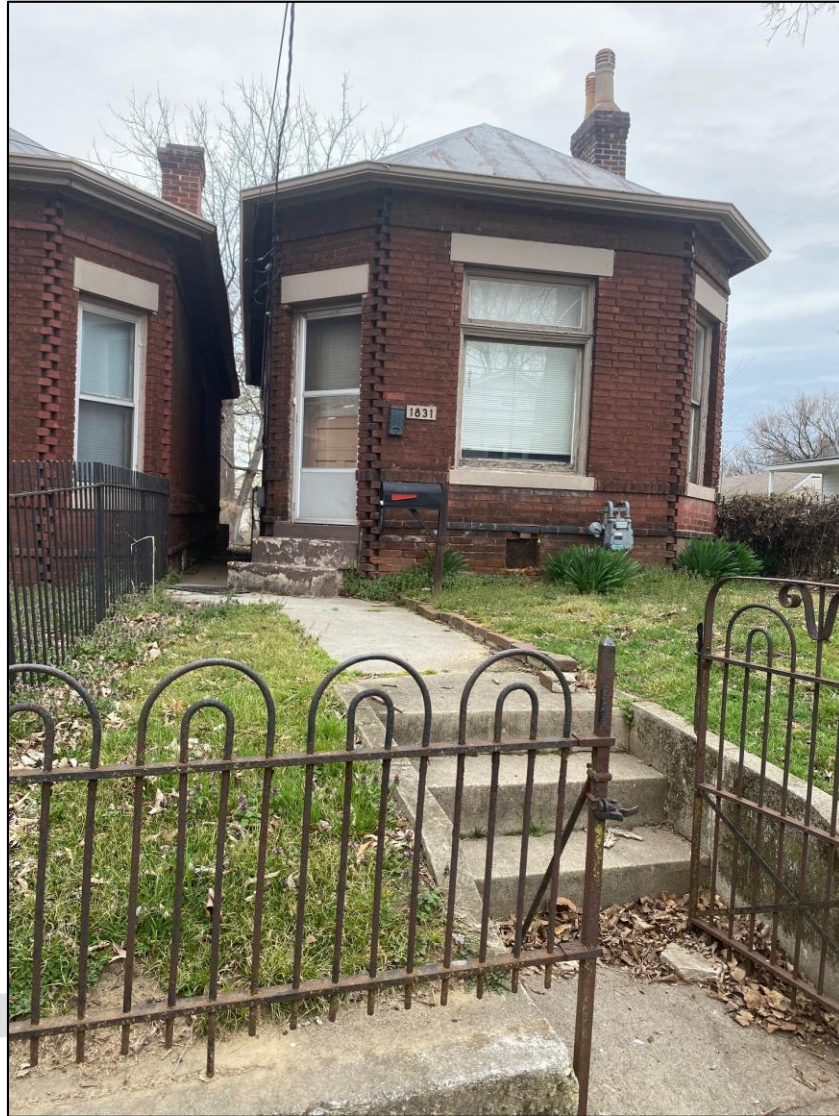
**Figure 13. Front (south) façade, looking north.**

The front façade, or south elevation, of the building contains a central wood picture window with a transom above and storm windows. To the west, the ½ lite, wood entry door with a storm door faces southwest. Concrete stairs lead to the entry. To the east of the central window, there is one 1/1 double-hung wood window with a storm window that faces southeast (**Figure 12** and **Figure 13**).

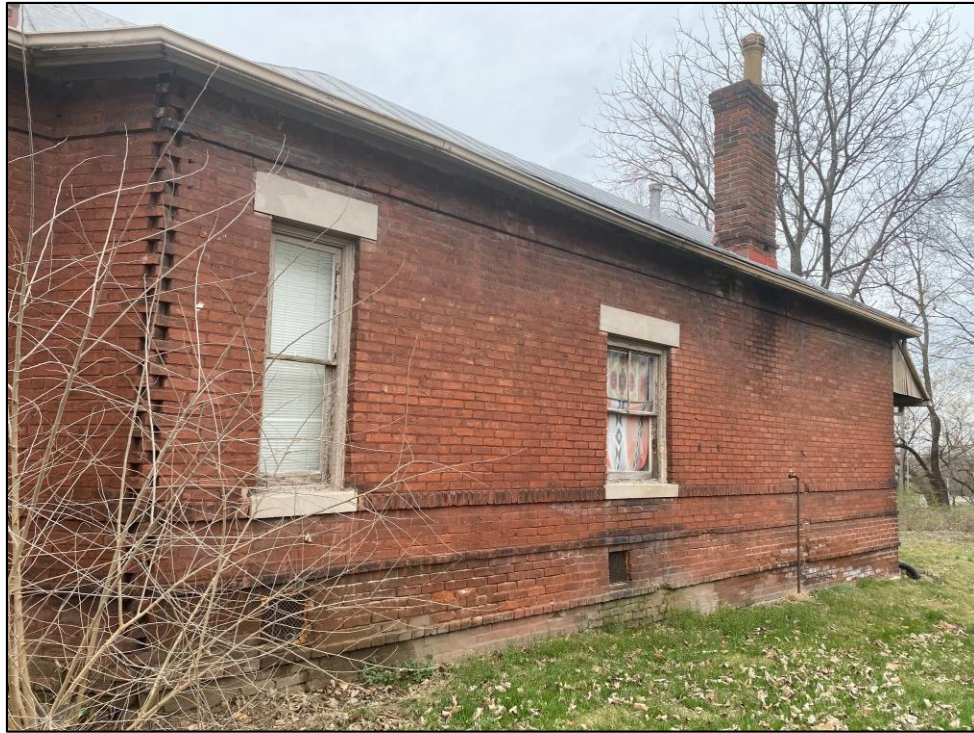
**Figure 14. The east elevation, looking northwest.**

The east and west elevations of the house are very similar (**Figure 14** and **Figure 15**). Both side elevations are mostly comprised of 1/1 double-hung wood windows. The west elevation contains two of these with a multi-lite casement window while the east elevation only contains two 1/1 double-hung wood windows (**Figure 16**). At the basement level on both elevations, there are openings where metal grates were located. Some of these grates are still intact and some of the openings have been covered with wood. There are two, very tall, brick chimneys located on the east side of the house. Both chimneys contain chimney pots.

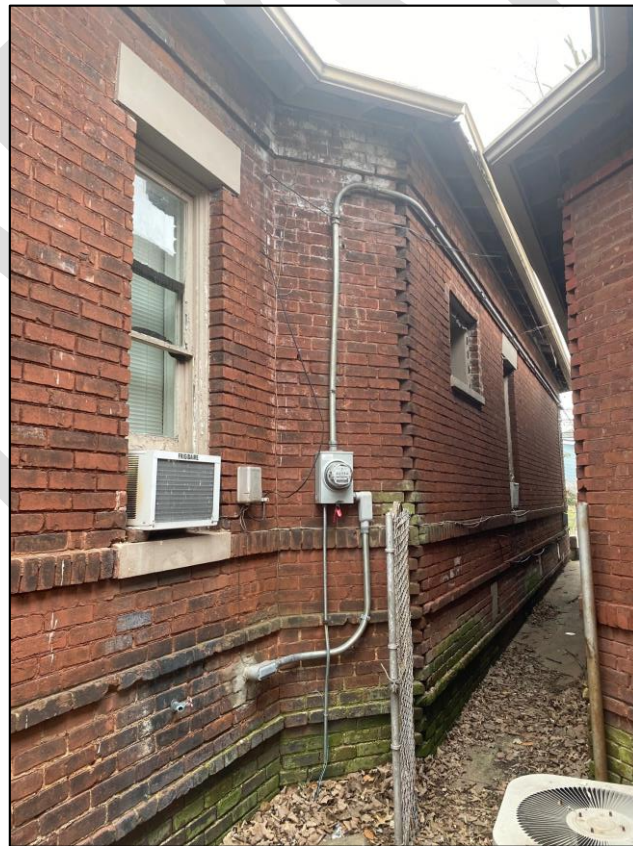
**Figure 15. West elevation, looking south.**

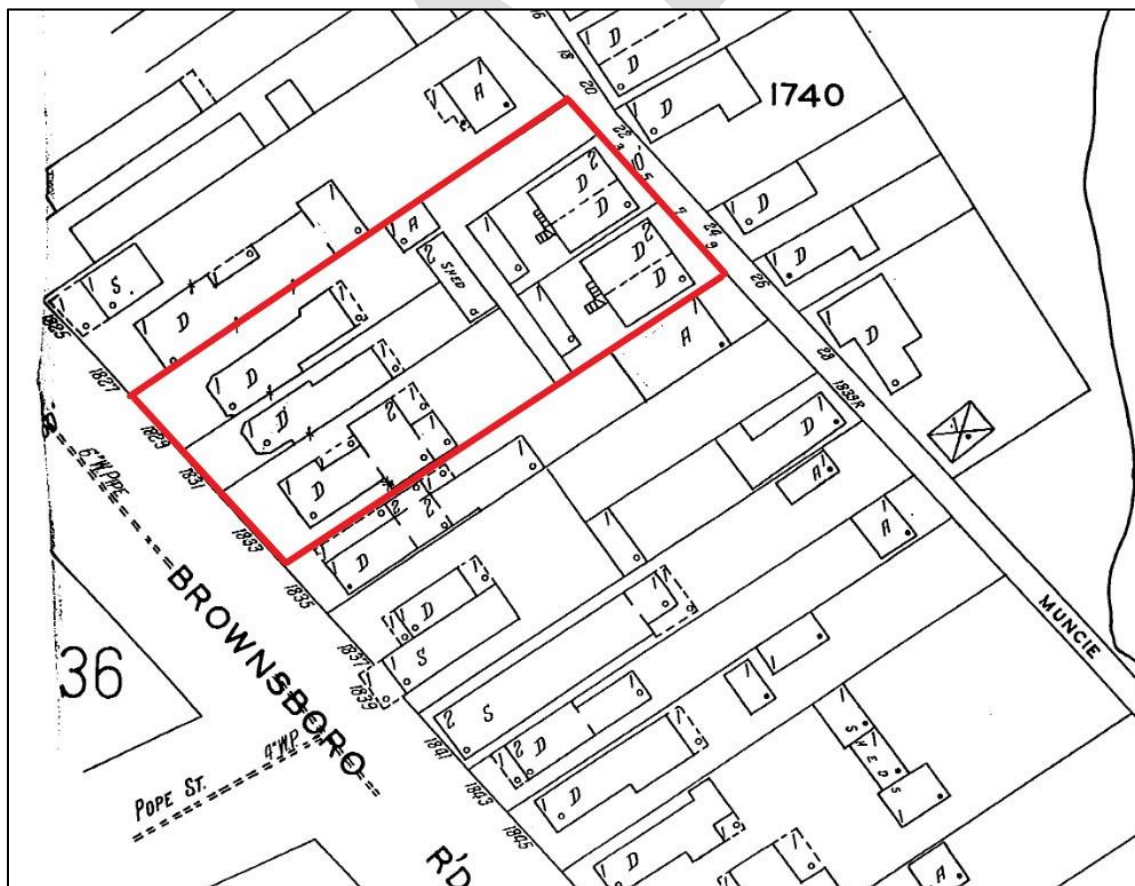
Figure 24. 1929 *Sanborn Fire Insurance Map*, Volume 7, Sheet 738 (red line shows requested designation boundary).

Around 1925, Letterle Avenue was renamed Brownsboro Road. The 1929 Sanborn Fire Insurance Map shows the addition of a small garage north of 1829 Brownsboro Road and a two-story shed behind both houses (**Figure 24**). The map also shows two duplexes that face Muncie Avenue; however, this street was not listed in the city directories. These buildings also did not last long as they were demolished between 1965 and 1971. Their history is currently unknown and how it may have impacted the houses at 1829 and 1831 Brownsboro Road.
