SIDING AND TRIM

DESIGN GUIDELINES

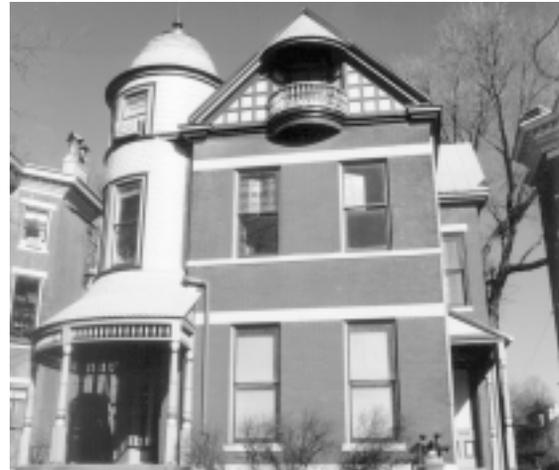
Three tiers of elaborate and dramatic wood trim seen in the porches, the tower, and the gable express the Queen Anne-character of this house.

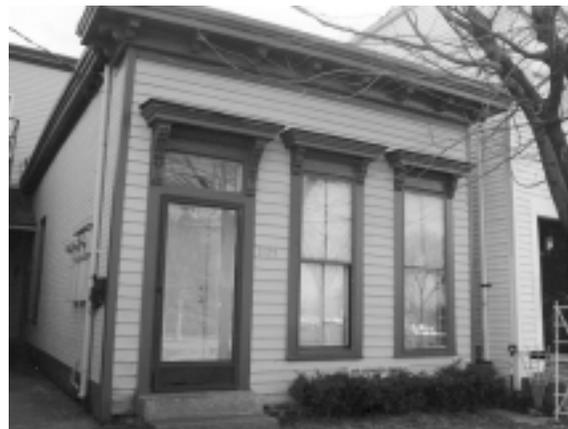
Rectilinear wood cladding and window and door trim combine to give this Italianate house a formal, geometric appearance.

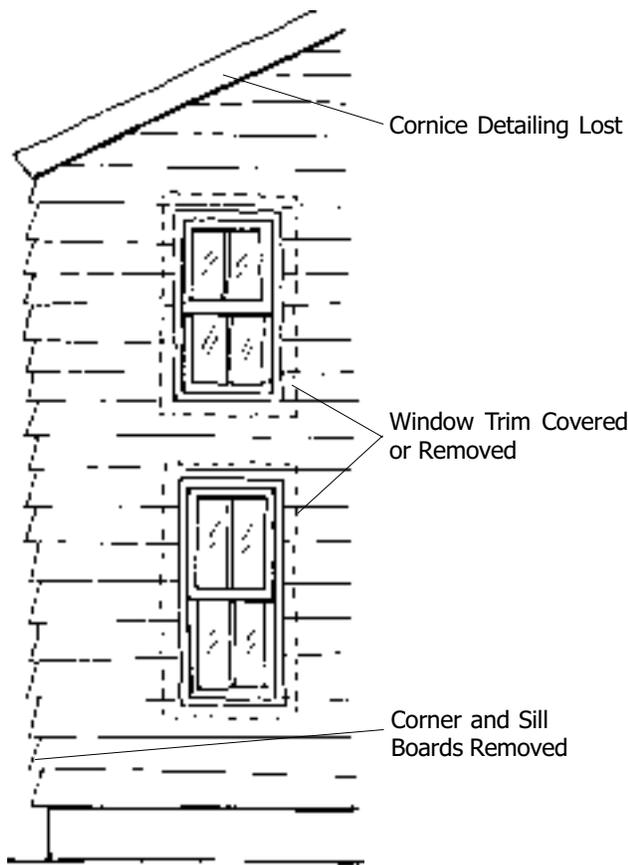
INSTALLATION OF REPLACEMENT SIDING SHOULD NOT OBSCURE OR DAMAGE HISTORIC TRIM

Inappropriate siding installation diminishes historic character.

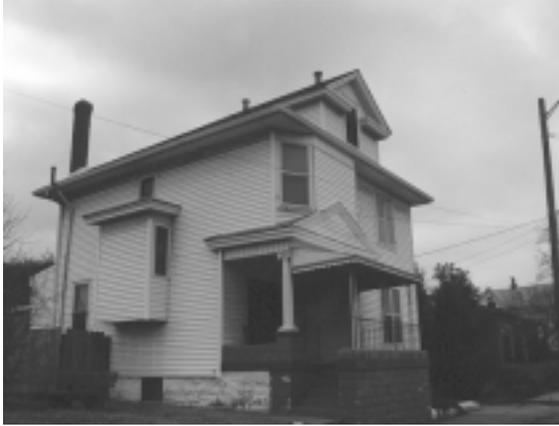
AVOID THE BOXY LOOK

If done thoughtlessly, the application of vinyl siding can obscure historic proportion and detail.

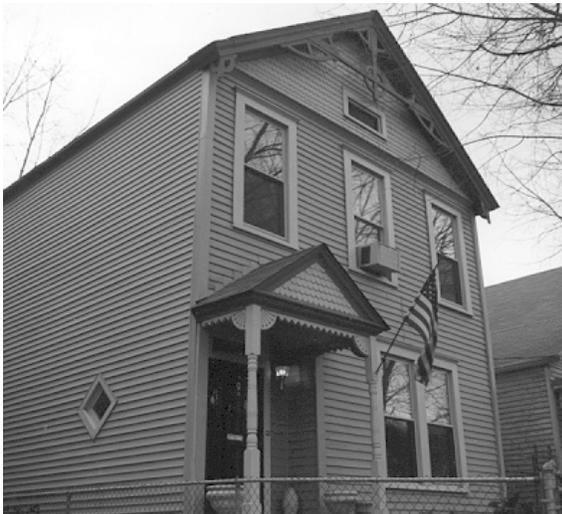
If you must use vinyl siding, limit it to the side and rear elevations as shown above and retain character-defining architectural features.

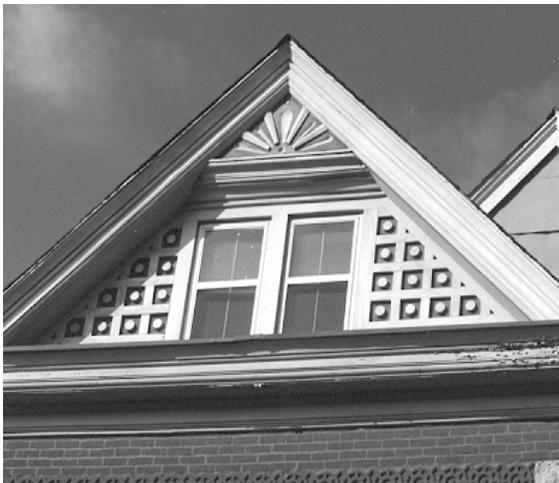
Gable ends are often backdrops for lavish and creative displays of ornamental woodwork.

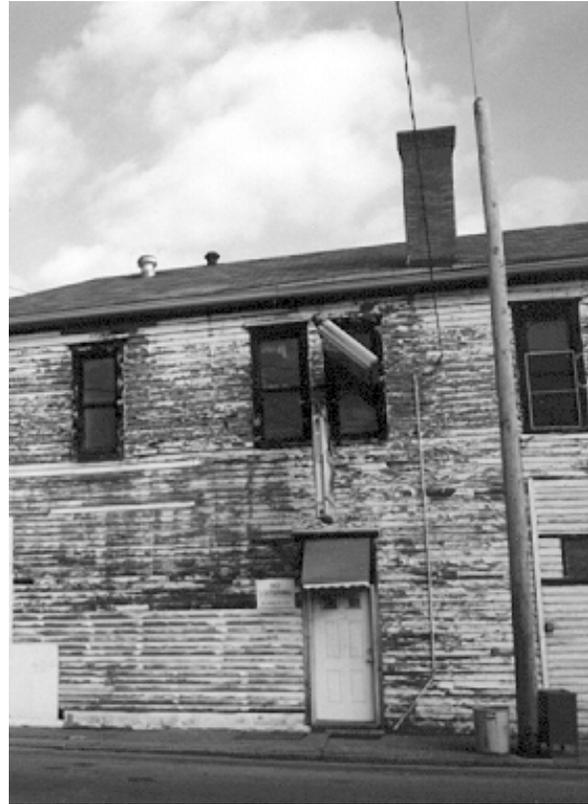
Coating systems are critical for the preservation of wood features. If left unaddressed, paint failure can lead to serious deterioration.

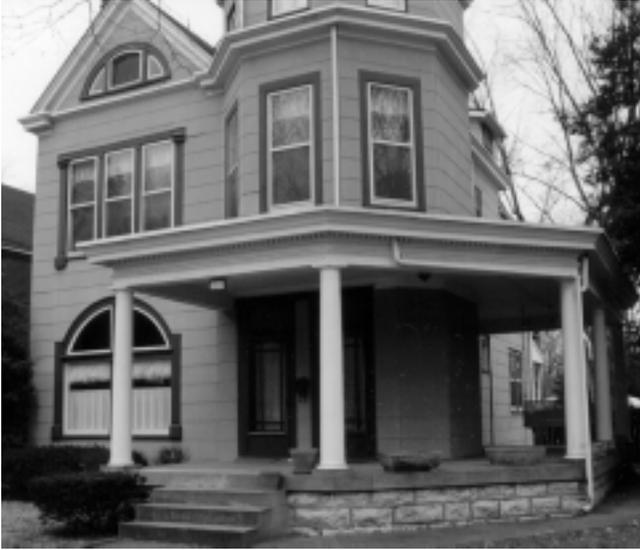
Compare the houses above and below. Their designs are the same, but trim and siding replacement has altered their character. Above, the house retains historic porch elements, but has lost its clapboard and shake siding.

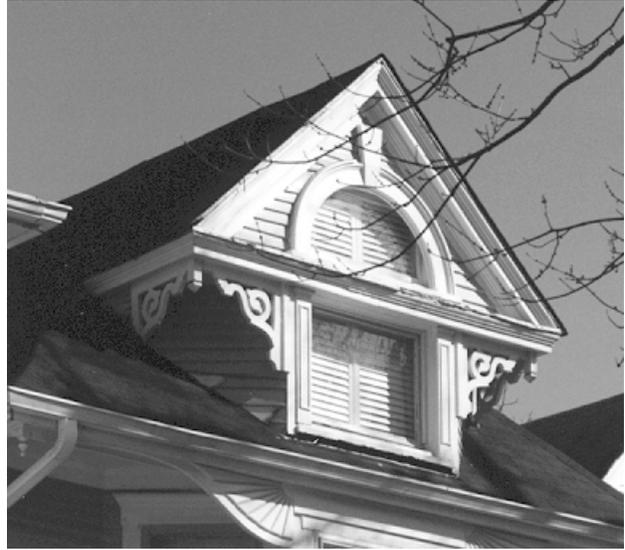
Long-term exposure to the elements can damage historic wood windows and their trim. Windows are important character-defining features, so check their condition regularly and address any problems before they become serious.

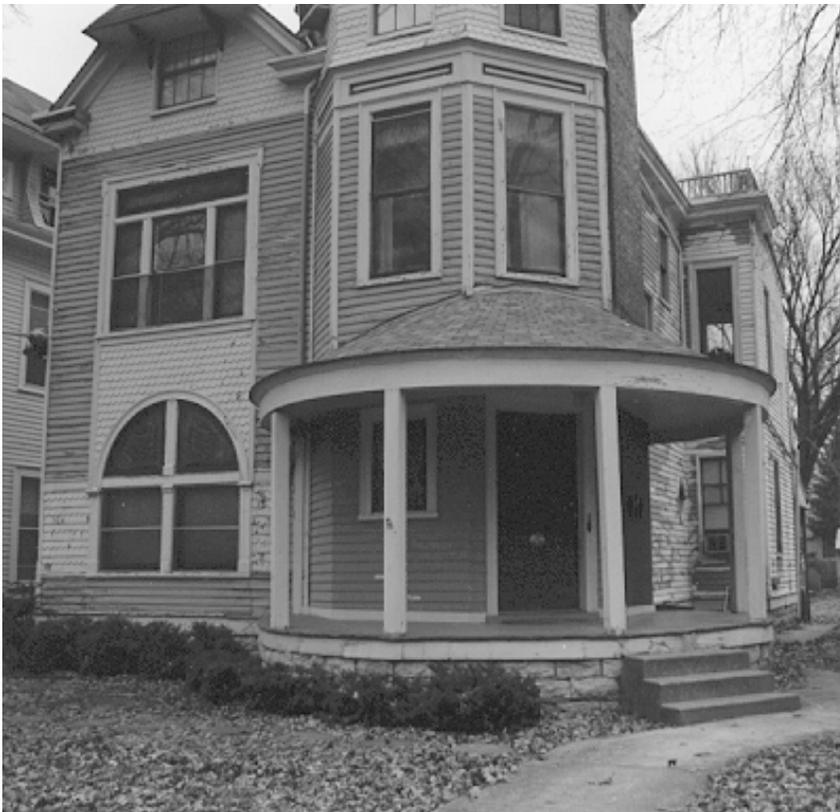
Above, the house retains its original siding, but its porch elements have been replaced by inappropriate substitutes that do not match the visual appearance of the original.

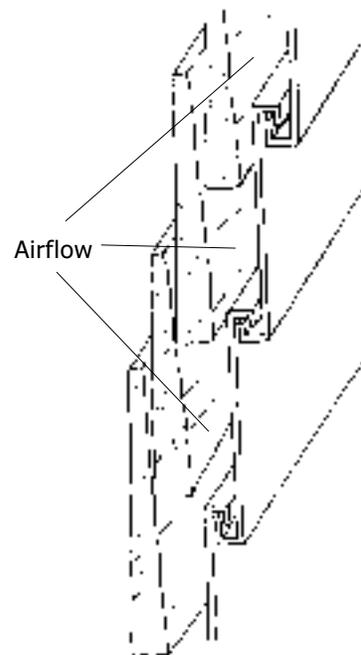
WITH VINYL SIDING MUST COME VENTILATION

Where vinyl siding is approved, airflow between historic siding and vinyl siding must be maintained, or moisture can cause unseen structural deterioration.
