GREENBAUM ASSOCIATES, INC.
GEOTECHNICAL & MATERIALS ENGINEERS

Re: Karst Survey
5101 Bardstown Road
Louisville, Kentucky
Project Number 19-277G

Diagram of Typical Karst Remediation

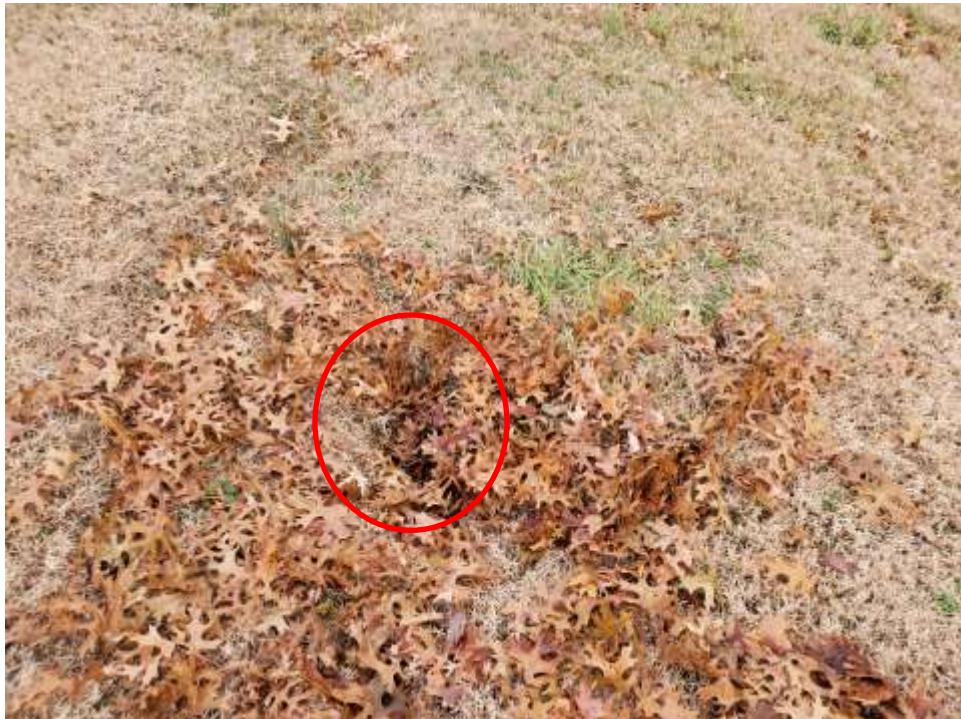
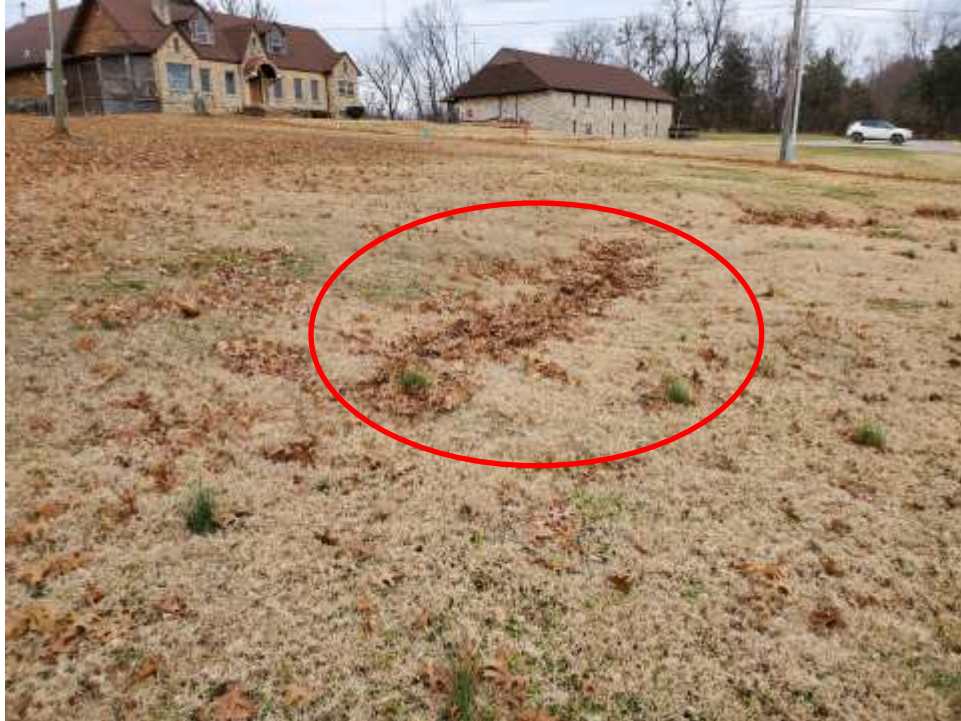
Yesterday I walked the above referenced site to discover any evidence of karst development. Rock appears to be very shallow at this site as evidenced by rock visible on the ground surface at a couple locations and large pieces of rock present in the material excavated and visible where a sewer was installed in the southwest portion of the property. In the northwest portion of the property, I found what appears to be a karst feature on the property. It forms a lineation across that portion of the property and an opening in the soil is visible at one point (see photographs below).

If construction is to take place in the portion of the site in which karst features are present, it will be necessary to expose the bedrock and install a filter in any crevices or openings in the bedrock. A diagram of a typical treatment of a karst feature using a filter is included with this letter for illustration.
