20-COA-0141
121 + 123 S. 7th St.

West Main Architectural Review Committee
Public Hearing

Bradley Fister, Historic Preservation Specialist
Sept 09, 2020

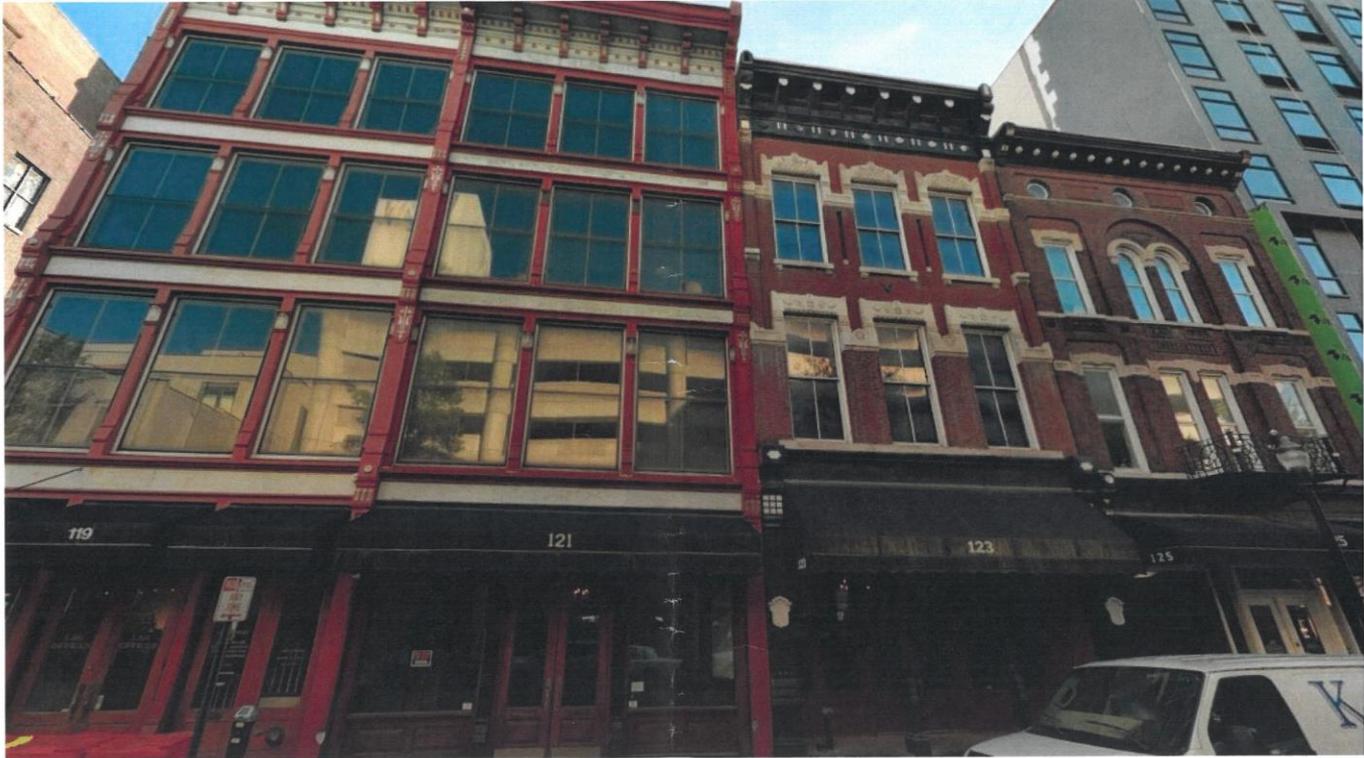
Window Details

A FRAME ELEVATION
 RECD THIS - 3
 1/2" x 1" - 0"
 FIN: 1/2" x 1/2" x 1" x 4' F)
 FIN: TO BE SELECTED
 CLEAR ANODIZED OR DARK BRONZE ANODIZED

B FRAME ELEVATION
 RECD THIS - 3
 1/2" x 1" - 0"
 FIN: 1/2" x 1/2" x 1" x 4' F)
 FIN: TO BE SELECTED
 CLEAR ANODIZED OR DARK BRONZE ANODIZED

C FRAME ELEVATION
 RECD THIS - 3
 1/2" x 1" - 0"
 FIN: 1/2" x 1/2" x 1" x 4' F)
 FIN: TO BE SELECTED
 CLEAR ANODIZED OR DARK BRONZE ANODIZED

D FRAME ELEVATION
 RECD THIS - 3
 1/2" x 1" - 0"
 FIN: 1/2" x 1/2" x 1" x 4' F)
 FIN: TO BE SELECTED
 CLEAR ANODIZED OR DARK BRONZE ANODIZED

E FRAME ELEVATION
 RECD THIS - 3
 1/2" x 1" - 0"
 FIN: 1/2" x 1/2" x 1" x 4' F)
 FIN: TO BE SELECTED
 CLEAR ANODIZED OR DARK BRONZE ANODIZED

F FRAME ELEVATION
 RECD THIS - 8
 1/2" x 1" - 0"
 FIN: 1/2" x 1/2" x 1" x 4' F)
 FIN: TO BE SELECTED
 CLEAR ANODIZED OR DARK BRONZE ANODIZED

At 123 S. 7th St. on the front façade there are three 2/2 double-hung windows on the second story, and three more of the same on the third story. As well as all the windows (approximately twenty) on the rear of the building. The replacement windows proposed are to be a static 2/2 aluminum window much like the windows located at 745 W. Main st.

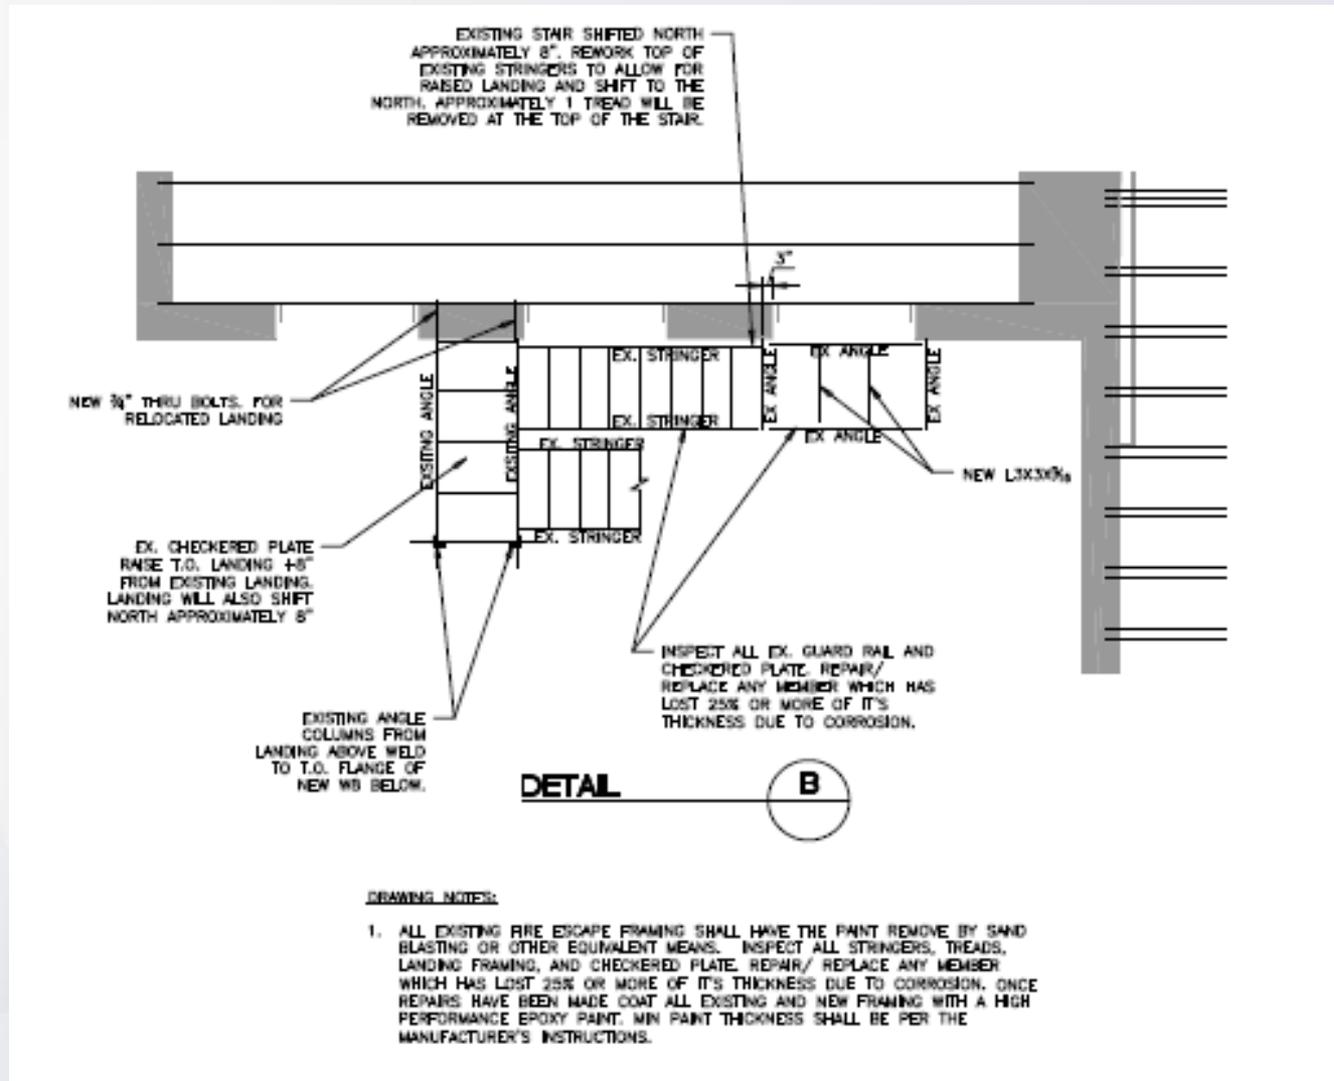
Fire Escape Details

The applicant also proposes to reinforce the existing fire escape on the rear of the building, and to add a walkway to it on the second floor to connect to one of the windows as another form of egress. The escape will be cleaned and painted uniformly.

The proposed changes to the fire escape, including the addition of a walkway that will connect to a window for egress purposes, meet the **Addition** Design Guidelines for the West Main Preservation District especially **A15**.

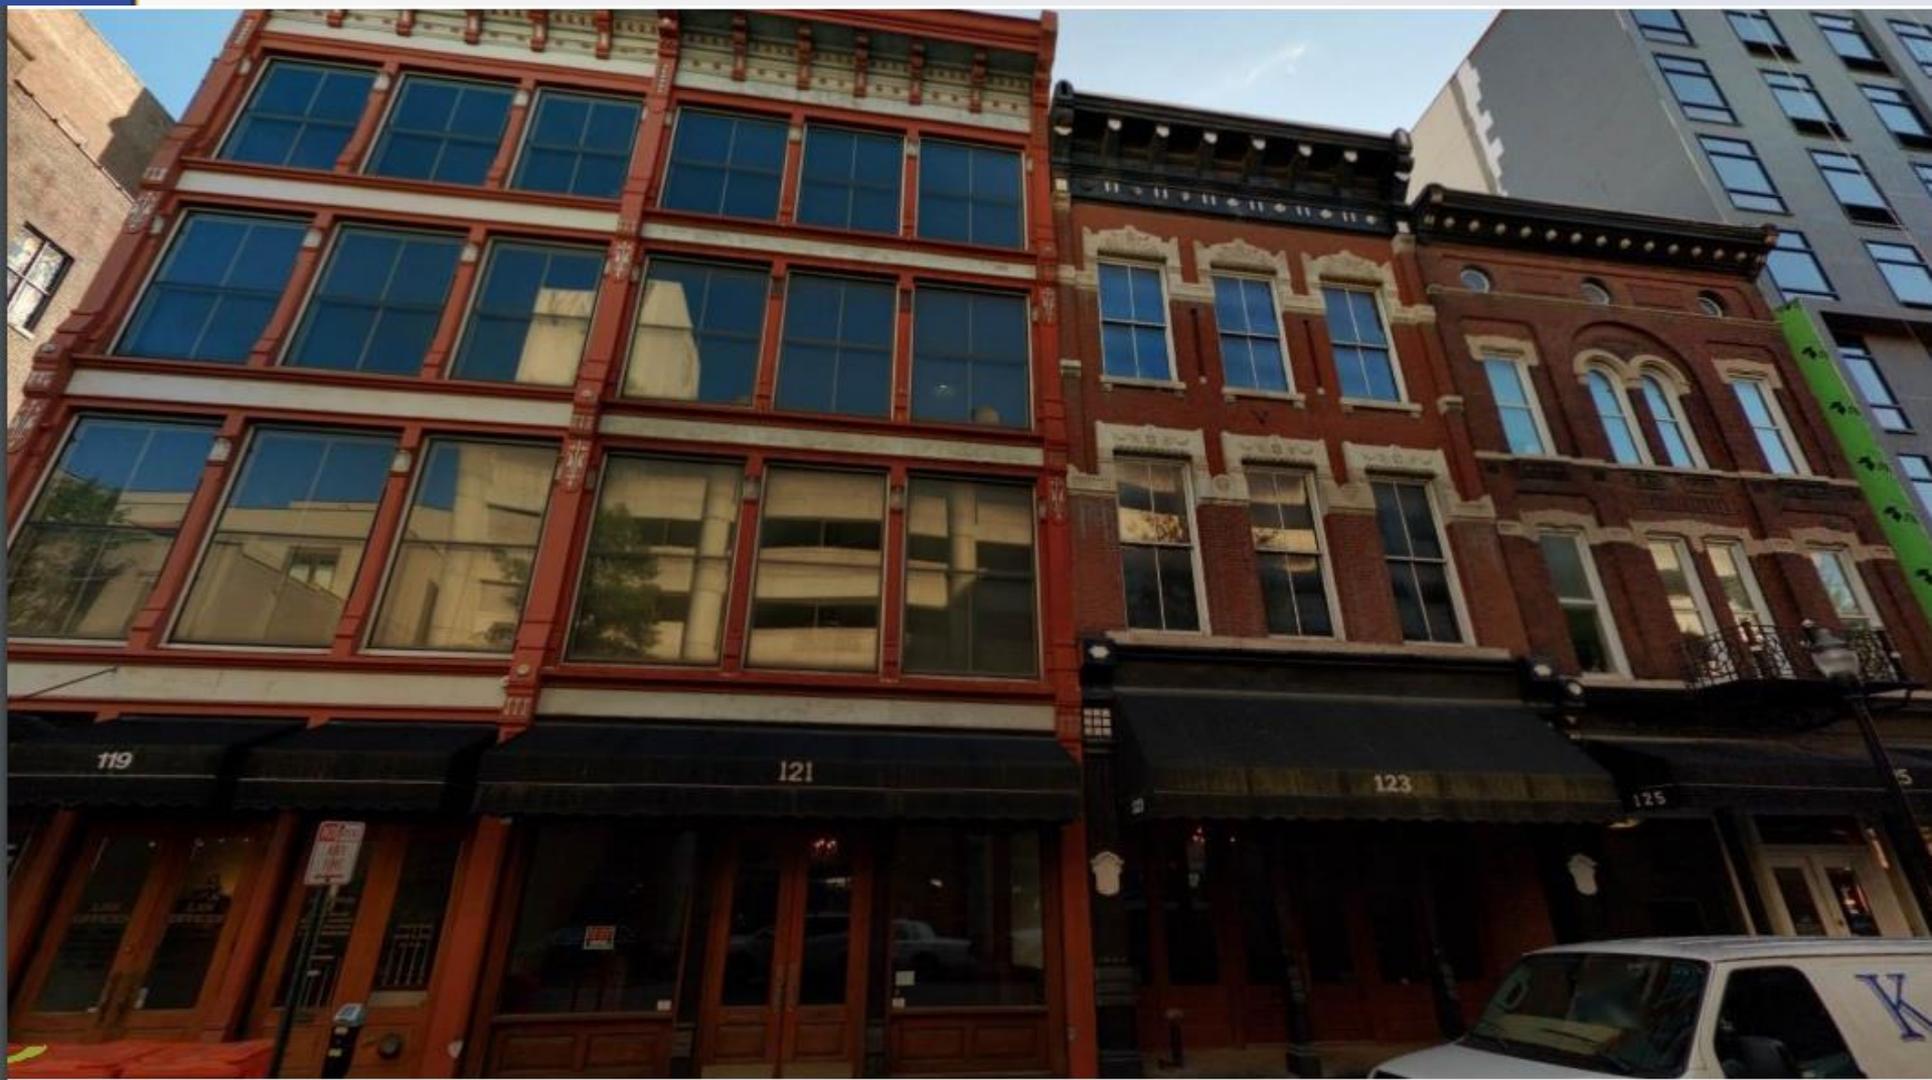
721 S. 7th St.

The applicant would like for the committee to approve their originally proposed window design. The applicant has provided images from two other properties in the district that have similar windows as to what they have proposed.

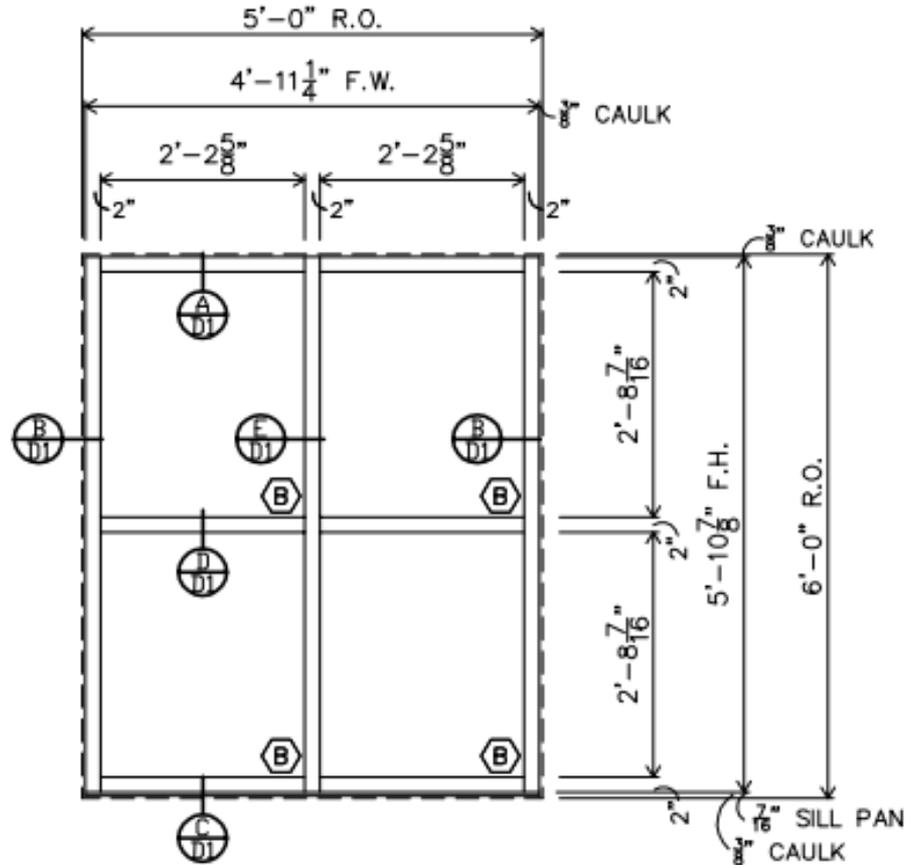
A FRAME ELEVATION
 E1 1/2" = 1'-0"

REQ'D THUS - 3
 YKK YES 45TU (2" X 4 1/2")
 FINISH TO BE SELECTED
 CLEAR ANODIZED OR DARK BRONZE ANODIZED

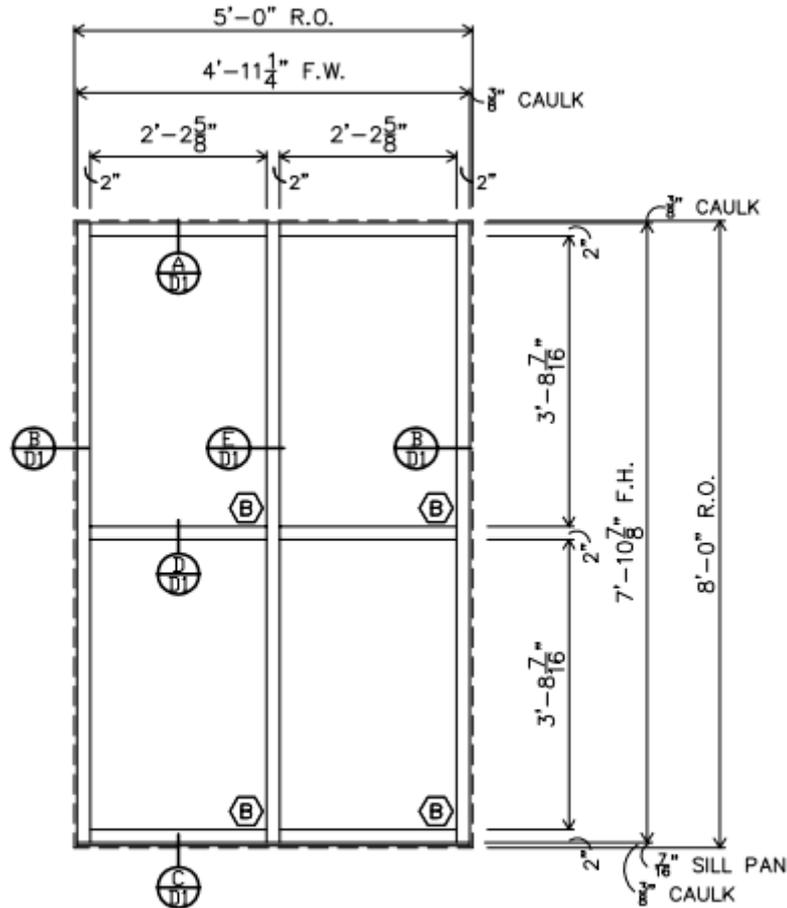
B FRAME ELEVATION
 E1 1/2"=1'-0"

REQ'D THUS - 3
 YKK YES 45TU (2" X 4 1/2")
 FINISH TO BE SELECTED
 CLEAR ANODIZED OR DARK BRONZE ANODIZED

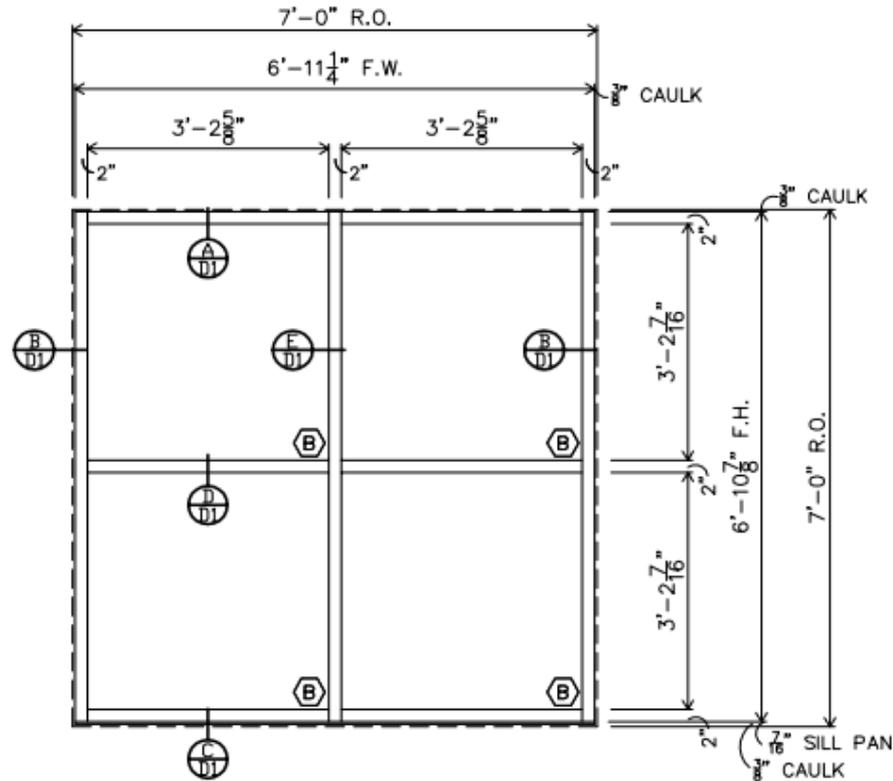
C FRAME ELEVATION
E1 1/2"=1'-0"

REQ'D THUS - 3
YKK YES 45TU (2" X 4 1/2")
FINISH TO BE SELECTED
CLEAR ANODIZED OR DARK BRONZE ANODIZED

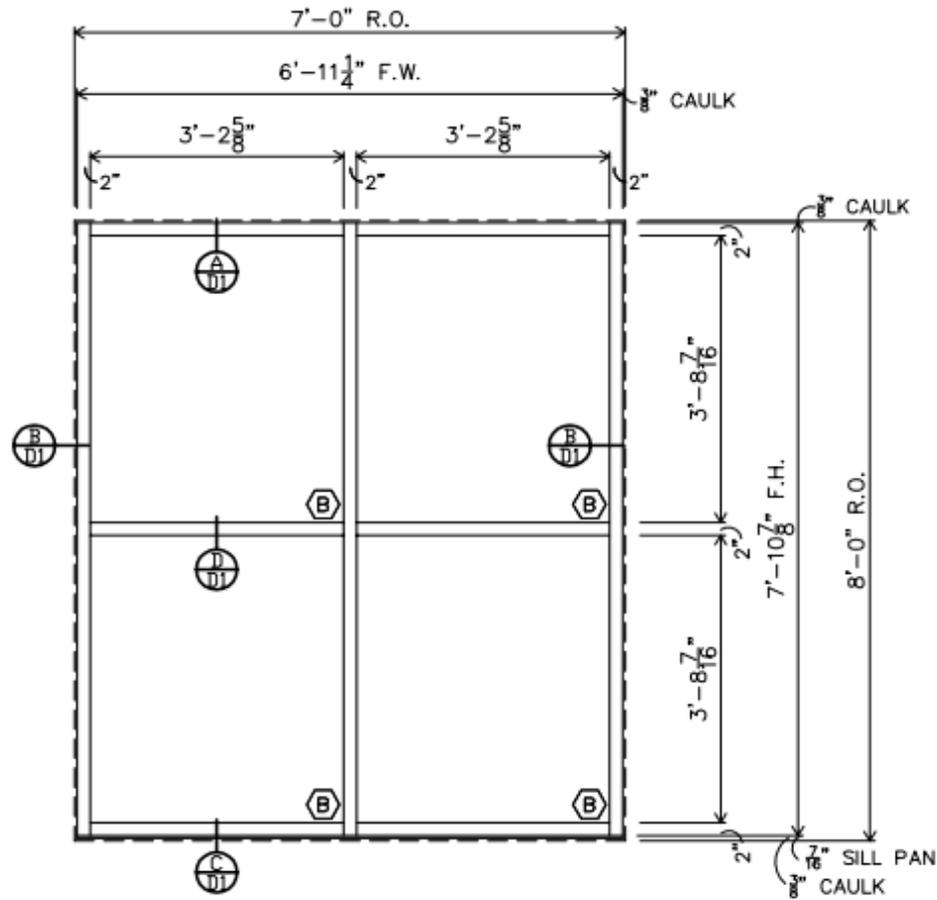
D FRAME ELEVATION
 E1 1/2"=1'-0"

REQ'D THUS - 3
 YKK YES 45TU (2" X 4 1/2")
 FINISH TO BE SELECTED
 CLEAR ANODIZED OR DARK BRONZE ANODIZED

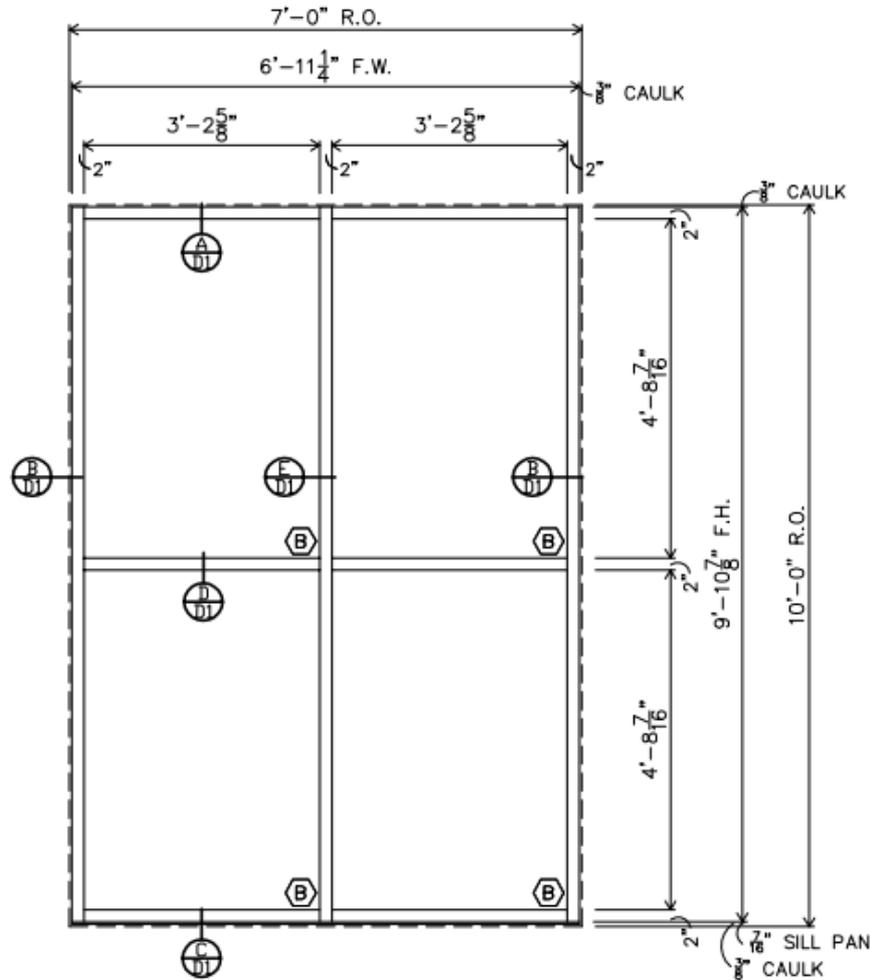
E FRAME ELEVATION
 E1 1/2"=1'-0"

REQ'D THUS - 3
 YKK YES 45TU (2" X 4 1/2")
 FINISH TO BE SELECTED
 CLEAR ANODIZED OR DARK BRONZE ANODIZED

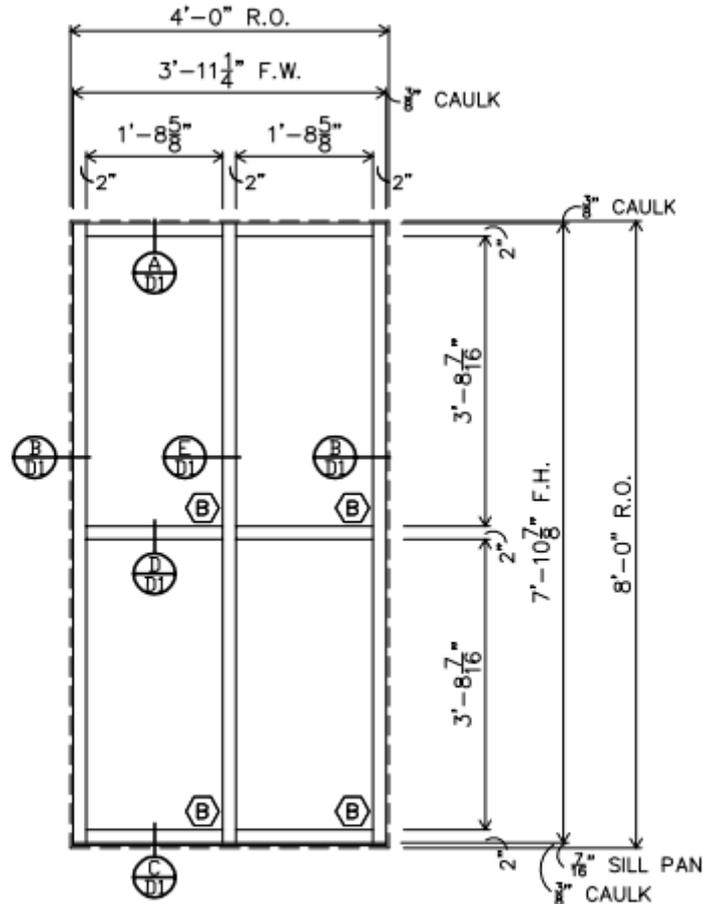
F FRAME ELEVATION
E1 1/2"=1'-0"

REQ'D THUS - 6
YKK YES 45TU (2" X 4 1/2")
FINISH TO BE SELECTED
CLEAR ANODIZED OR DARK BRONZE ANODIZED

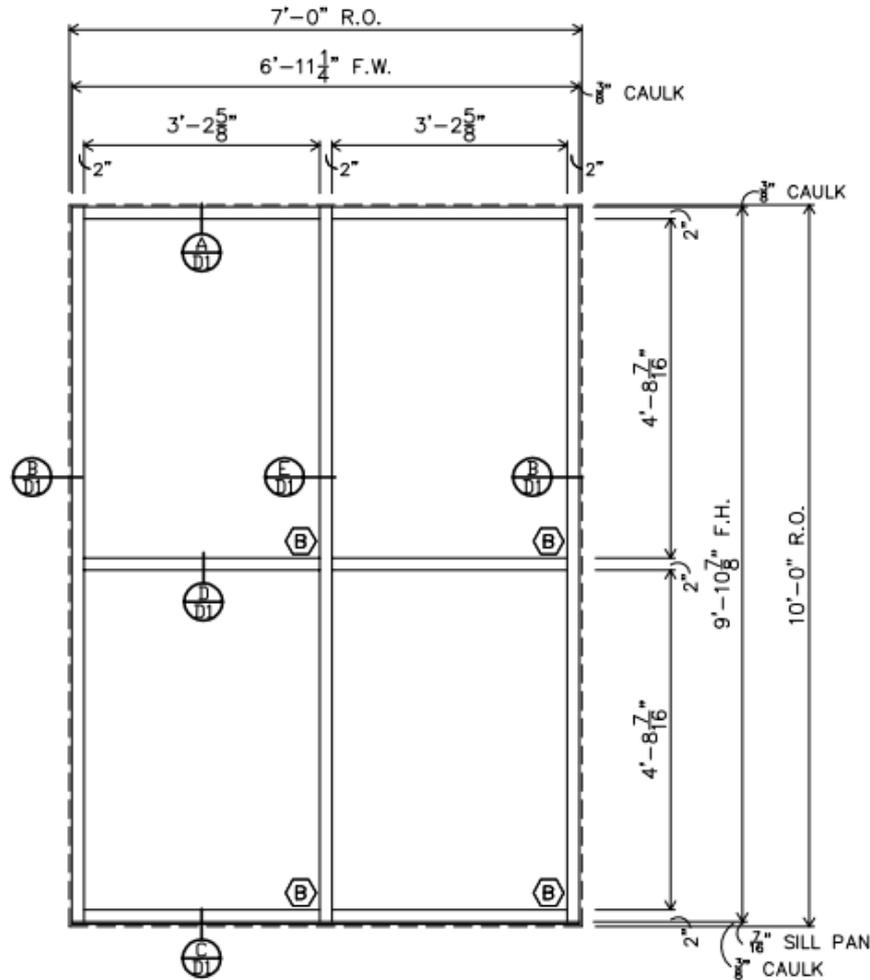
E FRAME ELEVATION
 E1 1/2"=1'-0"

REQ'D THUS - 3
 YKK YES 45TU (2" X 4 3/4")
 FINISH TO BE SELECTED
 CLEAR ANODIZED OR DARK BRONZE ANODIZED
