Geotechnical Survey Report

**Williams Properties / Stonestreet Development
Louisville, KY**

Re: Geotechnical Survey Report
Williams Properties / Stonestreet Development
Louisville, KY

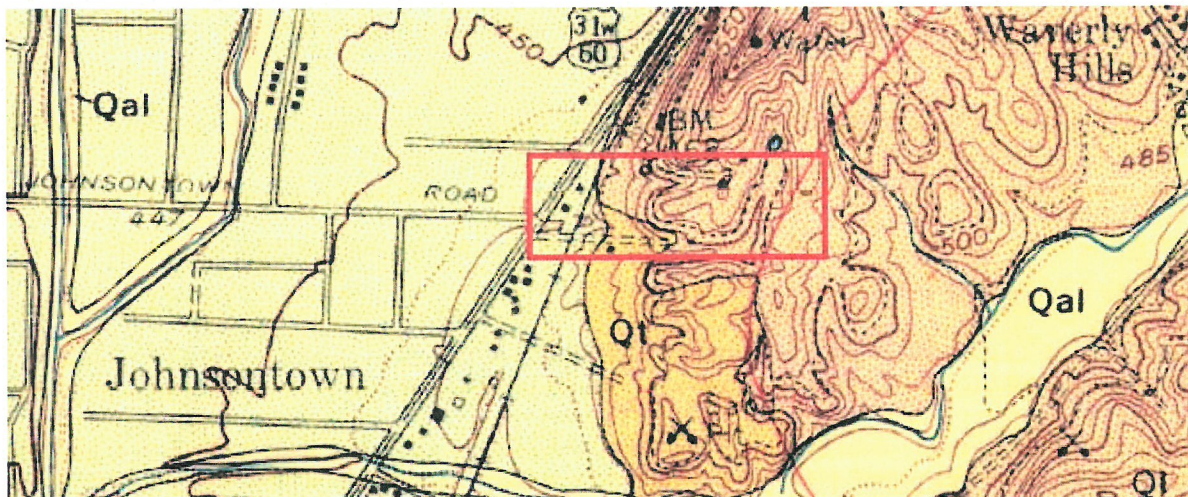
Figure 1 - Site Geology

These maps, with the site shown in Figure 1, indicated that the sloping areas subject to disturbance by the proposed development are likely underlain by Quaternary age Loess deposits at the surface which in turn are underlain by the Mississippian age Kenwood Siltstone Member of the Borden Formation. The Loess deposits can range in thickness from 0 to 30 feet and the Kenwood member is generally less than 40 feet thick but can be up to 100 feet thick. The Kenwood Member is typically interbedded within the Nancy Shale the New Providence shale members of the Borden Formation which can be up to 190 feet and 270 feet thick, respectively. Underlying all these units is the New Albany shale which extends to an unknown depth as the bottom of the unit has not been exposed.

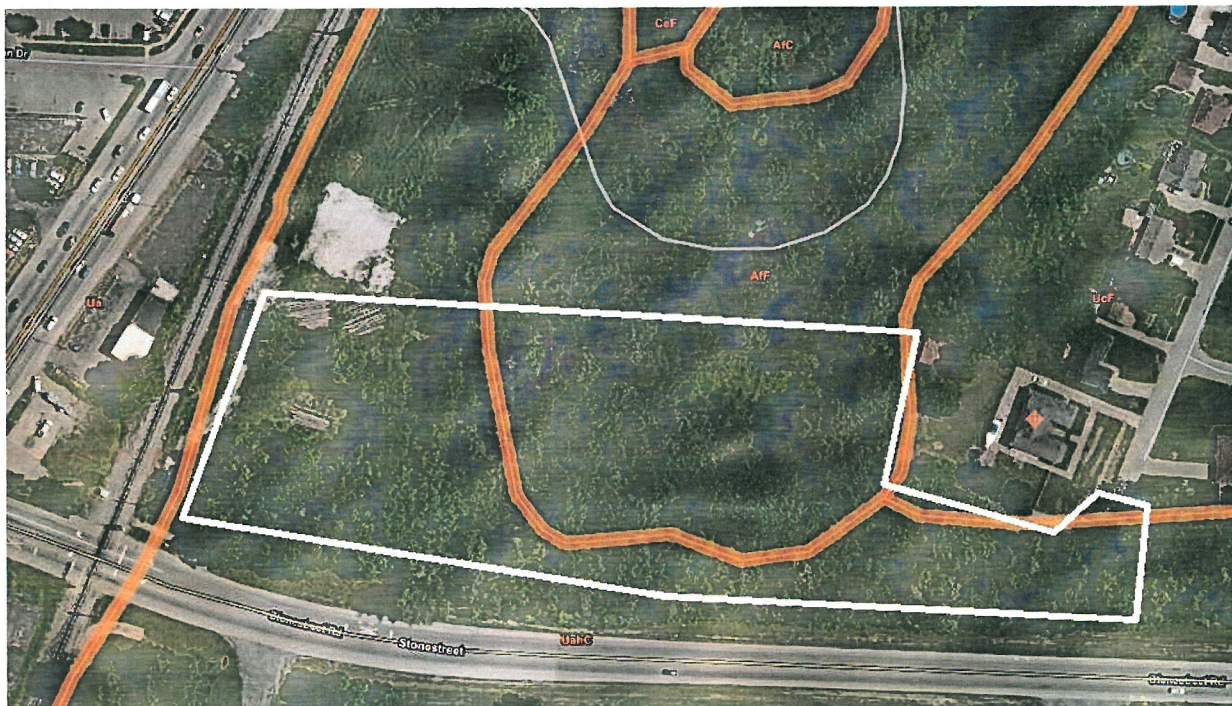
Figure 2 - Soil Data Map with Approximate Property Location

The USDA "Web Soil Survey" indicated 3 soil types for the site as shown in the Figure 2. Descriptions of these soil types are summarized below.

- AfF Alford silt loam – 25 to 50 percent slopes
 Parent Material: Thick fine-silty noncalcareous loess over silty residuum weathered from siltstone.
 Well drained, no flooding or ponding
 Low Plasticity
 Typical Profile:
 0 to 84 inches – silt loam

- AfC Alford silt loam – 6 to 12 percent slopes
 Parent Material: Thick fine-silty noncalcareous loess over silty residuum weathered from siltstone.
 Well drained, no flooding or ponding.
 Low Plasticity
 Typical Profile:
 0 to 84 inches – silt loam

- CeF Carpenter silt loam – 25 to 50 percent slopes
 Parent Material: Fine loamy colluvium derived from shale and siltstone over loamy residuum weathered from shale and siltstone.
 Well drained, no flooding or ponding
 Low to Moderate Plasticity
 Typical Profile:
 0 to 6 inches – silt loam
 6 to 38 inches – channery silty clay loam
 38 to 45 inches – very channery silty clay loam
 45 to 68 inches – weathered bedrock

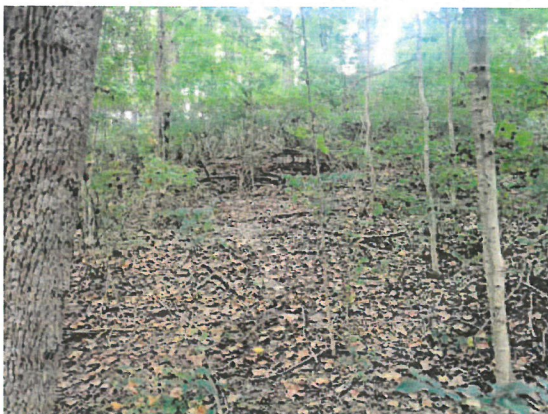
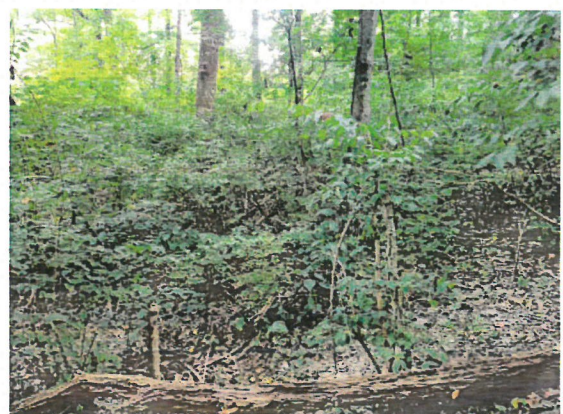
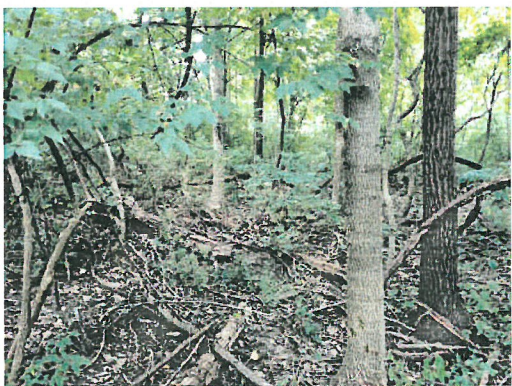
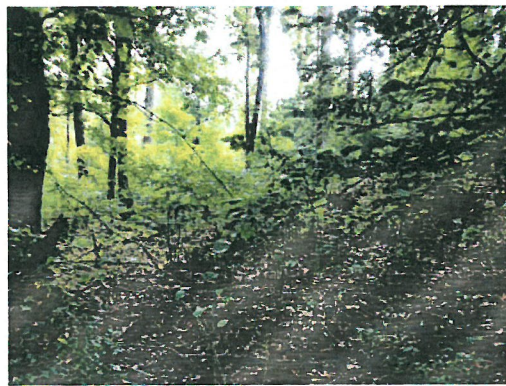
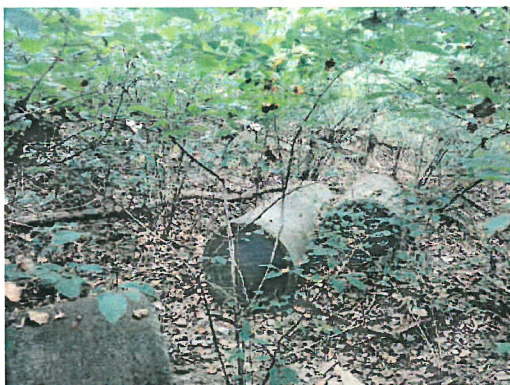
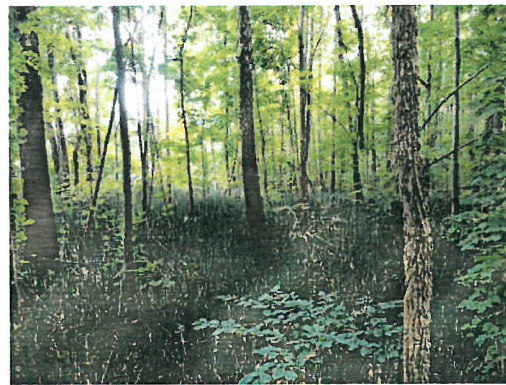
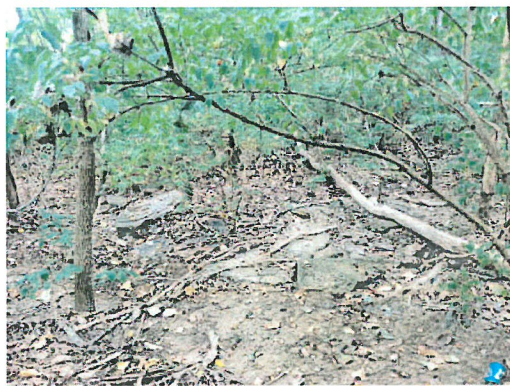
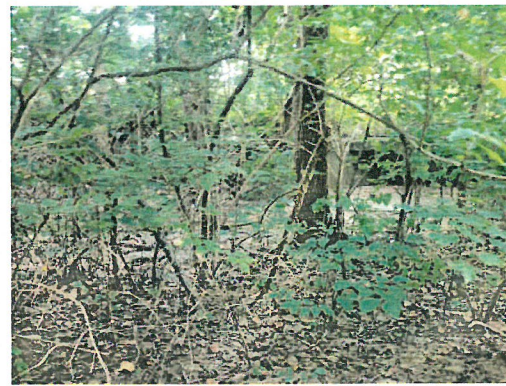
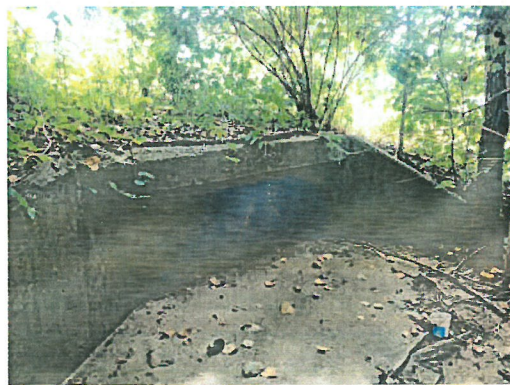
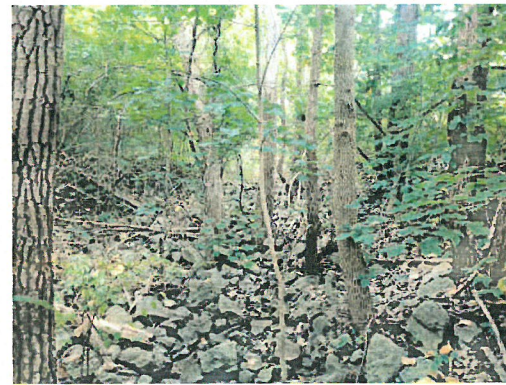
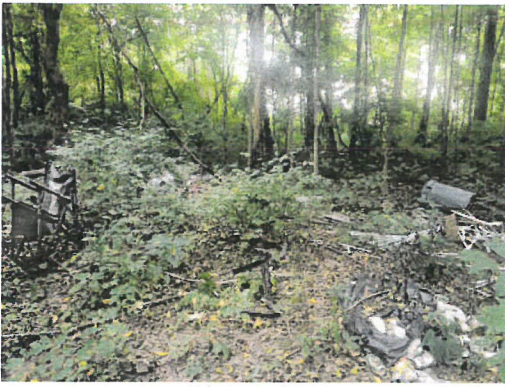
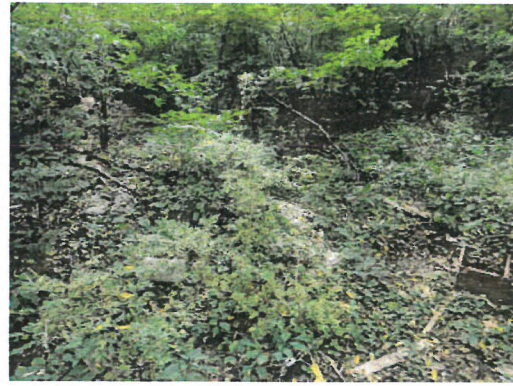
A visual reconnaissance of the site was performed on August 12th, 2019. Photos of the existing conditions were taken and are shown below. In general, the photos taken are an accurate representation of the site as a whole. No indications of slope instability including tilting or fallen trees due to slope movement, tension cracks, displaced soil, or any other evidence of slope instability were noted.

Based on our review of the above information and our experience on similar developments, it is our opinion the on-site slopes were stable at the time of our reconnaissance.

Based on the existence of slopes greater than 30% and the overall size and scope of the development which includes multiple buildings with both cut and fill slopes in excess of 10 feet in height, it is our opinion that a full-scale geotechnical investigation report be performed prior to building permit issuance to provide recommendations for appropriate foundation types and bearing capacities, engineered fill, pavements, and slopes.
