**Subject: Request for Jurisdictional Determination
6406 Leisure Lane Property
Jefferson County, Kentucky
Redwing Project No.: 16-149**

6406 LEISURE LANE PROPERTY
JEFFERSON COUNTY, KENTUCKY

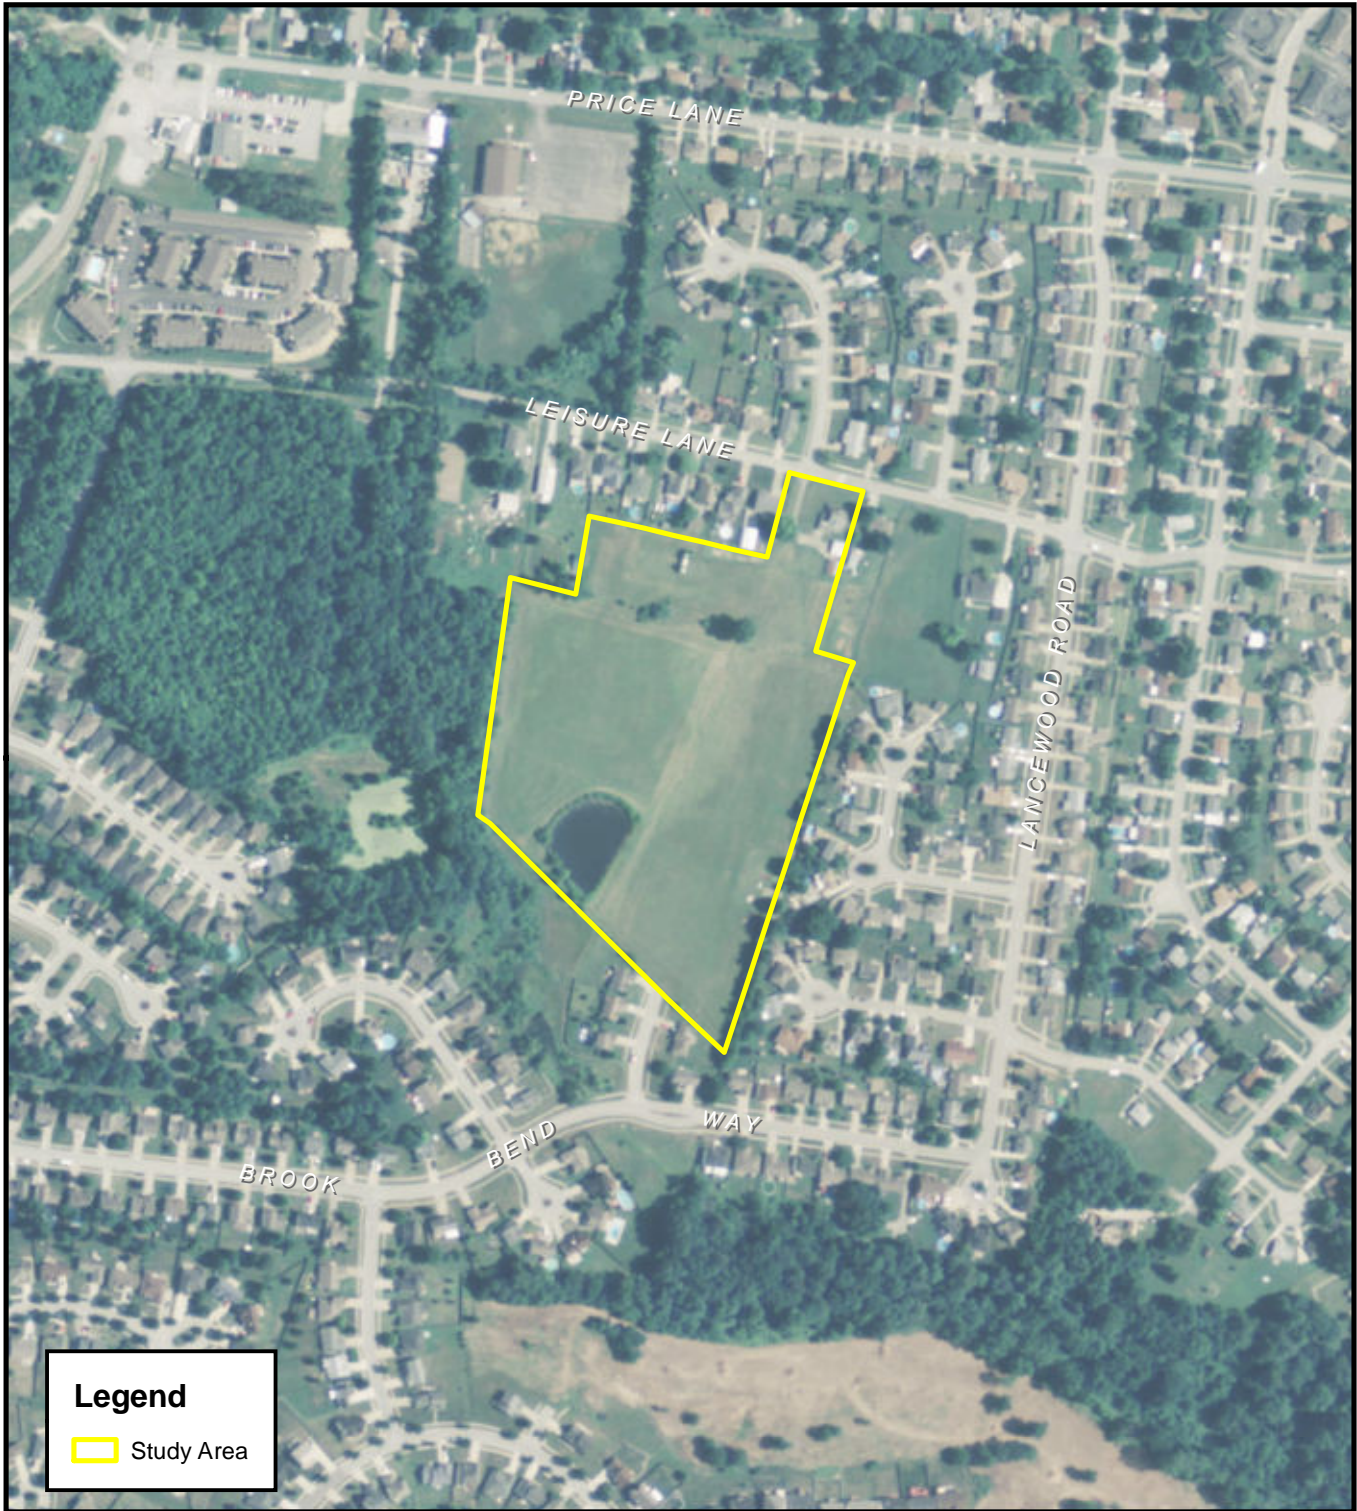
FIGURE 2

Vegetation: The study area consists mainly of maintained lawn, open field, and wetland (Figure 2). The maintained lawn species consist of tall fescue (*Schedonorus arundinaceus*), common dandelion (*Taraxacum officinale*), white clover (*Trifolium repens*), and English plantain (*Plantago lanceolata*). These species are listed as obligate upland (UPL) and facultative upland (FACU) in the *Eastern Mountains and Piedmont 2016 Final Regional Wetland Plant List* (RWPL).

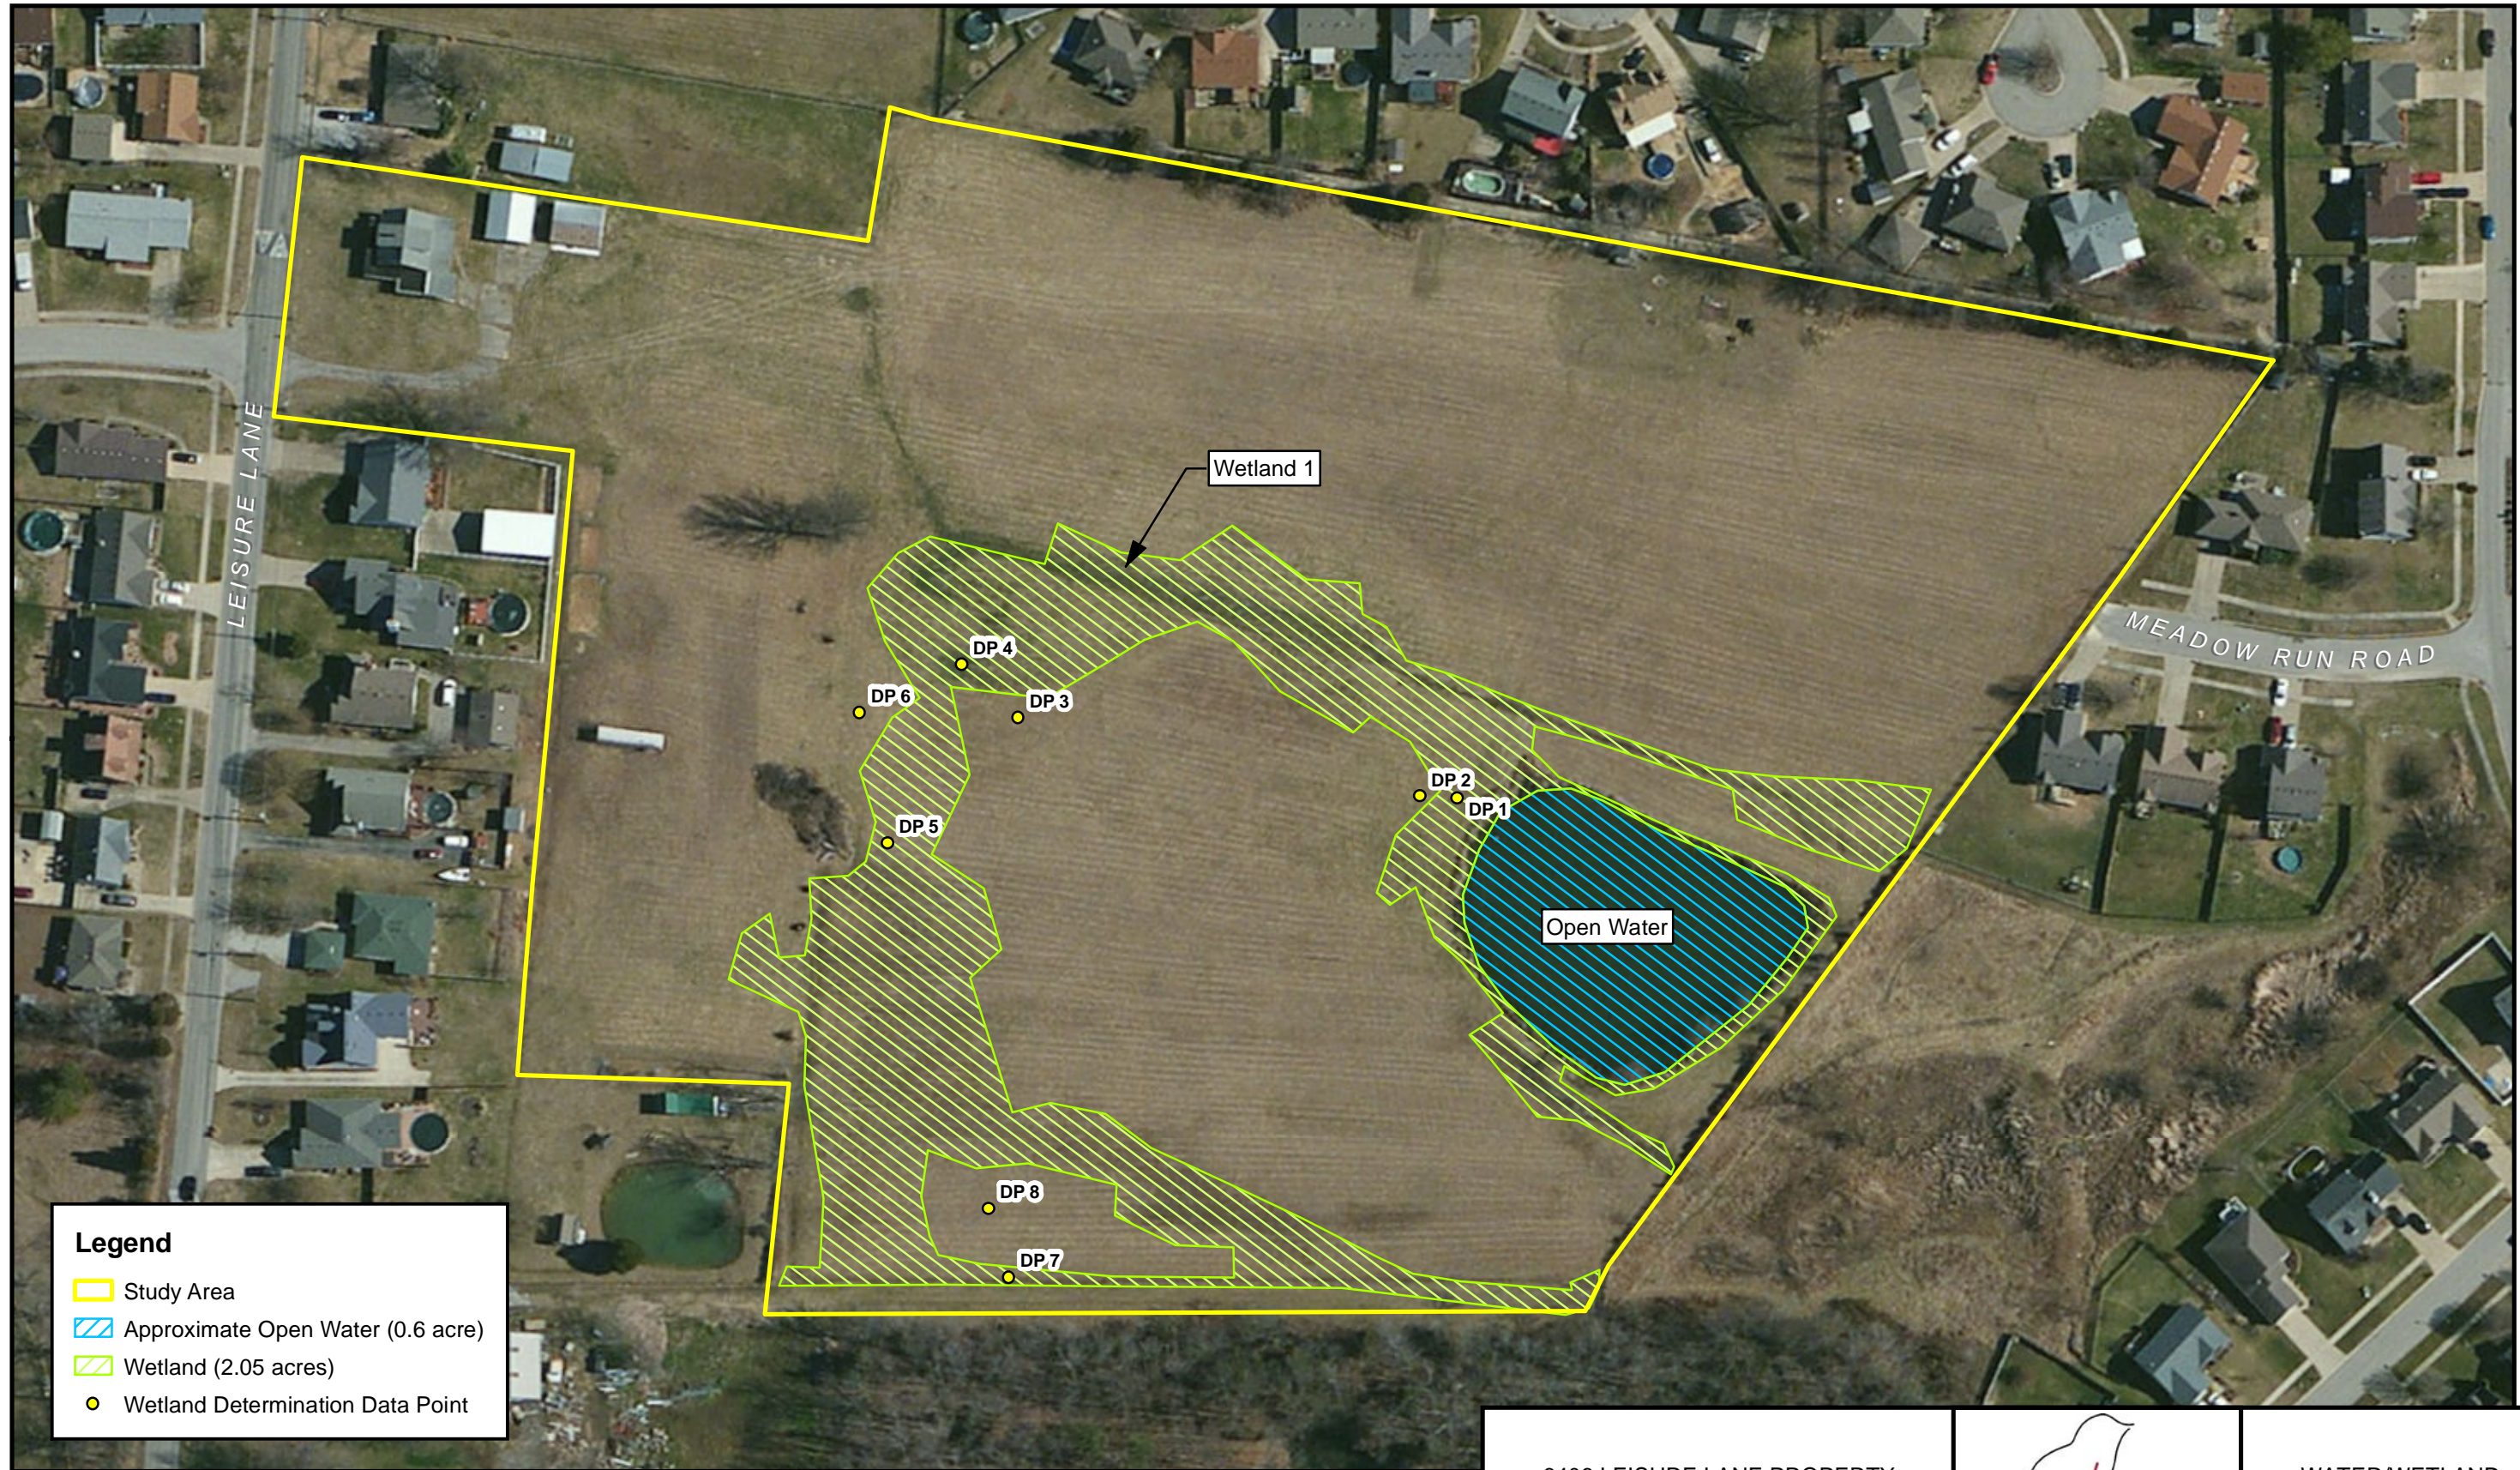
<p>REDWING ECOLOGICAL SERVICES, INC.</p>	<p>WATER/WETLAND LOCATION MAP</p>
REVISED DATE: 10-19-16	DRAWN BY: BGC/EDB/NAC	FIGURE 3

Water/wetland features identified within the study area include 2.05 acres of wetland and 0.6 acre of open water pond. The identified waters/wetlands are depicted on Figure 3 and described below. Soil, hydrology, and vegetation data were formally collected at eight points throughout the study area (Figure 3) and Wetland Determination Data Forms are attached as Appendix A. A draft Preliminary Jurisdictional Determination Form for the waters/wetlands is presented in Appendix B. Jurisdictional waters/wetlands have not been verified by the USACE.

Wetland: Wetland 1 (2.05 acres) is an emergent and scrub-shrub wetland located within the study area. The emergent portion is located in an open field and the scrub-shrub portion is located around Open Water 1. Wetland 1 is considered jurisdictional because it drains off the property into an unnamed tributary of Pennsylvania Run.

Open Water: Open Water 1 (0.6 acre) is an open water pond located in the central portion of the study area. Open Water 1 drains into Wetland 1 on its southwest side along an overflow channel. Open Water 1 is considered jurisdictional because of the connection to Wetland 1 and an unnamed tributary of Pennsylvania Run. The National Wetlands Inventory identifies the open water feature as Palustrine, Unconsolidated Bottom, Permanently Flooded, Diked/Impounded (PuBhh).

Soil, hydrology, and vegetation data were collected on Routine Wetland Determination Forms (Appendix A) at eight locations within the study area (Figure 3) and are discussed below.

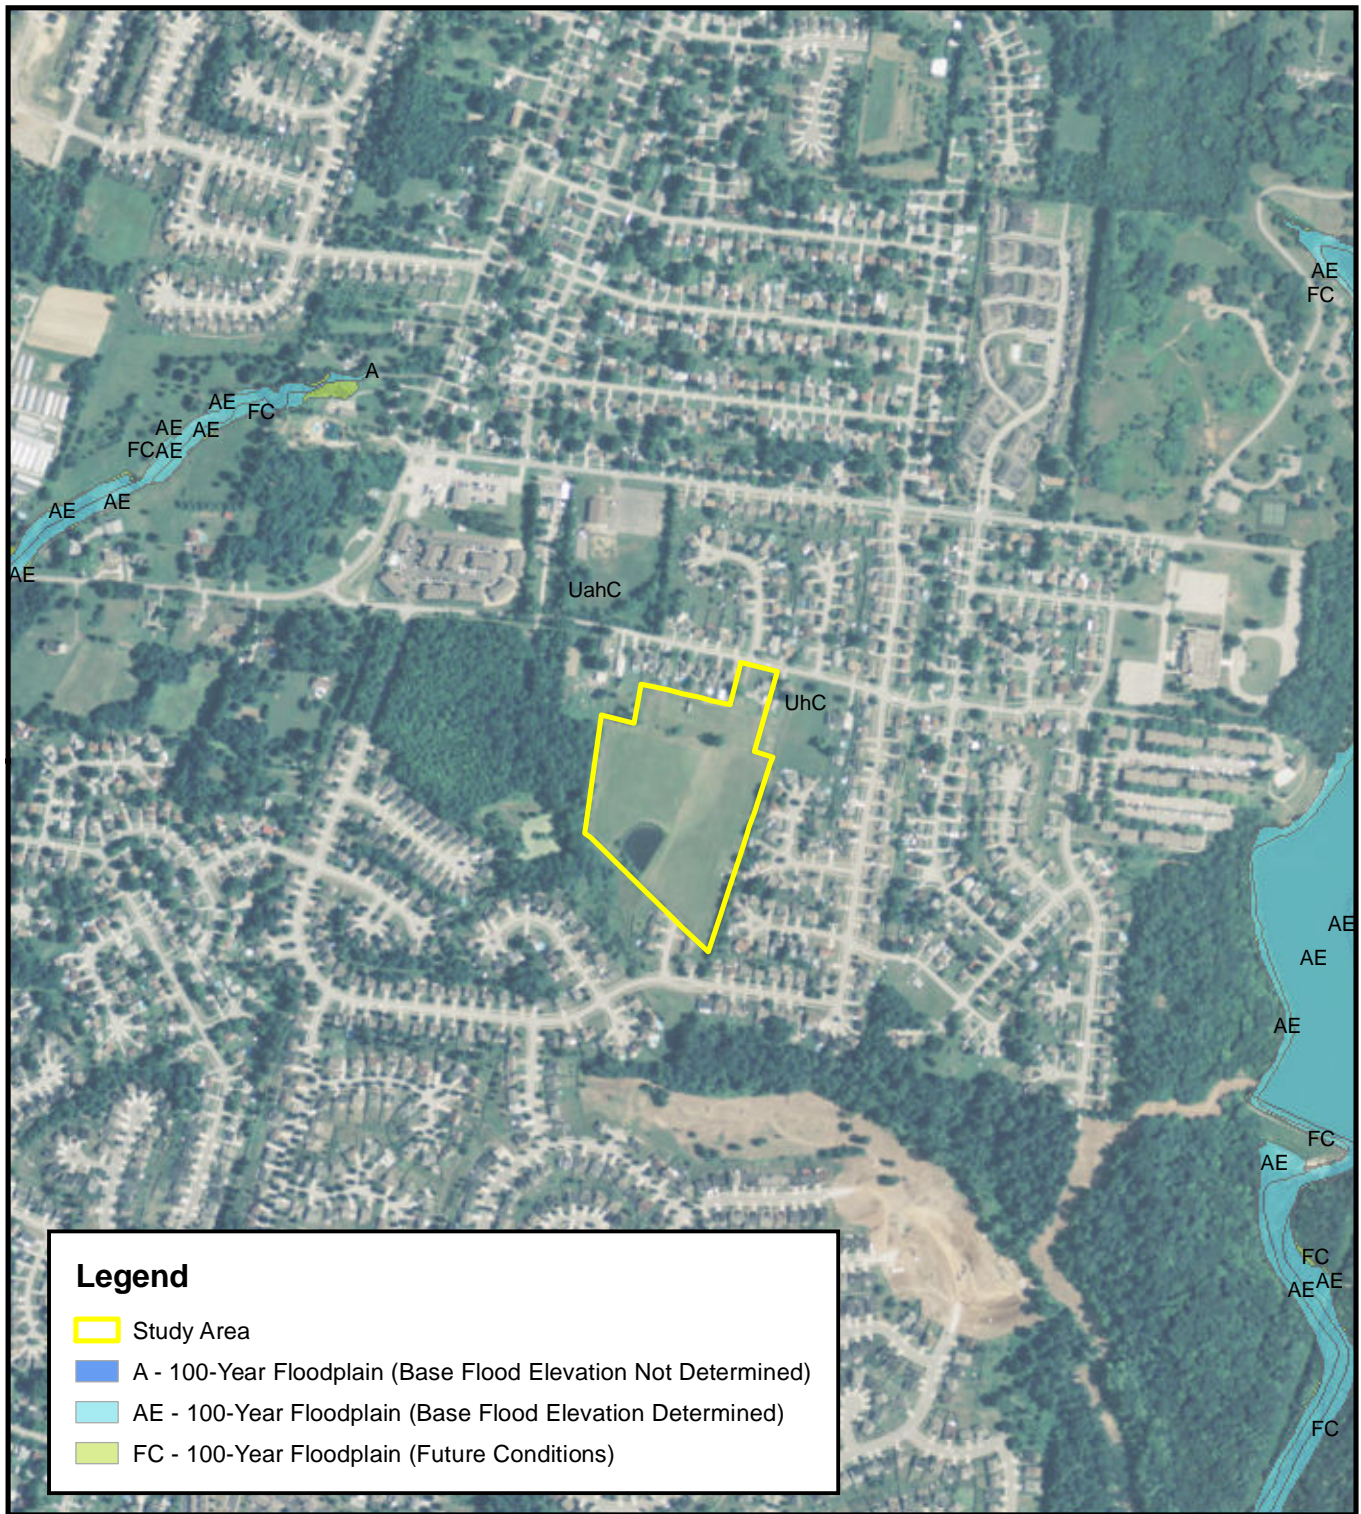
FIGURE 5

Hydrology: The main sources of hydrology to the study area include precipitation, surface runoff, and stormwater drainage from adjacent properties. The property is not located within the 100-Year floodplain (Figure 5). Hydrology indicators were observed within the wetlands and included oxidized rhizospheres on living root channels, saturation visible on aerial, geomorphic position, and the FAC-neutral test.

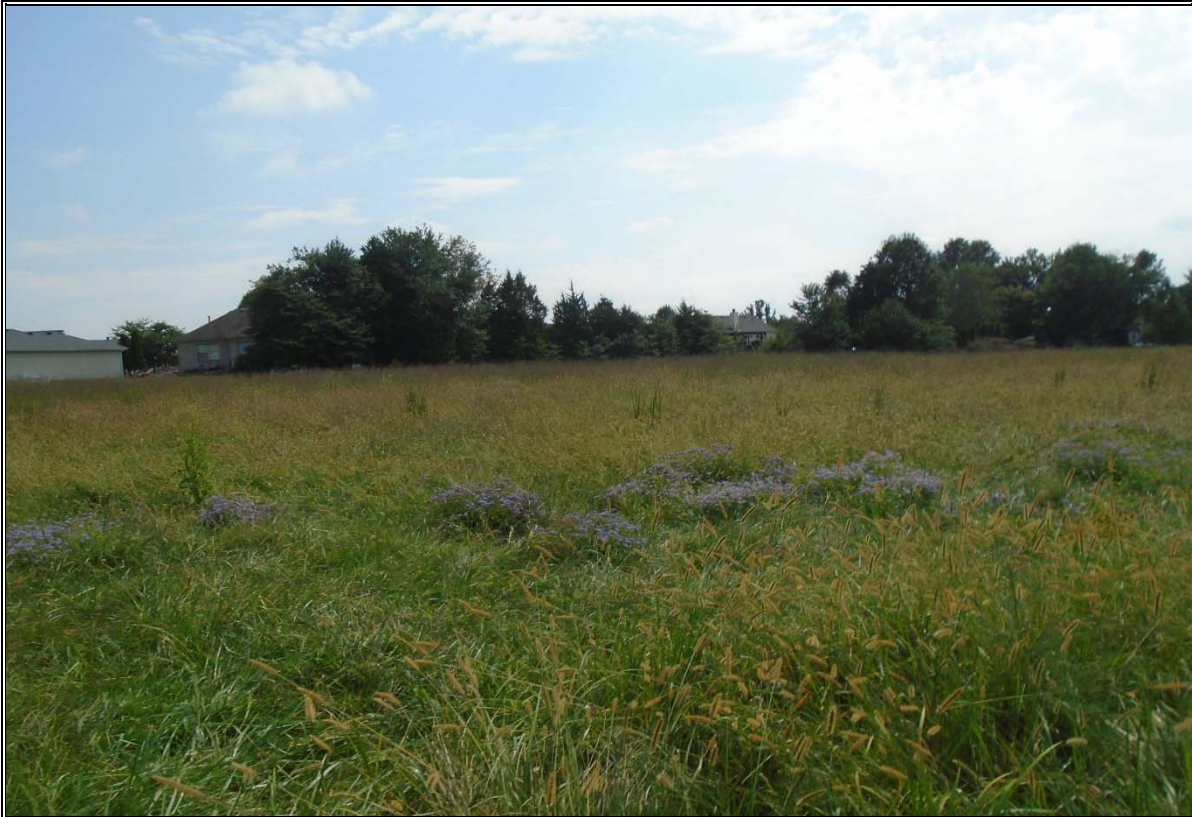
Photograph 1: View of the old field habitat typical across most the study area. September 15, 2016.

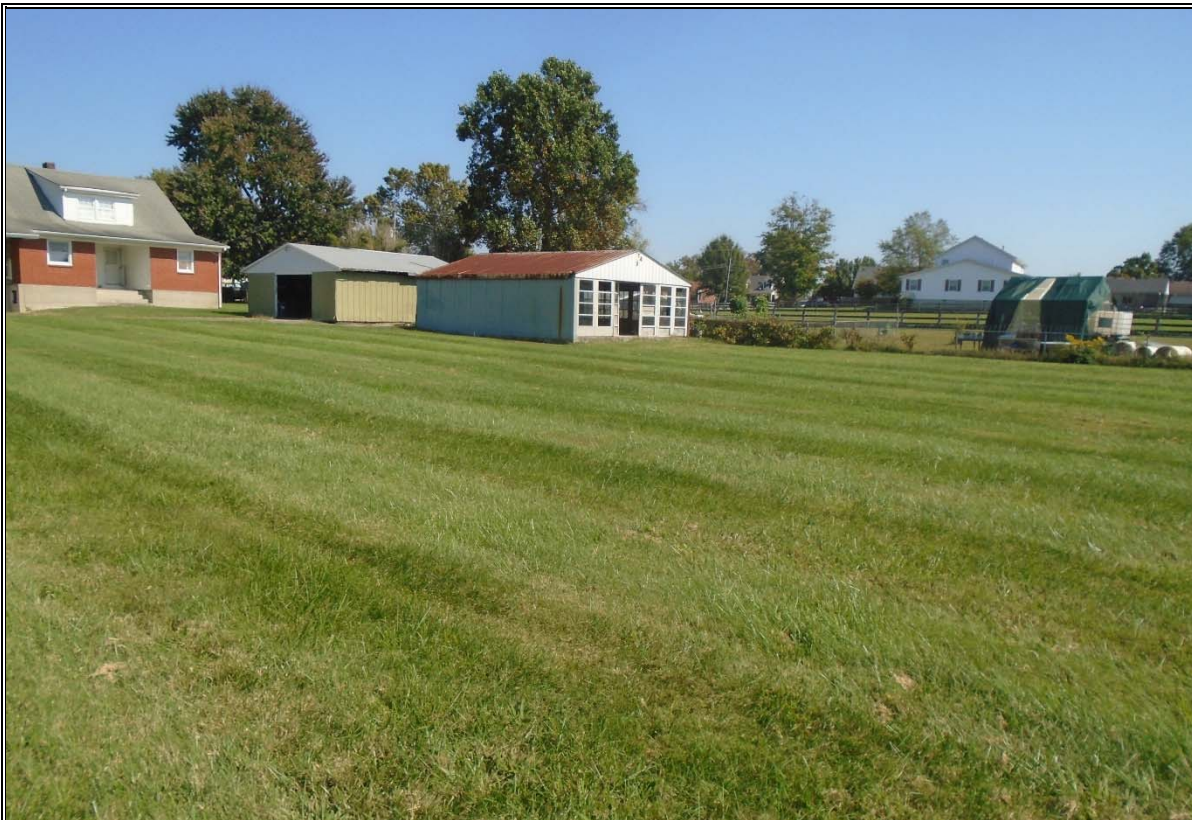
Photograph 2: View of the maintained lawn habitat that surrounds the residence located in the northern portion of the study area. October 6, 2016.

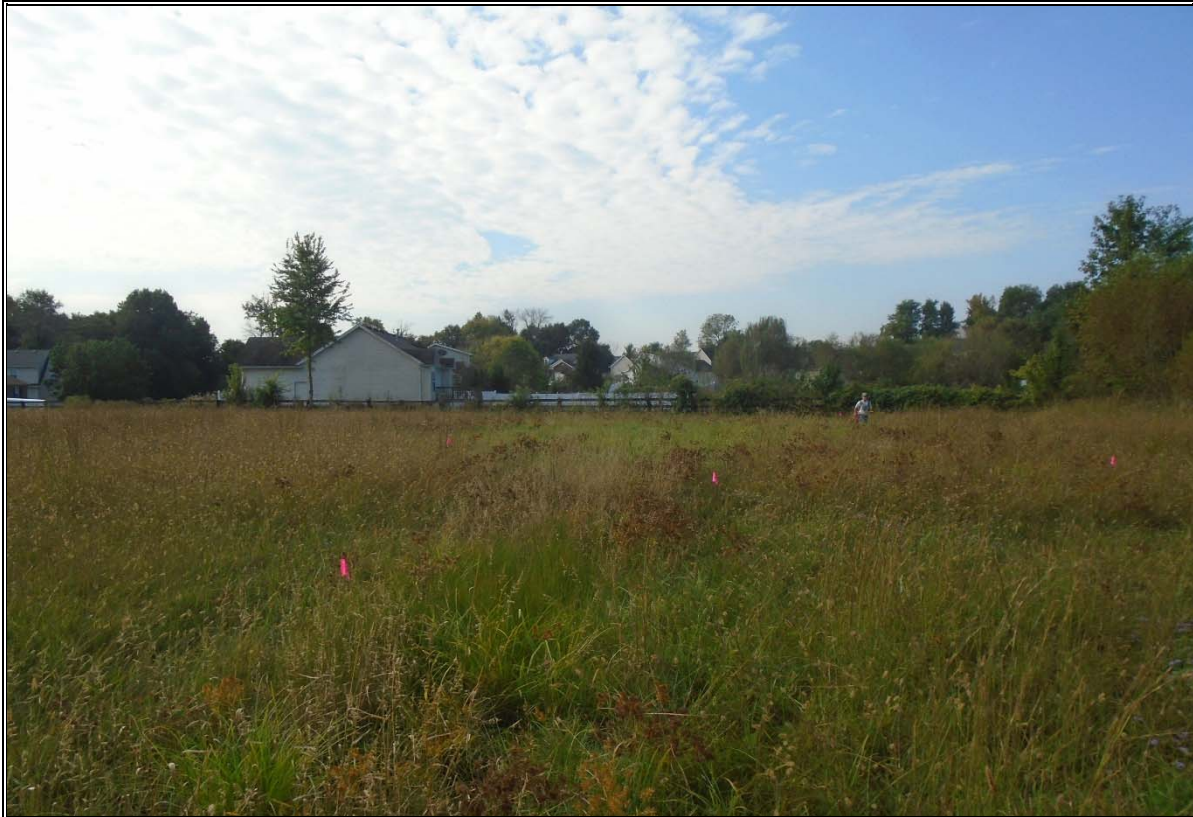
Photograph 3: View of the emergent portion of Wetland 1 located near the southern boundary of the study area. October 6, 2016.

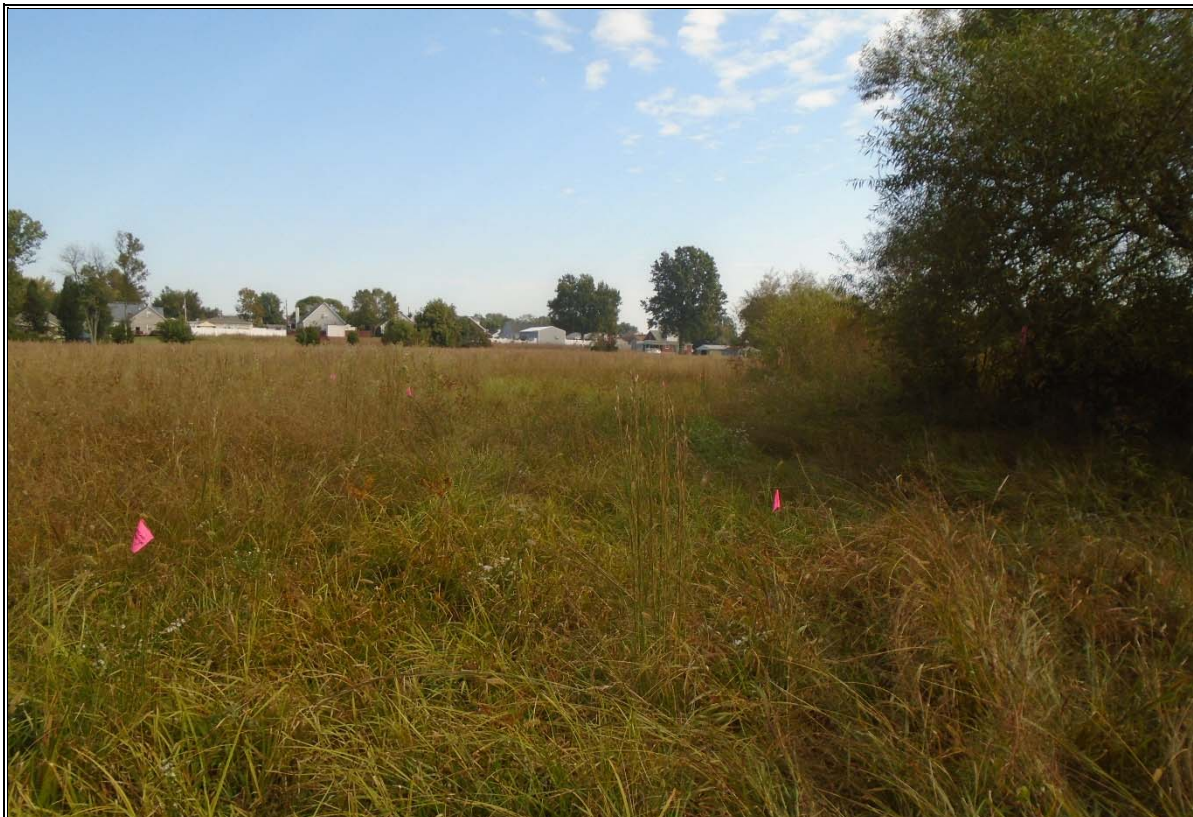
Photograph 4: View of Wetland 1 at the overflow for Open Water 1. October 6, 2016.

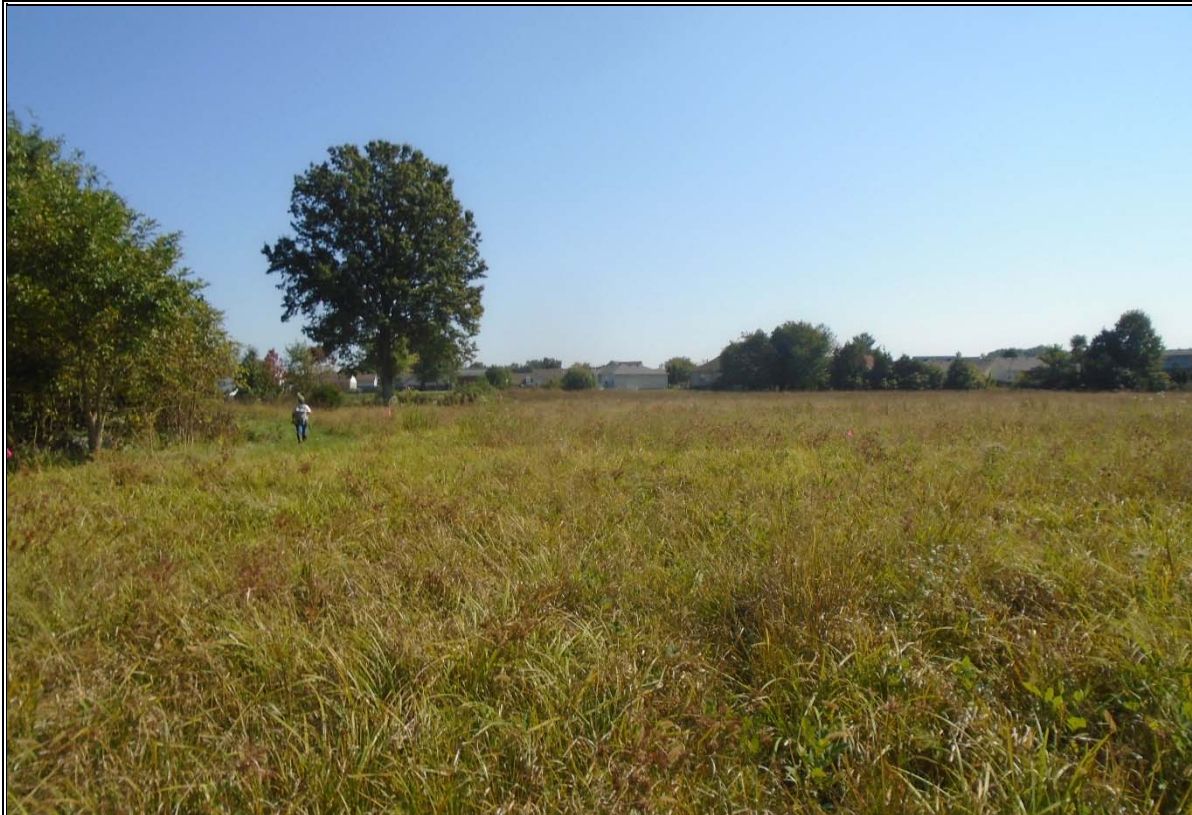
Photograph 5: View of the emergent portion of Wetland 1 located in the northern half of the study area. October 6, 2016.

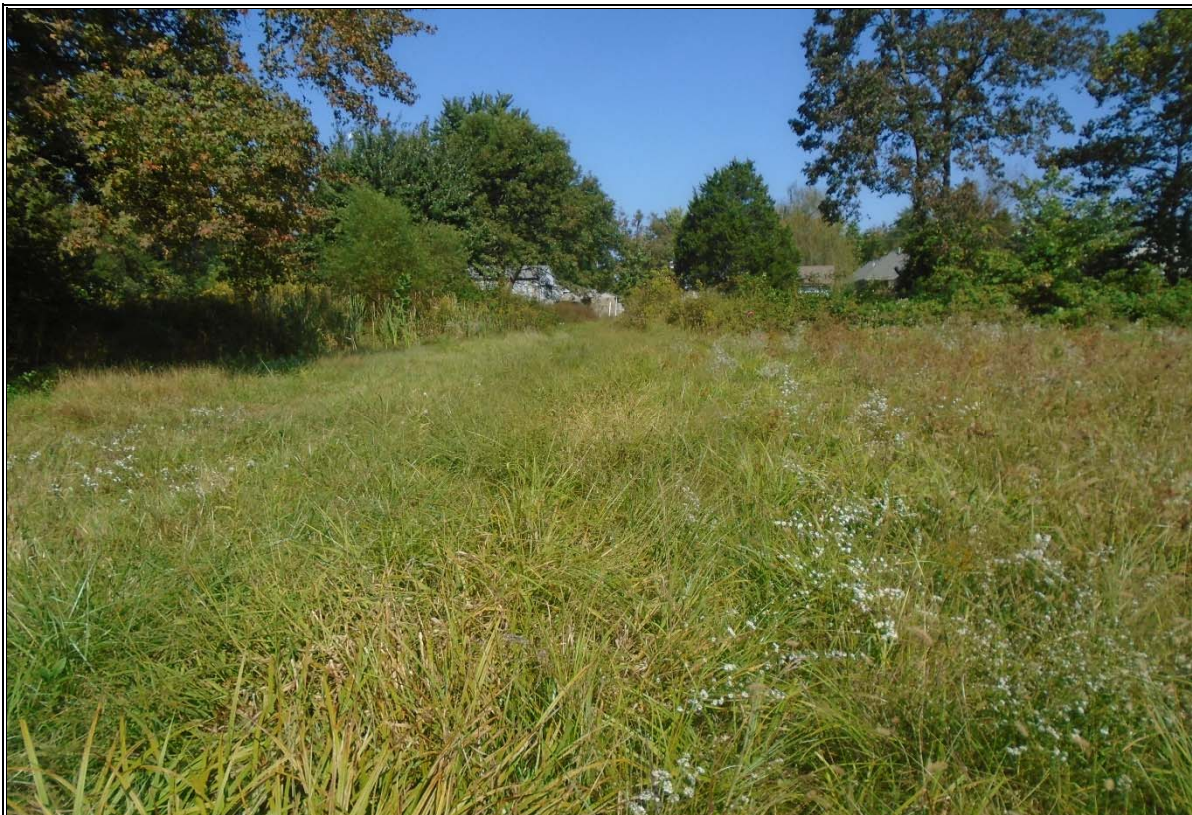
Photograph 6: View of the emergent portion of Wetland 1 located in the northwest corner of the site. The wetland appears to receive flow from an offsite open water feature located immediately north of the site. October 6, 2016.

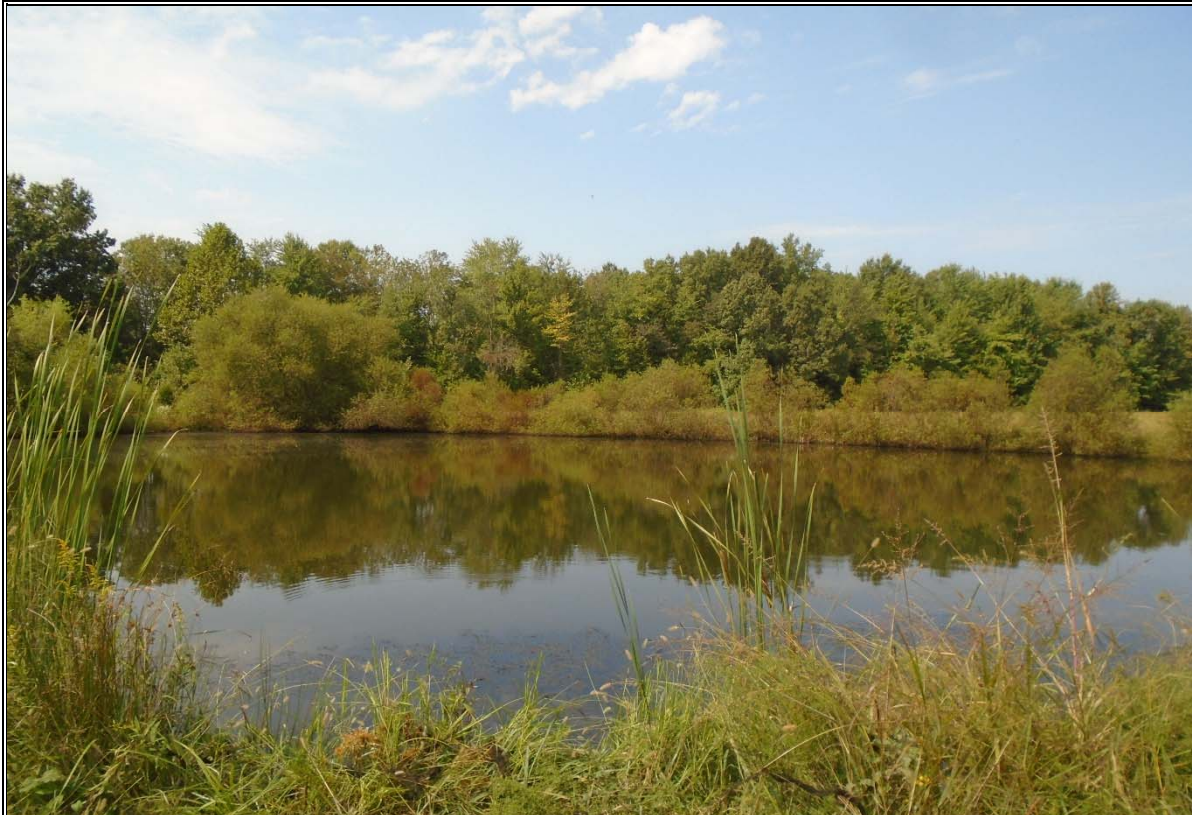
Photograph 7: View of Open Water 1 which receives flow from Wetland 1 and overflows into Wetland 1 as it exits the property near the southwest corner of the study area. The scrub-shrub portion of the wetland is located around the open water. September 15, 2016.

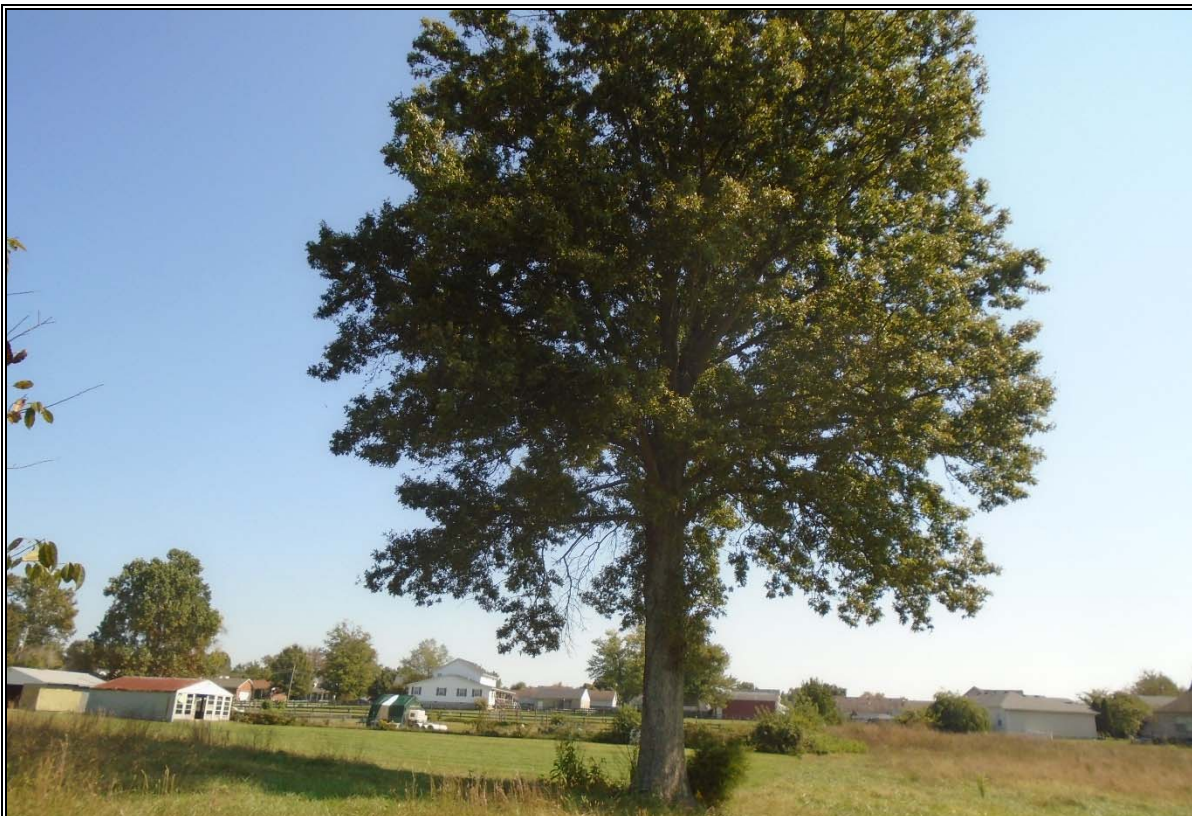
Photograph 8: View of the northern portion of the study area facing east. October 6, 2016.
