KARST RECONNAISSANCE SURVEY

HURSTBOURNE APARTMENTS DEVELOPMENT
LOUISVILLE, KENTUCKY

SME Project No. 089555.00
June 16, 2022

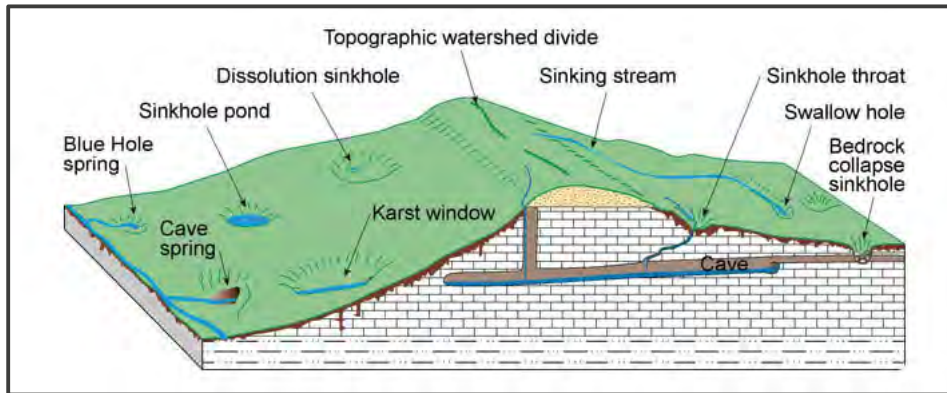
FIGURE 2 - KARST TERRAIN FEATURES ⁽¹⁾

Swell and swale topography (e.g., undulating hills intermixed with shallow depression) are also characteristic of karst, with localized depressions typically being the result of subsidence related to sinkhole activity. The figure below is characteristic of features associated with karst terrain.

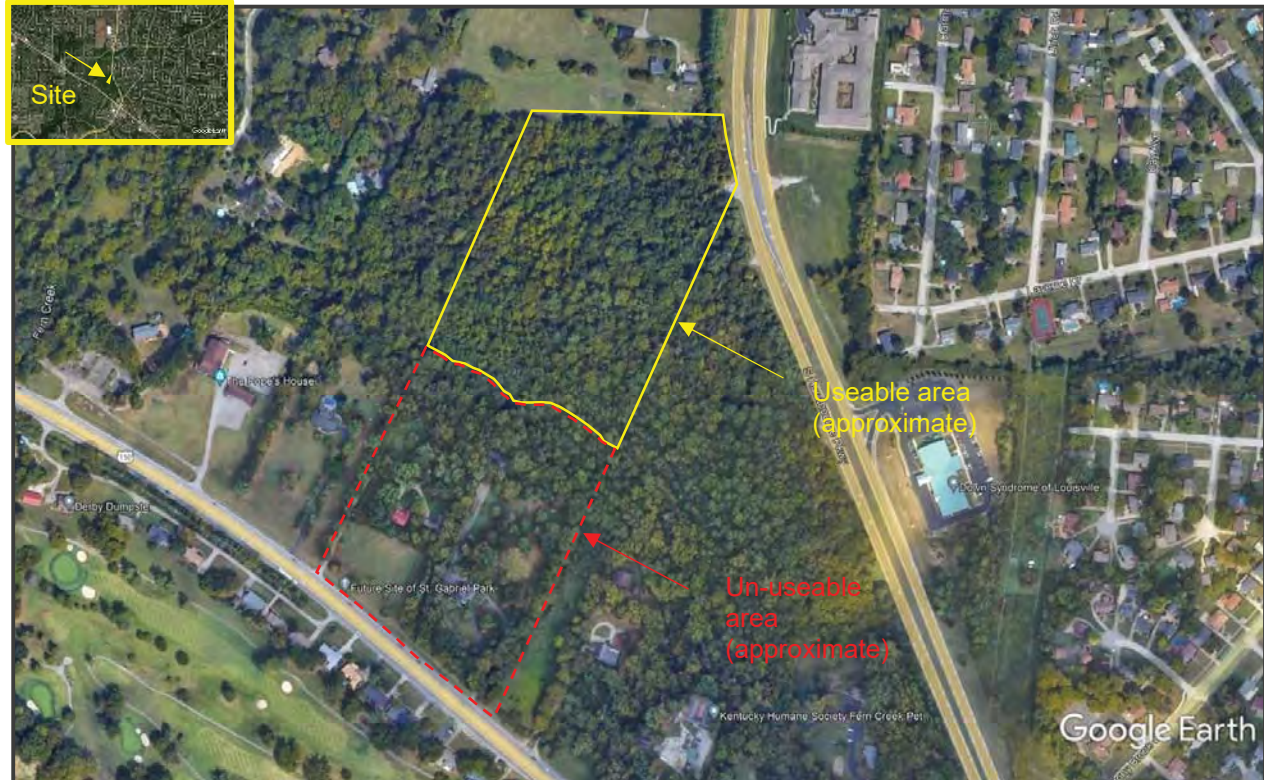
FIGURE 3 – SITE LOCATION MAP

The project site is densely wooded with a mixture of deciduous trees and brush. A dilapidated wooden fence was observed along the northern boundary of the site between the project site and 4700 South Hurstbourne Parkway. Based on the topographic information obtained from the figure titled "Concept Plan - 4900 S Hurstbourne Parkway" dated December 22, 2021, existing topography within the project area is described as rolling. In general, site grades gradually increase from about elevation 617 feet near the

northwest corner of the project area and slope down towards the south/southeast. The highpoint (approximately elevation 638 feet) of the site is near the east-central portion of the useable area. The low point within the useable portion of the project area (based upon limited topographic information) is approximately elevation 565 feet +/- near the stream adjacent to the southern border of useable area. However, development is not planned for the southern portion of the useable area where steep slopes exist.

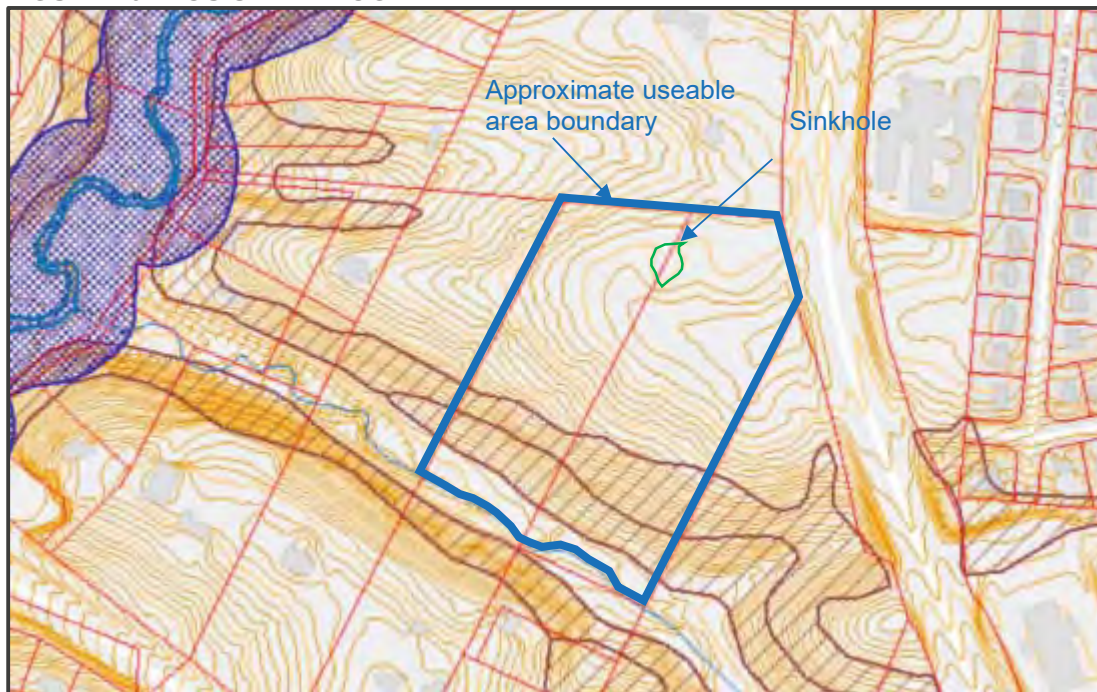
FIGURE 10 - LOUISVILLE LOGIC MAP ⁽¹⁾

Our review of the Louisville/Jefferson County Information Consortium (LOGIC) interactive GIS map indicated potentially steep slopes (represented by hatched zone) in the southern portion of the “useable area” as defined on the site concept plan. However, no development is planned in the area where steeper slopes were observed. Site topography (represented by 2-ft contour intervals) does not suggest obvious sinkhole activity, although the outline of the sinkhole previously identified on the karst potential map is visible (outer rim contour highlighted in green below). Shallow nuanced karst features are difficult to identify without closer contour characterization. The expanded boundary of Fern Creek (represented by the dark blue lines) represents the flood plain zone. Information obtained from LOGIC indicates the tributary along the southern boundary of the “useable area” is an intermittent stream as defined by the United States Geological Survey (USGS).

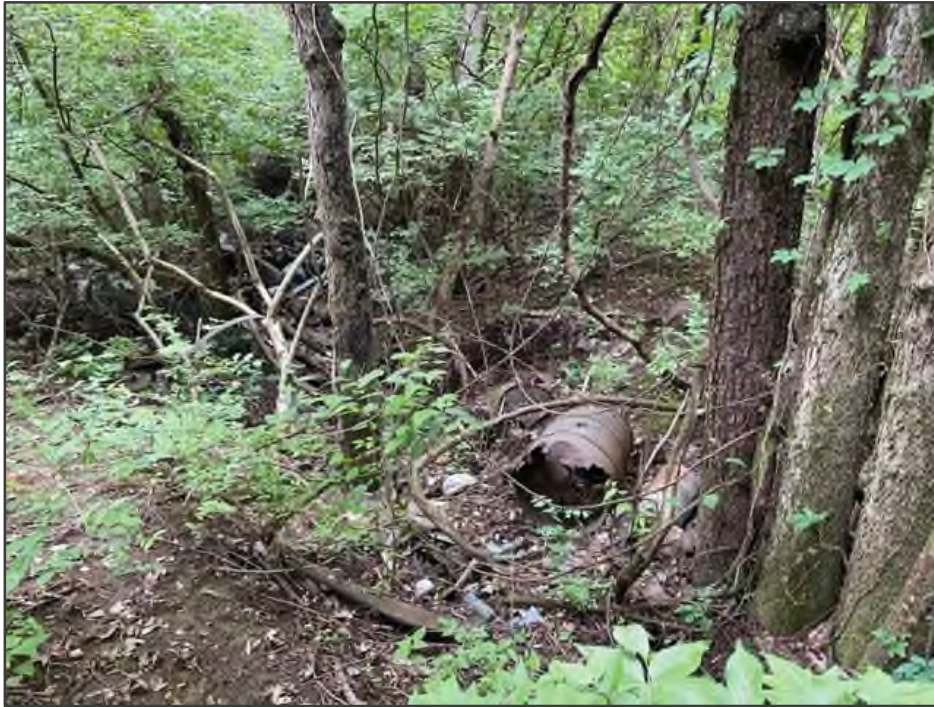
The site was overgrown with dense vegetation including brush, vines, and deciduous trees. The sinkhole feature referenced on the available geologic maps, LOGIC map, and site development plan was identified. The sinkhole was large, irregularly shaped feature of undetermined depth. Due to the feature's size and mature tree canopy, it was impractical to evaluate the depth or lateral dimensions via field measuring or via GPS. Various debris, including metal drums and cans, were observed in the sinkhole opening.

PHOTO NO. 1: Sinkhole – north central portion of site

Sinkhole features identified within structural areas (i.e., building or pavements) will require remediation during construction or utilization of alternative foundation systems as directed by the Geotechnical Engineer of Record, assuming the proposed structure locations cannot be shifted. We recommend identified and suspected sinkhole features be evaluated prior to construction (ideally during the planning stage) to determine impacts on the proposed development. Characterization of identified anomalies can be performed by performance of additional test borings (beyond quantity per geotechnical evaluation scope), excavation, and/or geophysical surveys.

For this specific project, there is limited available space for development due to the presence of steep slopes along the southern portion of the defined “useable” area. Shifting the development further south will require careful consideration and engineering analysis to address development on slopes. Therefore, it is likely the development plan cannot be easily modified, and the sinkhole feature will require remediation prior to construction of buildings or pavements. Specialized foundation systems may also be required for structure(s) in close proximity to the existing sinkhole feature.

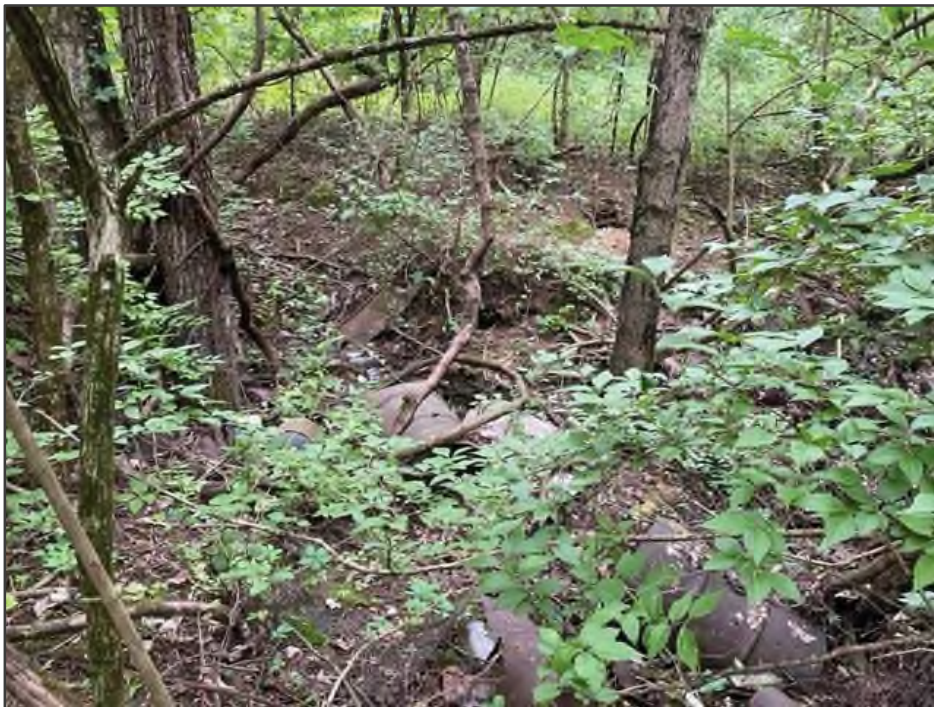
PHOTO NO. 2: Sinkhole – north central portion of site

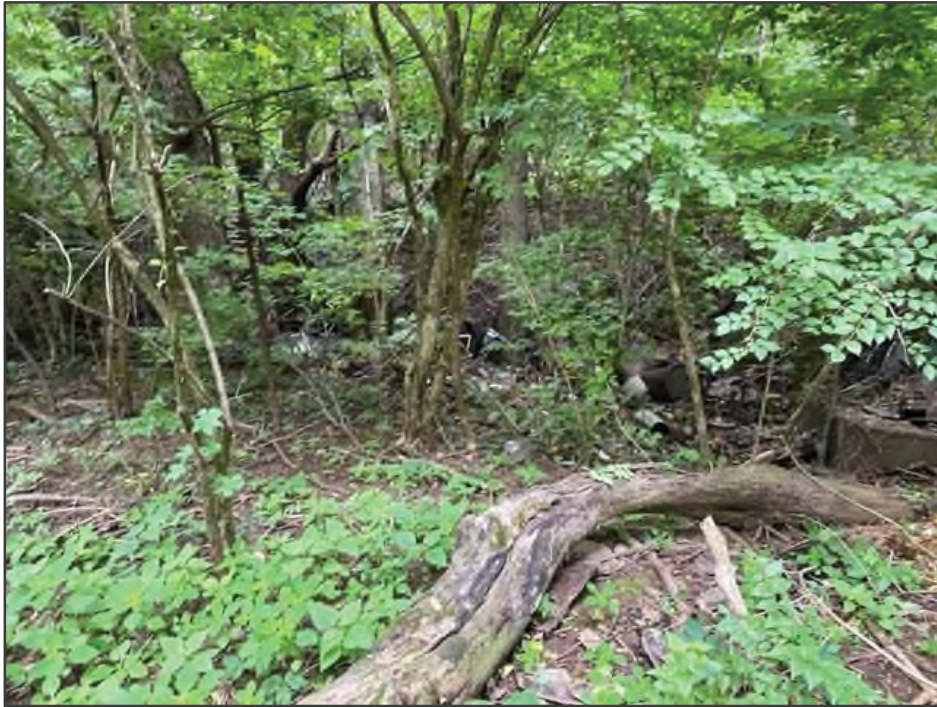
PHOTO NO. 3: Sinkhole – north central portion of site

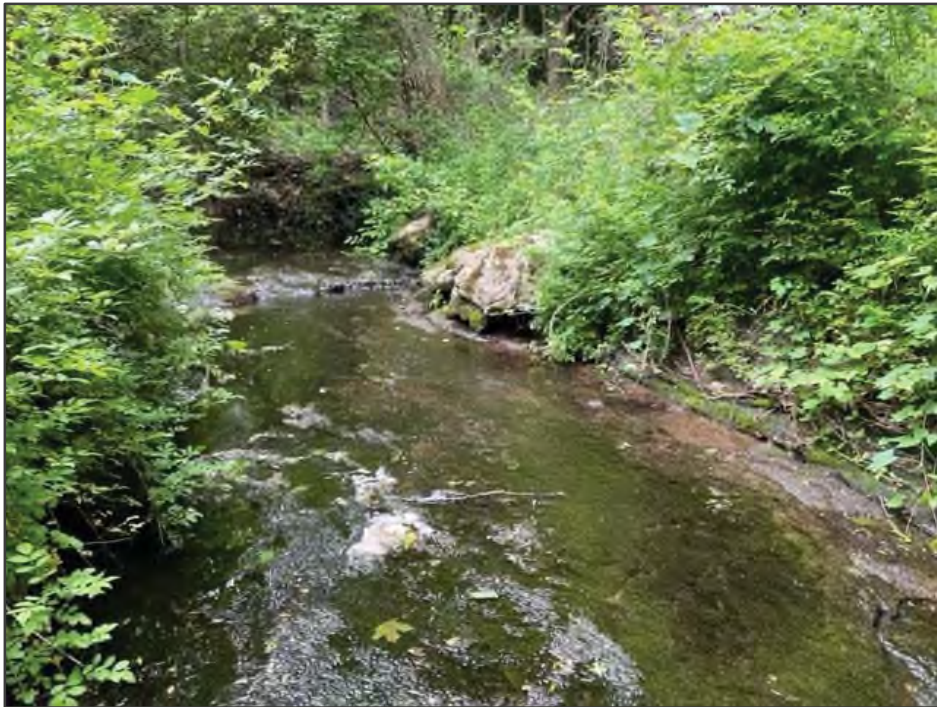
PHOTO NO. 4: Stream at southern boundary of useable area in southeast quadrant

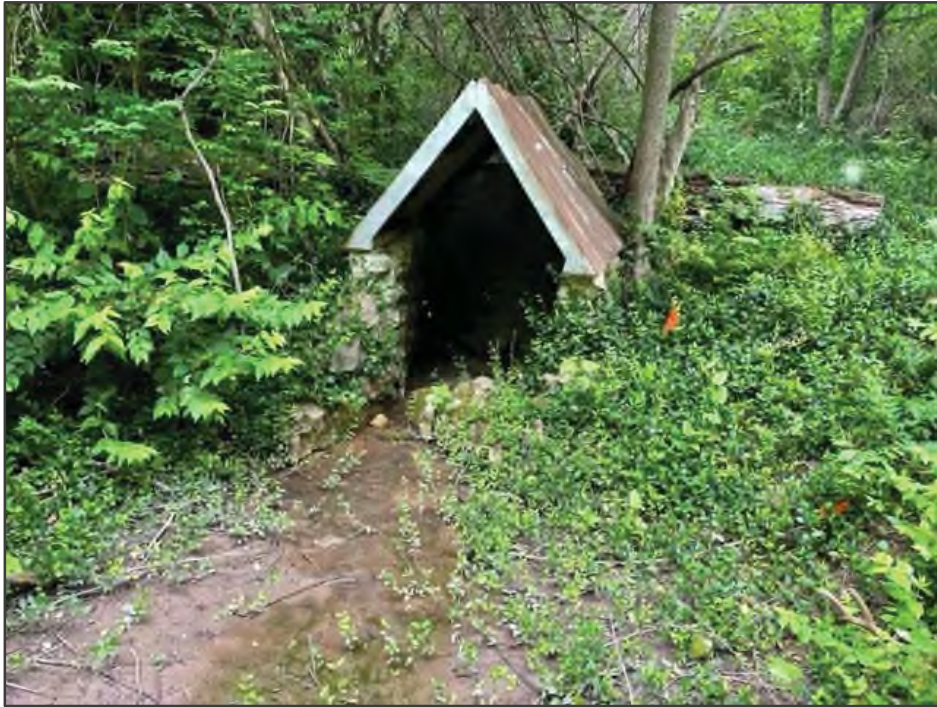
A suspected springhouse was observed near the southwest corner of the site, adjacent to the western property line for 5119 Bardstown Road and just north of the stream. This structure included stone walls on three sides and an A-frame metal roof. The ground surface near the spring was relatively moist, but no free water or spring discharge was observed emanating from the suspected spring house.

PHOTO NO. 5: Springhouse near southwest corner of useable area

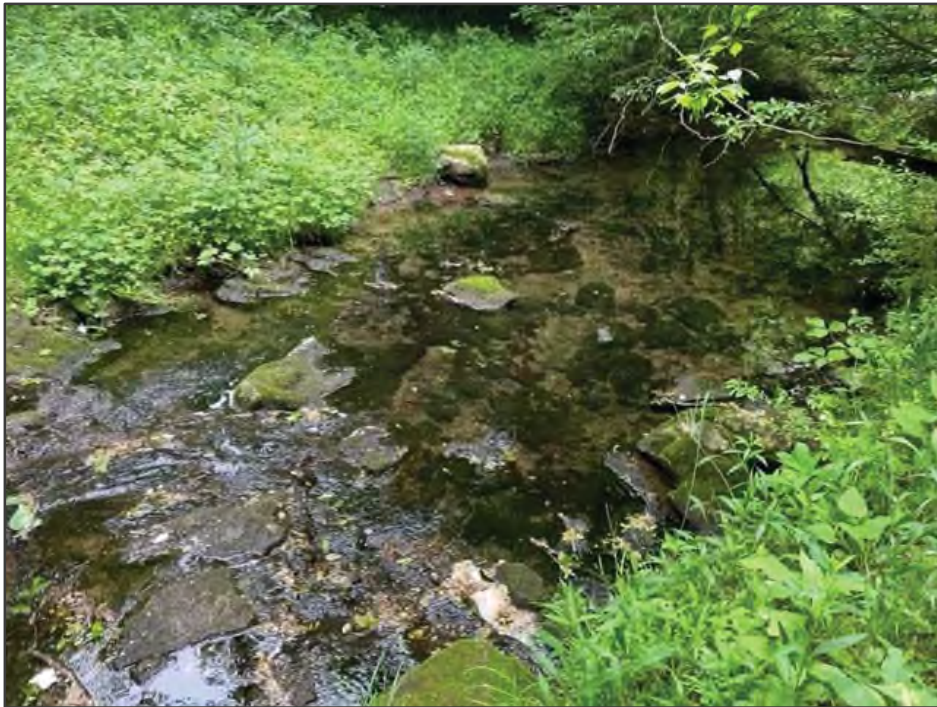
PHOTO NO. 6: Stream at southern boundary of useable area near southwest corner

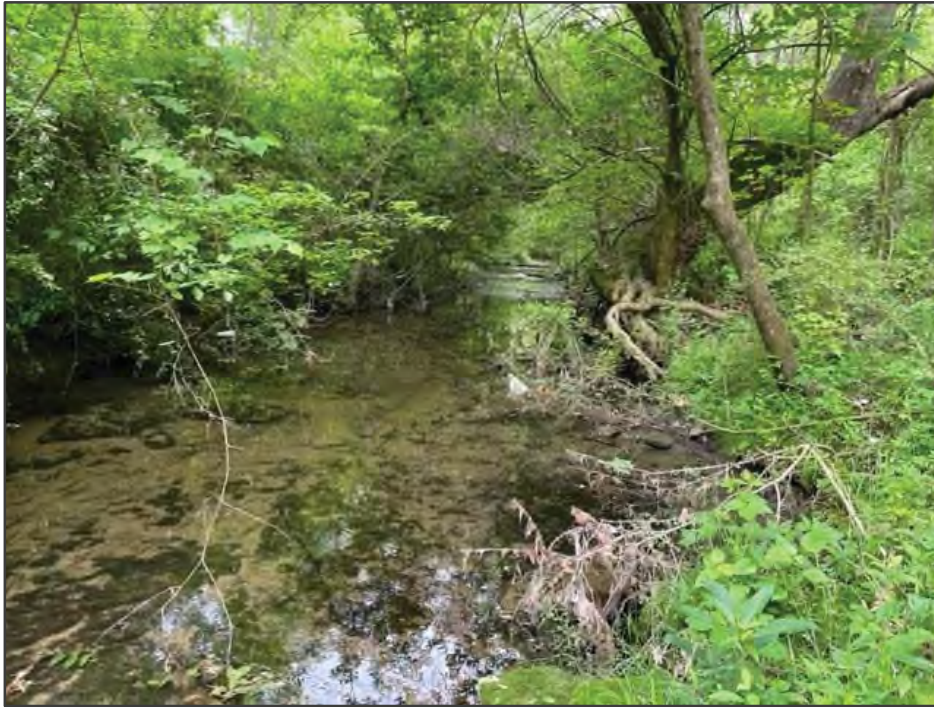
PHOTO NO. 7: Stream at southern boundary of useable area in southwest quadrant
