TRANSMITTAL FORM

DATE	October 11, 2019	REF #	3637
RE:	Beulah Church Apartments		
	Karst Survey Report

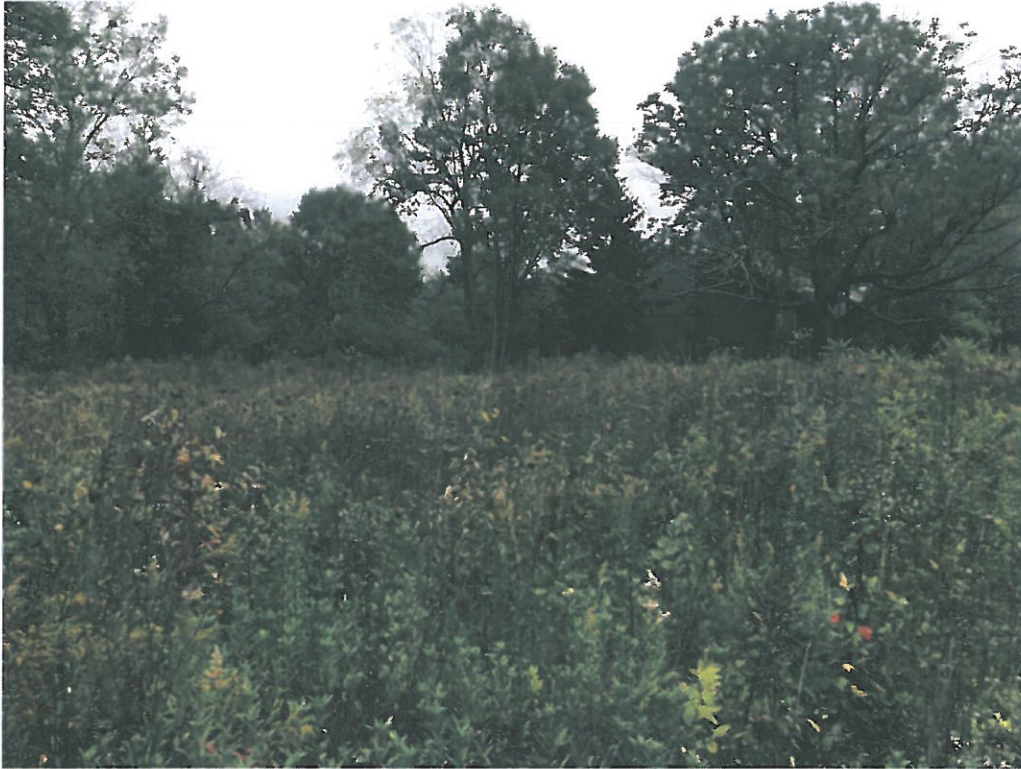
Photo 1: High weeds and grasses with dense undergrowth

or been transported away from underneath that location, another sign of potential subsurface karst. It should be noted
that the densely vegetated condition of the site, with high weeds and grasses and thick undergrowth, significantly inhibited
the engineer's ability to see the ground well enough for proper inspection for much of the site. This site is considered medium
risk of encountering sinkholes and other karstic features during construction, and care should be taken during earthwork
and construction to notify the geotechnical consultant if and when any suspected sinkholes are encountered and to
remediate them properly.

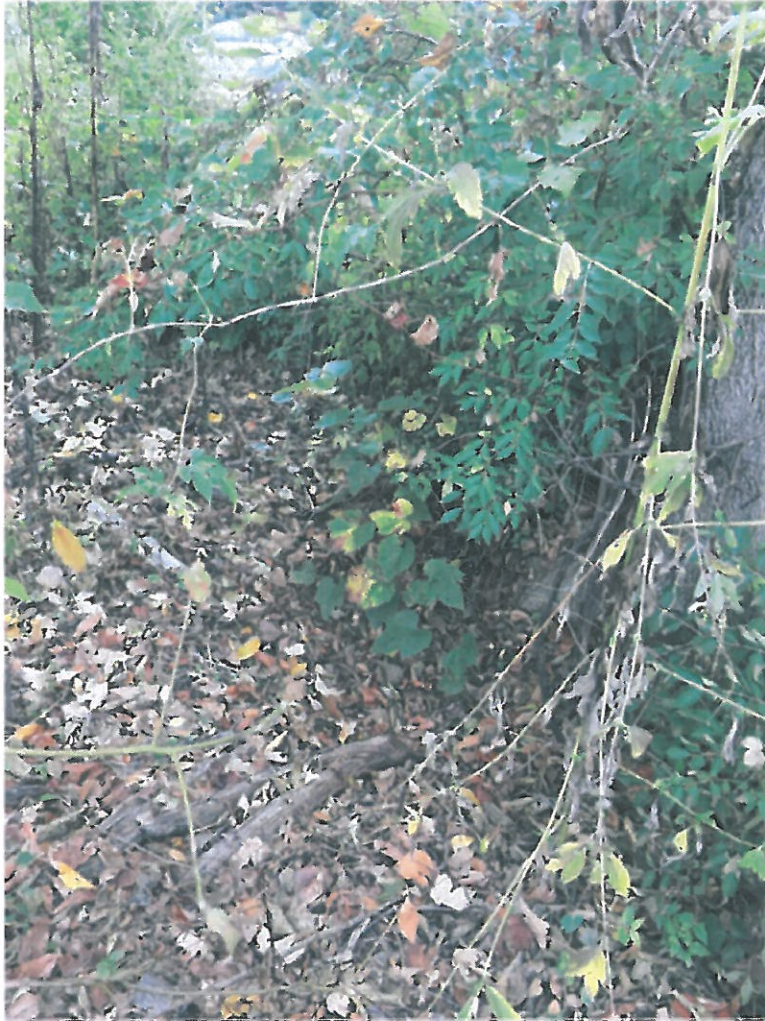
REMARKS: Mindel Scott engineer, Travis Brown, conducted online research to assess karst potential at the project site.
The Kentucky Geologic Map service online characterizes the site as being of medium karst potential with no mapped
sinkholes on the site or in the immediate vicinity. The engineer visited the site on 10/9/2019 to perform a visual
inspection. Upon walking the site the engineer's experience agrees with online mapping. One potential karstic
feature was encountered, which was a closed depression near a tree in the tree line along the east side of the existing
driveway. Closed depressions indicate an area which has an inability to drain on the surface, which forces infiltration.
Infiltration in areas of karst prone geology such as this site (Louisville Limestone) can often point to subsurface karst
features and sinkholes. Additionally, the soil subsidence of a closed depression indicates the supporting soil has consolidated

Photo 2: Closed depression near tree just east of driveway
