## Historic Landmarks and Preservation Districts Commission

### Report to the Committee

**Case No:** 23-COA-0067  
**Classification:** Staff Review

**Property Address:** 1105 S. 1st Street

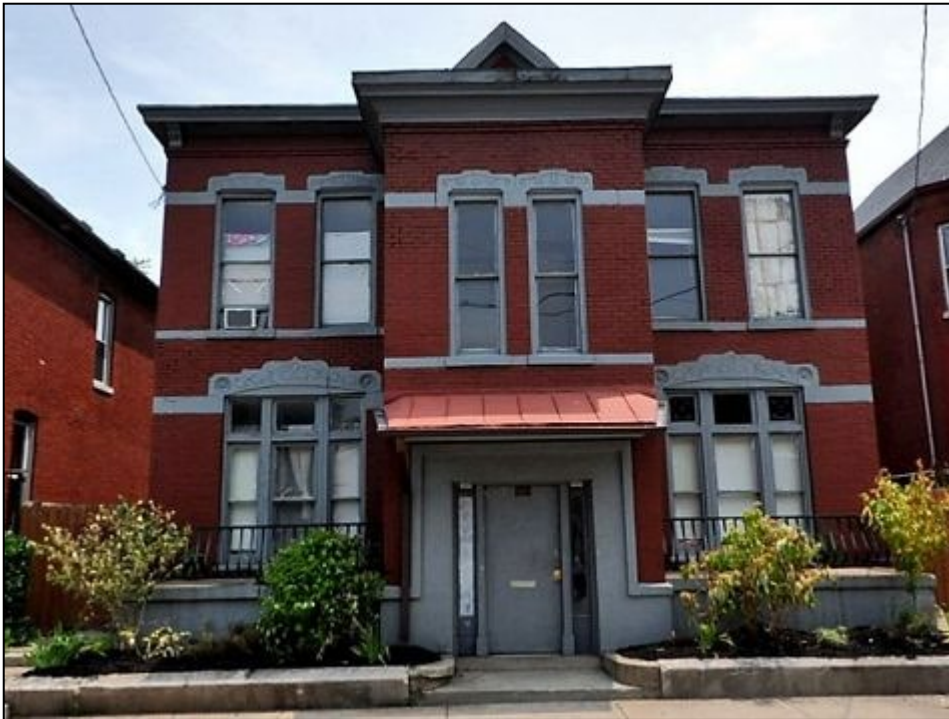
The proposed after-the-fact door replacement generally does not meet the design guidelines for **Door**. The previous door was a solid door with a mail slot (**Figure 1**). It was not historic or original to the home. The historic door was a  $\frac{3}{4}$  lite wood door, which was replaced without Landmarks' approval (**Figure 2**). Although the new door appears to be the same size as the previous door, the new door is a modern door with horizontal slat details. Its design is not fitting with the architectural character of the home. Specifically, the replacement door does not conform with the following guidelines:

**Figure 1.** Photo of 1105 S. 1<sup>st</sup> Street prior to door replacement.

Even though the historic entry door had been previously replaced with a solid door, the guidelines still call for a replacement door that is compatible with the architectural character of the building. Because the after-the-fact request does not meet the design guidelines for Door, staff recommends denial of the request. A  $\frac{3}{4}$  lite door or a more traditional, paneled, solid door could be considered.

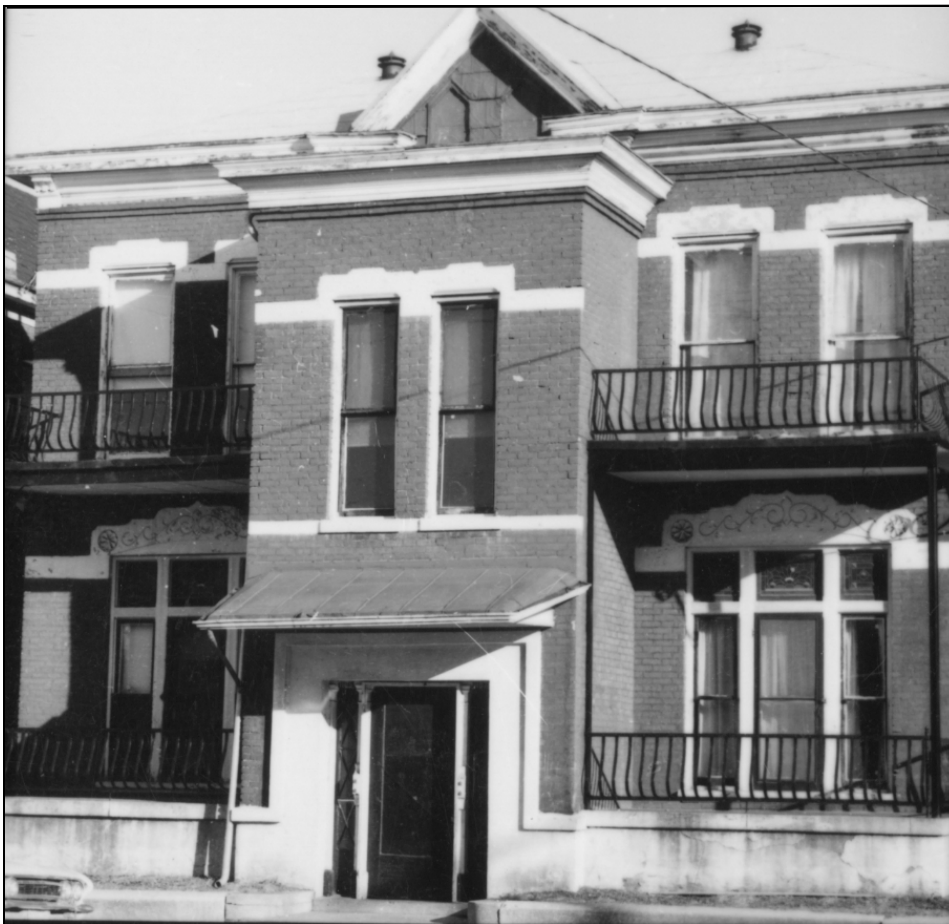
- **D3:** The designation photo shows the original door as a  $\frac{3}{4}$  lite wood door. While it had been previously replaced with a solid door, both were more compatible with the architectural character of the building. The modern door is not appropriate.

- **D4:** The designation photo shows the original door as a  $\frac{3}{4}$  lite wood door. The previous door was a solid door as is this replacement door. However, neither door duplicate the design of the original.

**Figure 2.** 1974 Designation Photo of 1105 S. 1<sup>st</sup> Street.

- **D12:** A non-original, non-historic door was replaced with a new door. However, the new door is not appropriate to the period and style of the building. It is too modern in design. A  $\frac{3}{4}$  lite door like the original or a more traditional solid door would be more appropriate.
