## **Bardstown Road/Baxter Avenue Corridor Review Overlay (BROD) District**

Report of the Urban Design Administrator to the  
Committee

**Case No:** 21-OVERLAY-0037  
**Classification:** Non-Expedited

**Property Address:** 1703 Bardstown Rd (Zwanky V, formerly Slay Boutique)  
**Applicant:** Ahmad Fadhil  
8703 Chelmer Lane  
Louisville, KY 40220  
**Property Owner:** Ahmad Fadhil  
8703 Chelmer Lane  
Louisville, KY 40220  
**Project Cost:** \$25,000 (estimated)

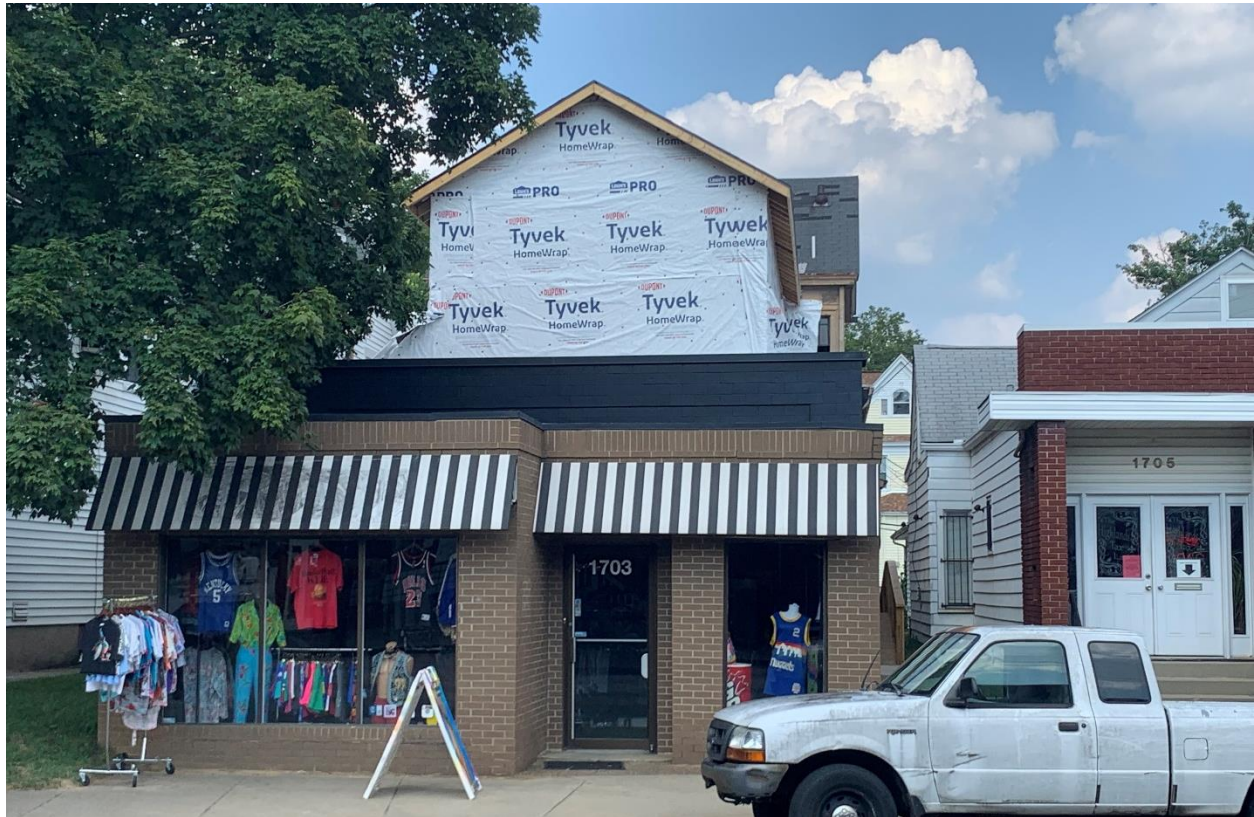
**1703 Bardstown, Existing Conditions, from Bardstown Rd**  
Staff, August 24, 2021

While not complete, the new dormer addition has been constructed and is an existing condition. The framing has been completed and the roof deck, fascia, 2 windows on the northwestern side façade, and a window on the southeastern side facade have been installed. However, final exterior materials (including shingles and siding) and planned additional windows/doors on the front facade have not been installed. It is situated in the same general location as the demolished dormers, atop the front part of the original structure.

Details concerning the original dormers were not provided. In comparing photos, the new dormer addition is not like for like in terms of design, scale, or massing. The new dormer addition does not have the same footprint of the original dormers. The original dormers had a unique and varied roof form, consisting of a roof design that is somewhat of a double gable roof with distinct front and rear portions. The front portion had a traditional gable roof and a single double hung window in the sidewall fronting Bardstown Rd. The rear portion was setback

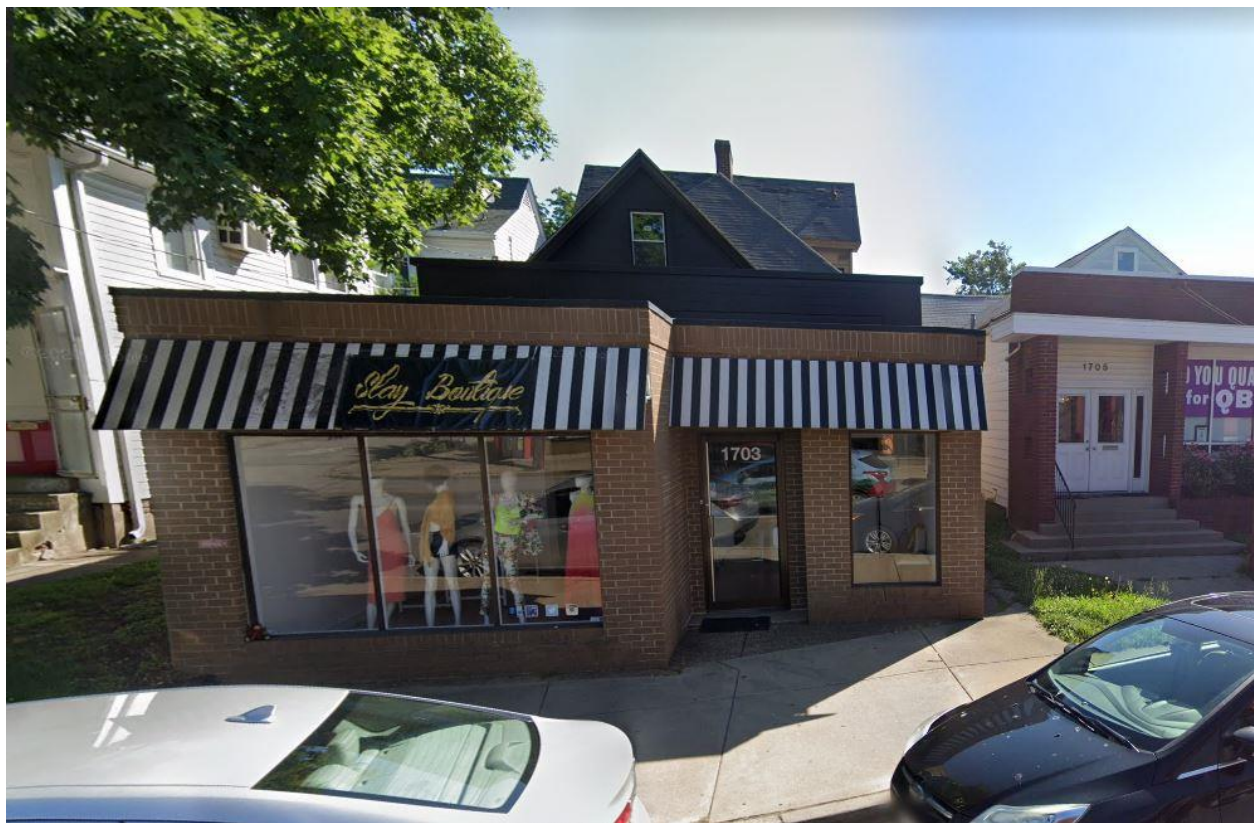
**1703 Bardstown, Previous Conditions, from Bardstown Rd**  
Google, May 2019

several feet from the front portion and had a sloping shingled roof instead of a sidewall (resembling a hip roof). Photos of the original and new dormers are provided later in this report.

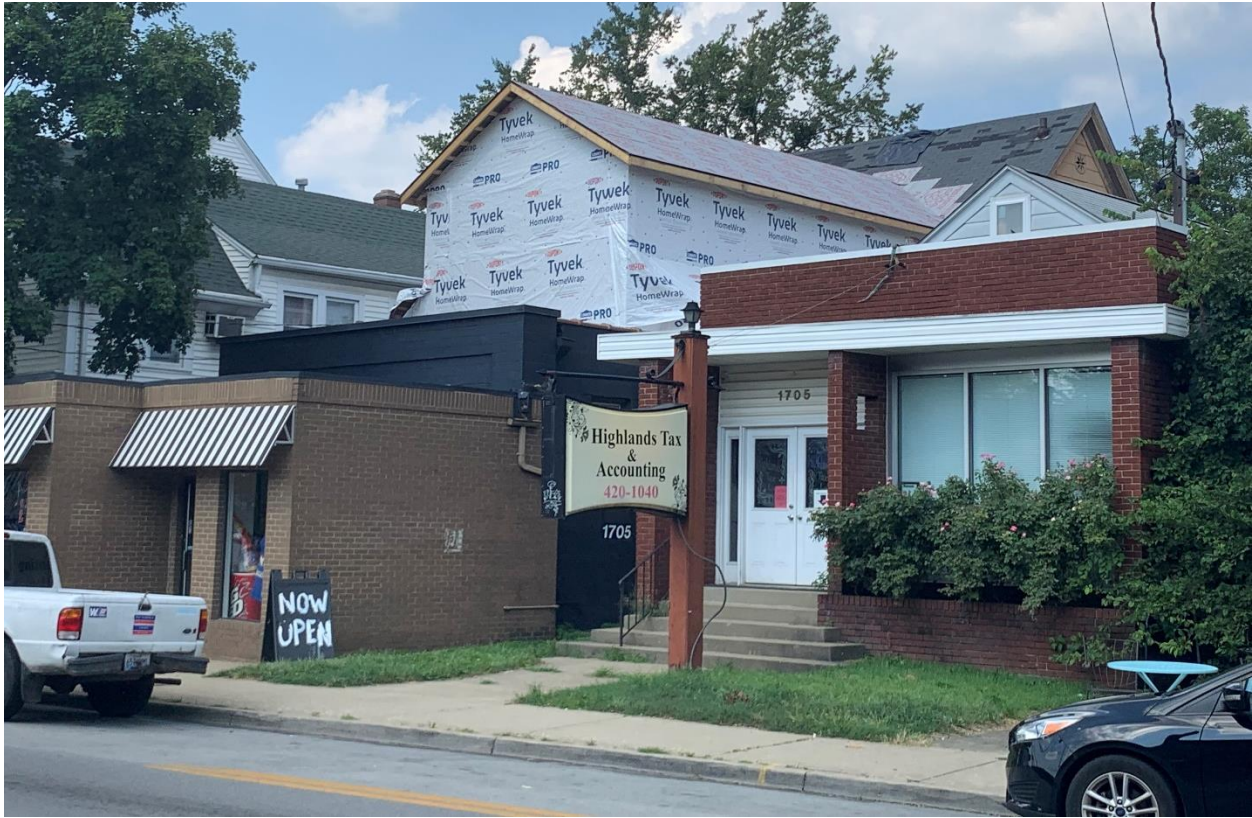
**1703 Bardstown, from Bardstown Rd**  
August 24, 2021

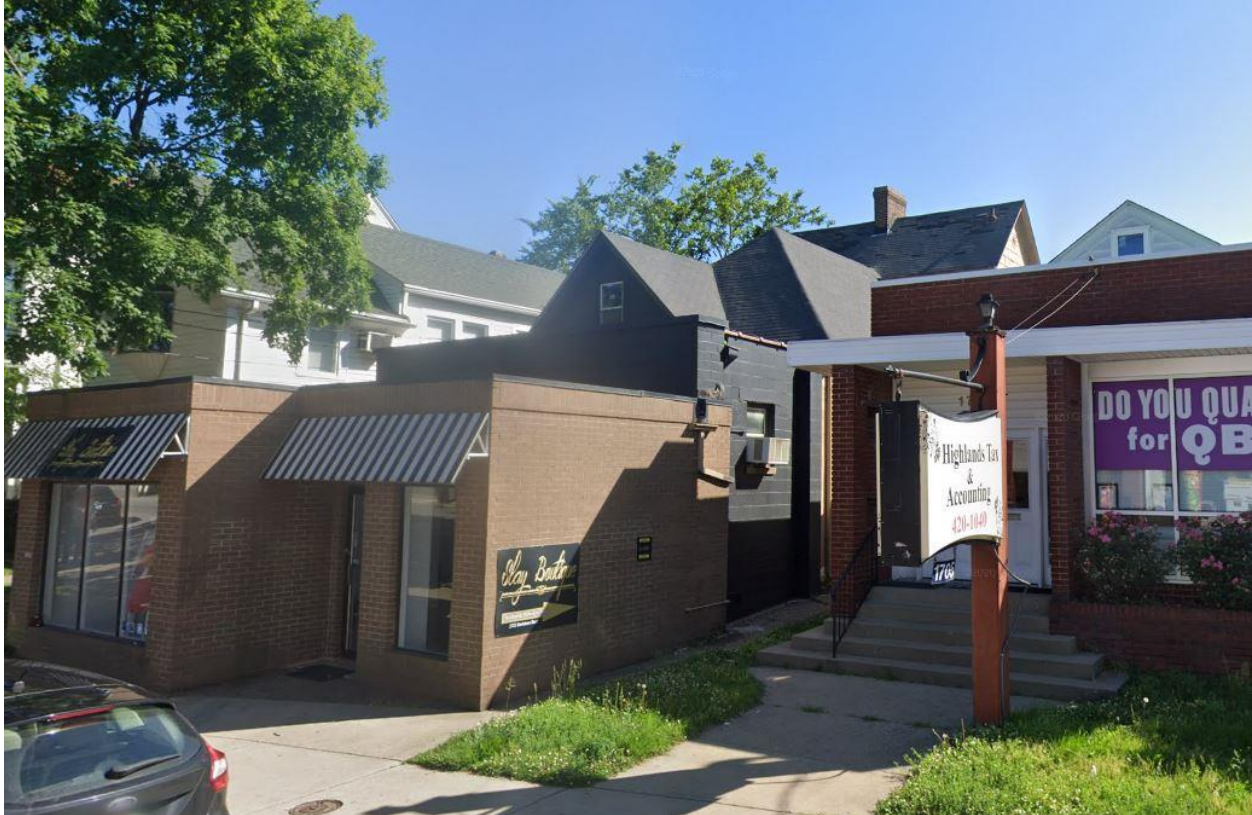
**1703 Bardstown, Previous Conditions, from Bardstown Rd**  
Google, May 2019
