1829 & 1831 Brownsboro Road Houses

Draft Report on the Proposal for Designation as an Individual Landmark

(22-LANDMARK-0001)

**Metro Historic Landmarks and
Preservation Districts Commission**

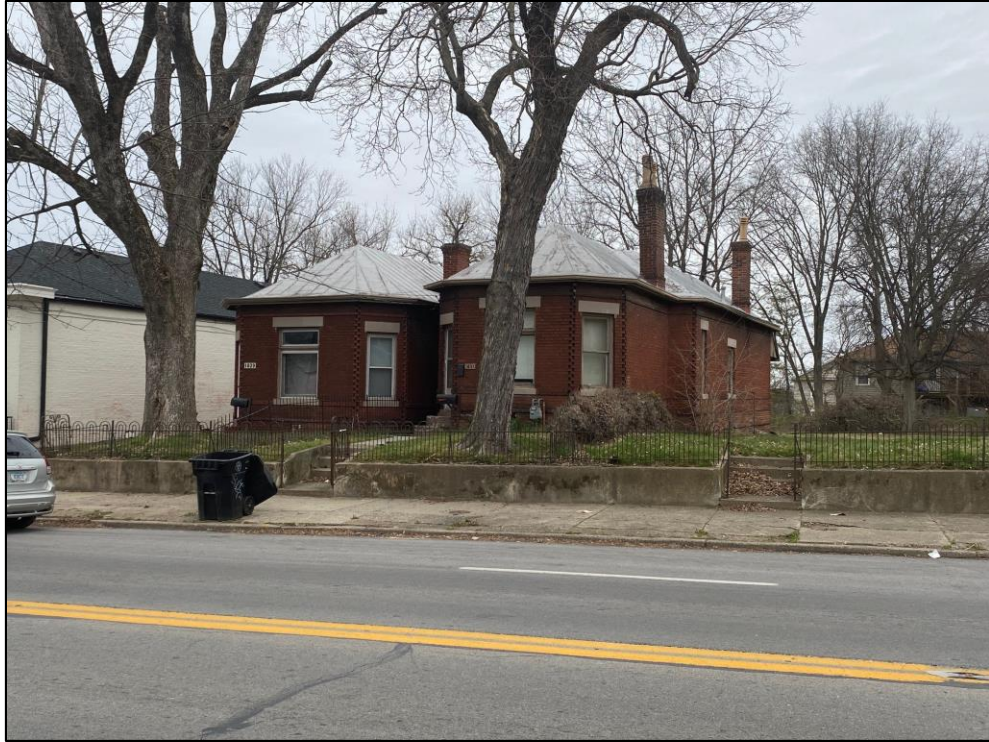
Figure 3. 1829 is on the left, 1831 is in the center, and the vacant lot (1833) is on the right, looking northwest.

The 1829 & 1831 Brownsboro Road Houses are now located on one parcel known as 1829 Brownsboro Road in Louisville, Kentucky. The property is situated on the north side of Brownsboro Road northwest of the intersection with Pope Street and east of the intersection with Mellwood Avenue (**Figure 1**). The locally designated Butchertown Preservation District is across Mellwood Avenue to the west, and the Clifton Preservation District is across Brownsboro Road to the south (**Figure 2**). The 1829 & 1831 Brownsboro Road Houses as well as the vacant lot to the east (formerly known as 1833 Brownsboro Road) are comprised of one parcel totaling 0.3971 acres. There are two residential buildings on the parcel (**Figure 3** and **Figure 4**).

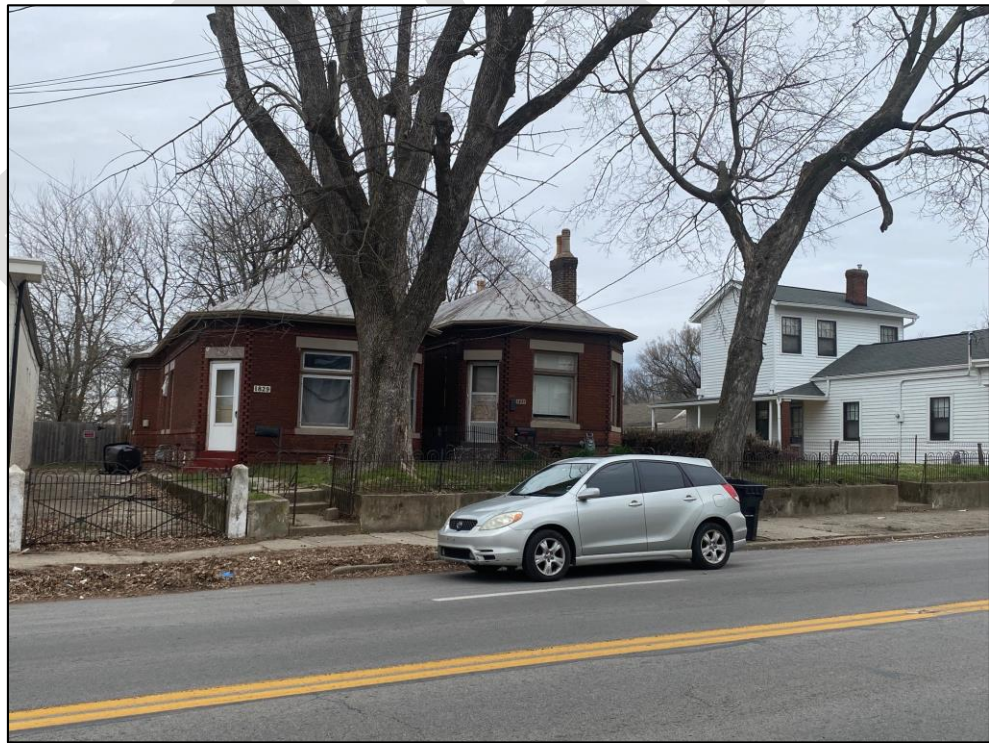
Figure 4. 1829 and its driveway are on the left, 1831 is in the center, and the vacant lot (1833) is on the right, looking northeast.

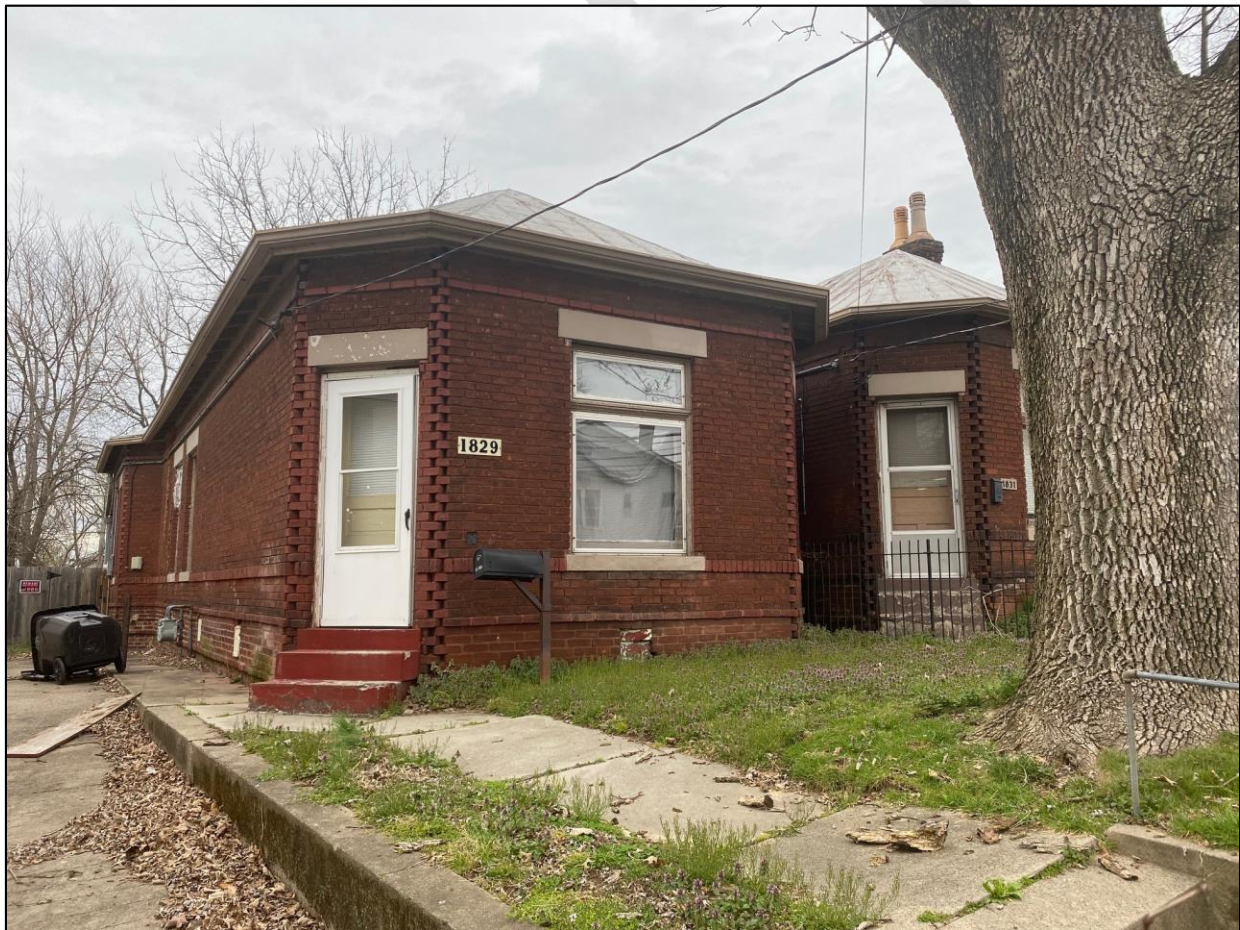
Figure 5. Front (south) façade and west elevation, looking northeast.

Built circa 1905, 1829 Brownsboro Road is elevated from the street with a concrete retaining wall and iron fence. The house has a brick foundation, brick masonry walls, and a hipped roof clad in standing seam metal. Open wood soffits are located under the eaves, and two brick chimneys are situated on the east side of the roof. The window openings have a concrete sill and lintel above. The masonry walls feature three lines of brick belt course on all of the elevations as decorative detail. Furthermore, numerous corners of the building show bricks laid at 45-degrees creating a decorative technique. Mortar is located deep within the 45-degree instead of at the edge of the brick like most mortar joints.

The front façade, or south elevation, of the building contains a central wood picture window with a transom above and storm windows. To the west, the ½ lite, wood entry door with a storm door faces southwest. Concrete stairs lead to the entry. To the east of the central window, there is one 1/1 double-hung wood window with a storm window that faces southeast (**Figure 5, Figure 6, and Figure 7**).

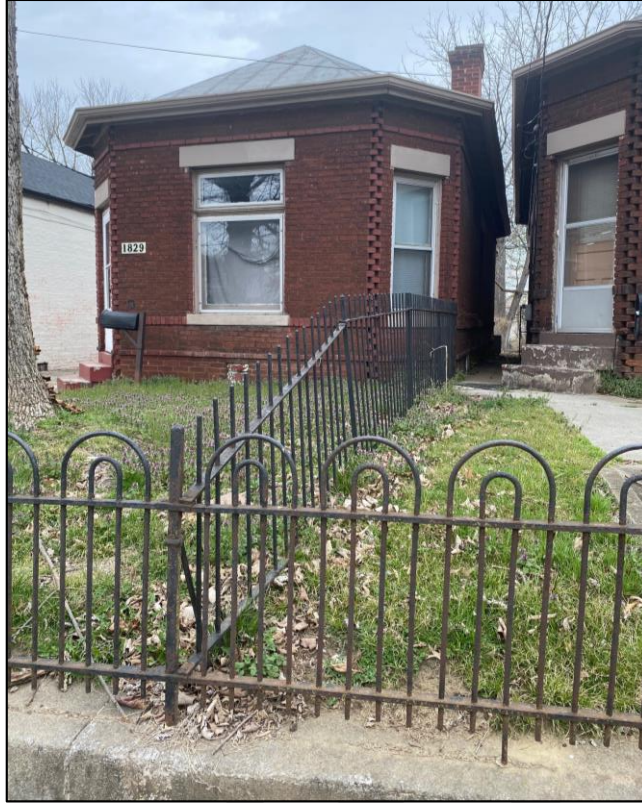
Figure 6. Front (south) façade, looking north.

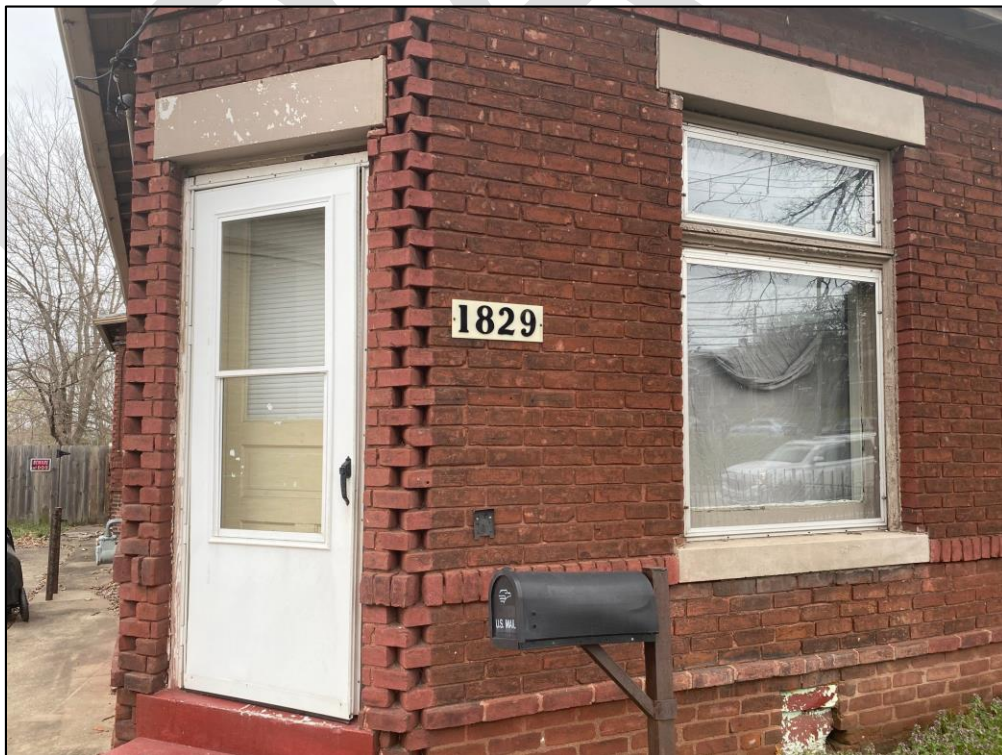
Figure 7. Brick detail on the front (south) façade, looking north.

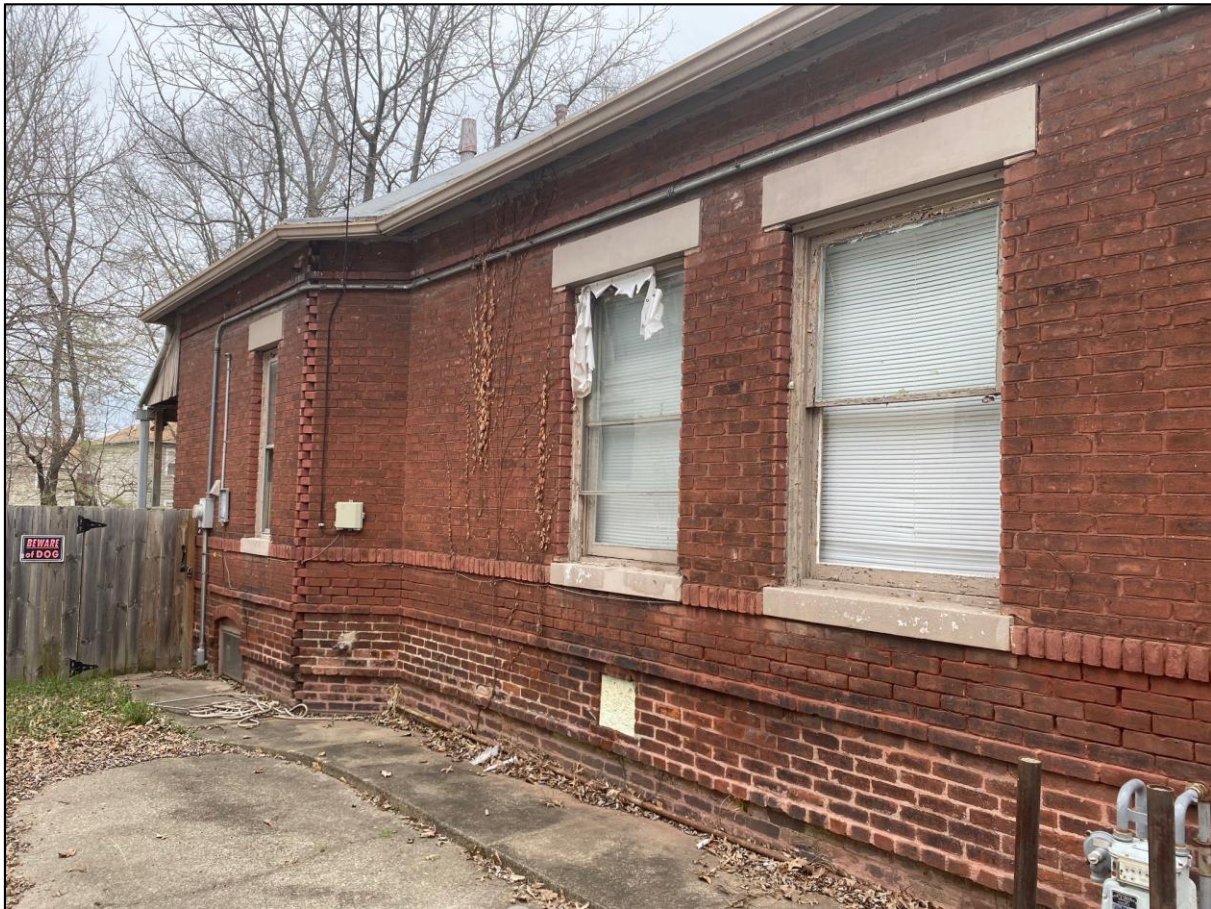
Figure 8. The west elevation, looking northeast.

The east and west elevations of the house are very similar (**Figure 8** and **Figure 9**). Both side elevations are mostly comprised of 1/1 double-hung wood windows. The west elevation contains three of these while the east elevation only contains two. At the basement level on both elevations, there are openings where metal grates were located. Some of these grates are still intact and some of the openings have been covered with wood (**Figure 10**). There are two brick chimneys located on the east side of the house. The northernmost chimney has one chimney pot.

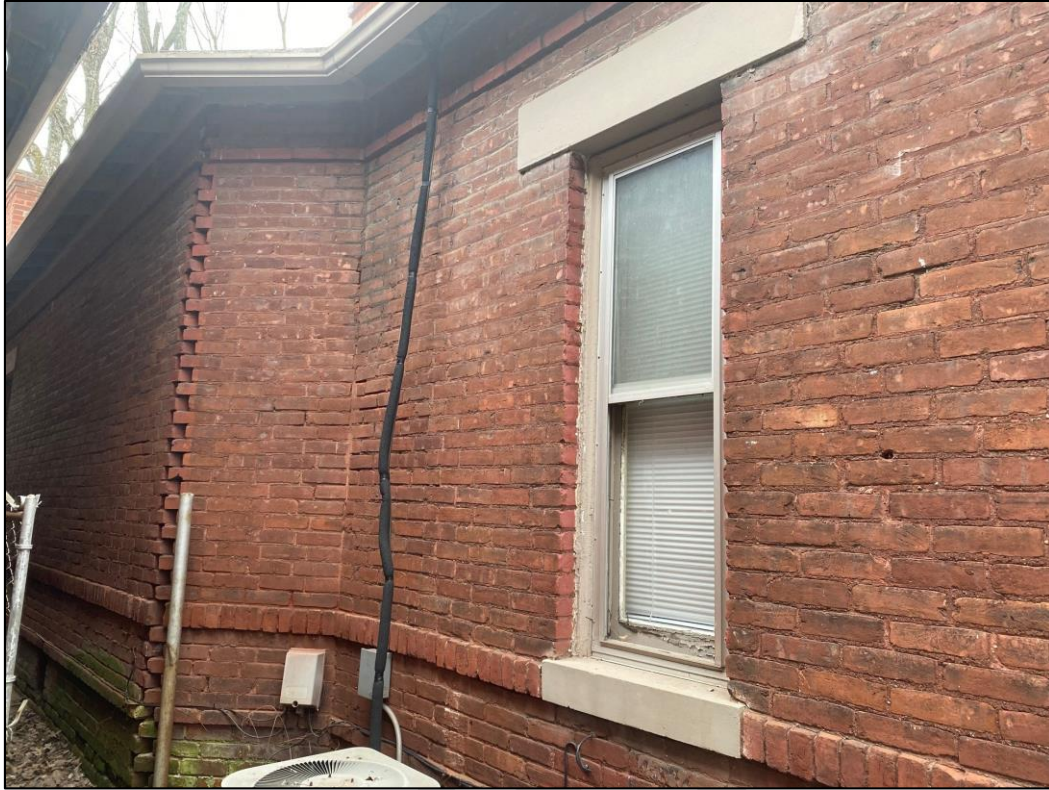
Figure 9. East elevation, looking southwest.

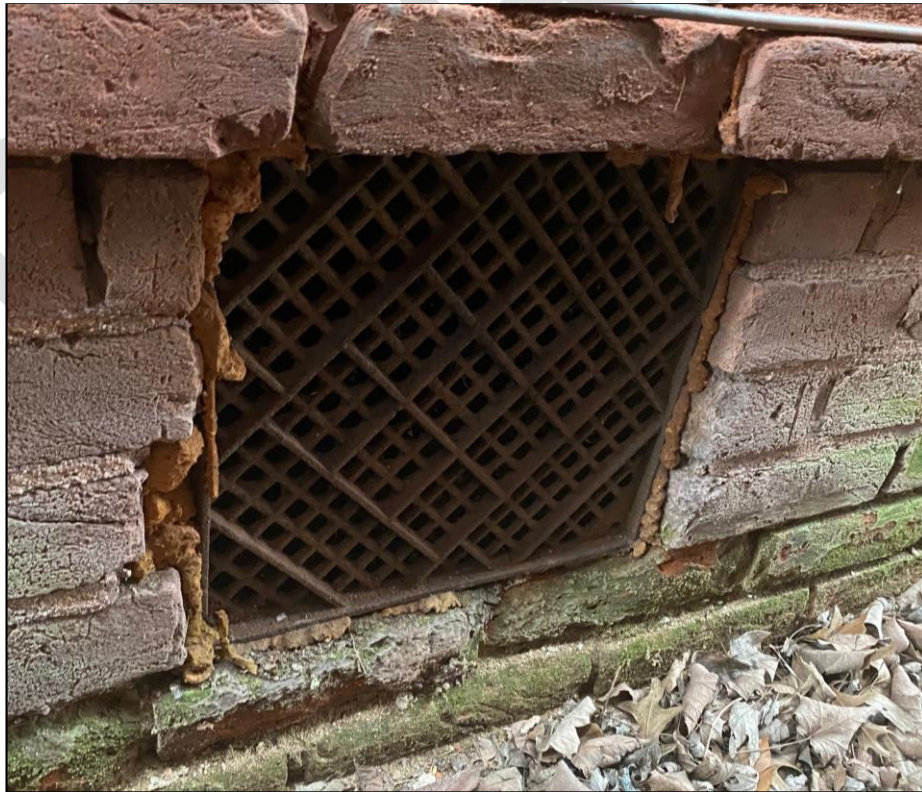
Figure 10. Detail of the basement level grate.

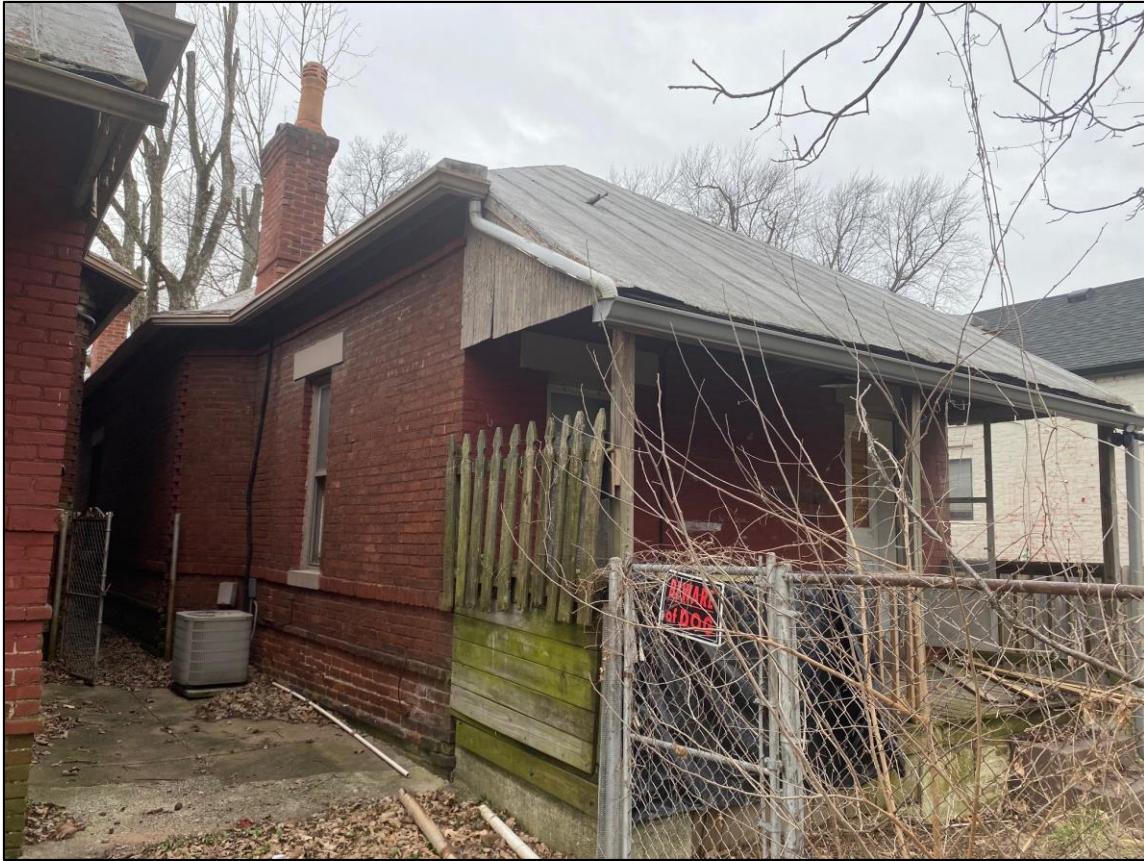
Figure 11. Rear (north) elevation, looking southwest.

The north, or rear, elevation contains one 1/1 double-hung wood window on the east side and a 1/2 lite entry door with a storm door on the east side. The rear portion of the roof extends down to become cover for the rear porch with wood posts. The porch has concrete foundation with wood floor boards (Figure 11).

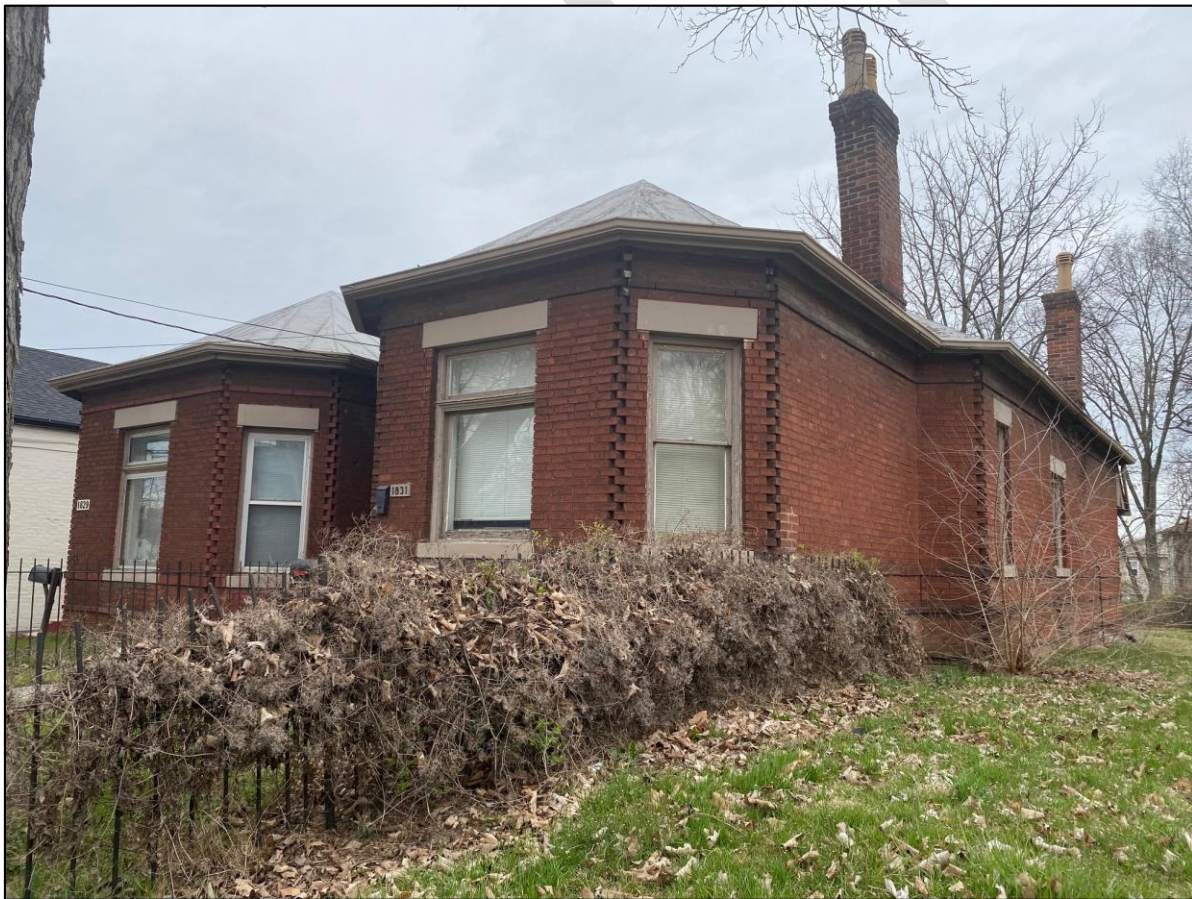
Figure 12. Front (south) façade and east elevation, looking northwest.

Built circa 1905, 1829 Brownsboro Road is elevated from the street with a concrete retaining wall and iron fence. The house has a brick foundation, brick masonry walls, and a hipped roof clad in standing seam metal. Open wood soffits are located under the eaves, and two brick chimneys are situated on the east side of the roof. The window openings have a concrete sill and lintel above. The masonry walls feature three lines of brick belt course on all of the elevations as decorative detail. Furthermore, numerous corners of the building show bricks laid at 45-degrees creating a decorative technique. Mortar is located deep within the 45-degree instead of at the edge of the brick like most mortar joints.

The front façade, or south elevation, of the building contains a central wood picture window with a transom above and storm windows. To the west, the ½ lite, wood entry door with a storm door faces southwest. Concrete stairs lead to the entry. To the east of the central window, there is one 1/1 double-hung wood window with a storm window that faces southeast (**Figure 12** and **Figure 13**).

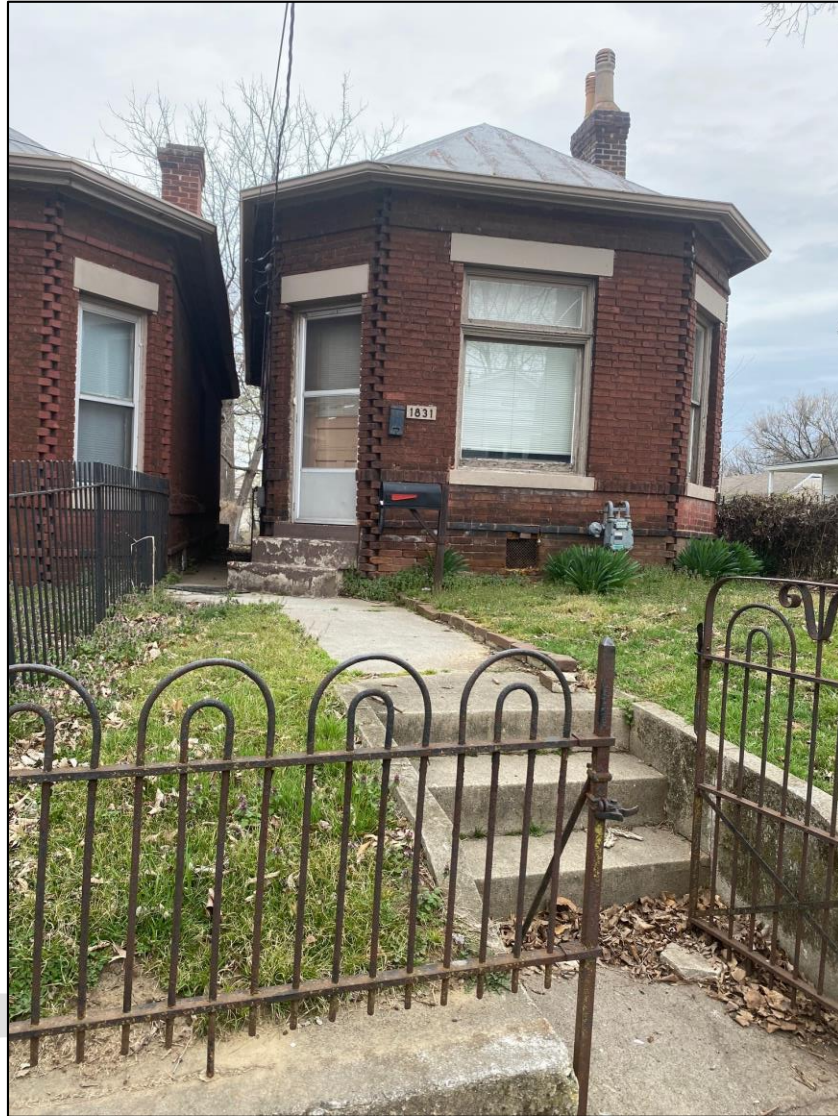
Figure 13. Front (south) façade, looking north.

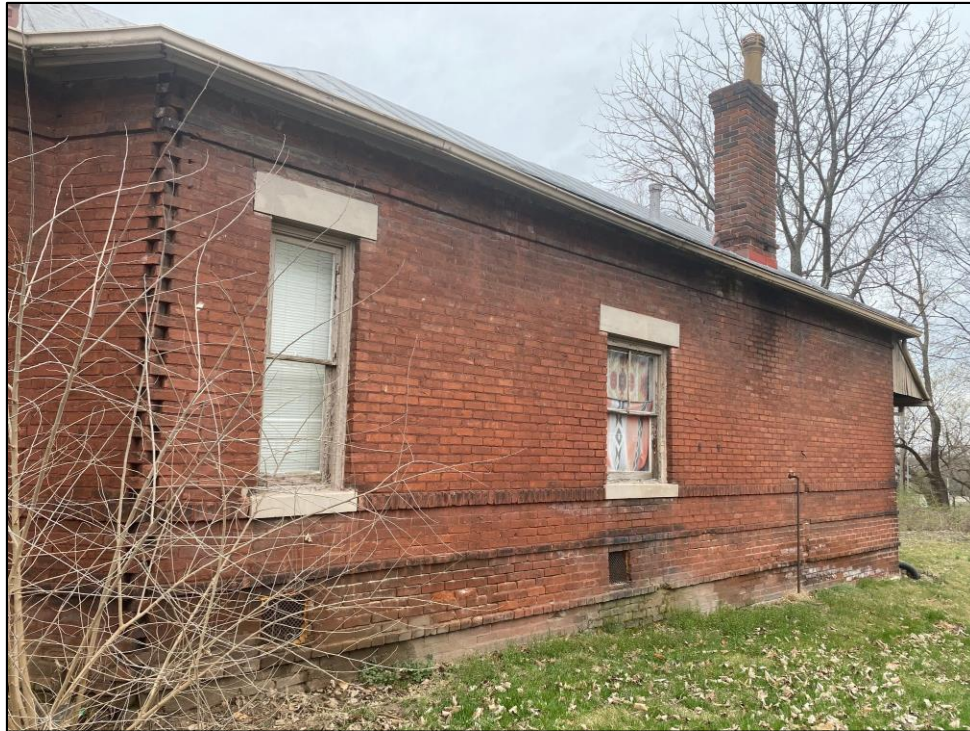
Figure 14. The east elevation, looking northwest.

The east and west elevations of the house are very similar (**Figure 14** and **Figure 15**). Both side elevations are mostly comprised of 1/1 double-hung wood windows. The west elevation contains two of these with a multi-lite casement window while the east elevation only contains two 1/1 double-hung wood windows (**Figure 16**). At the basement level on both elevations, there are openings where metal grates were located. Some of these grates are still intact and some of the openings have been covered with wood. There are two, very tall, brick chimneys located on the east side of the house. Both chimneys contain chimney pots.

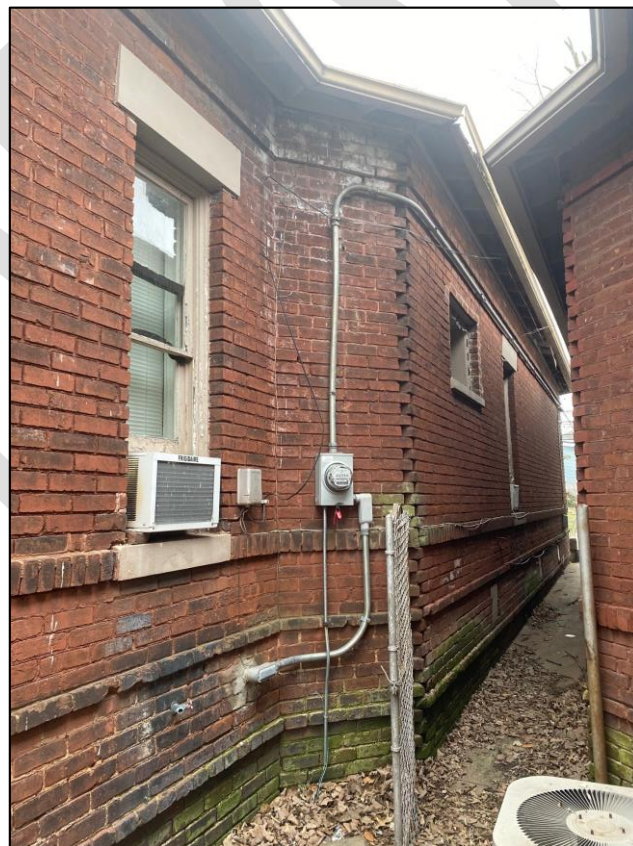
Figure 15. West elevation, looking south.

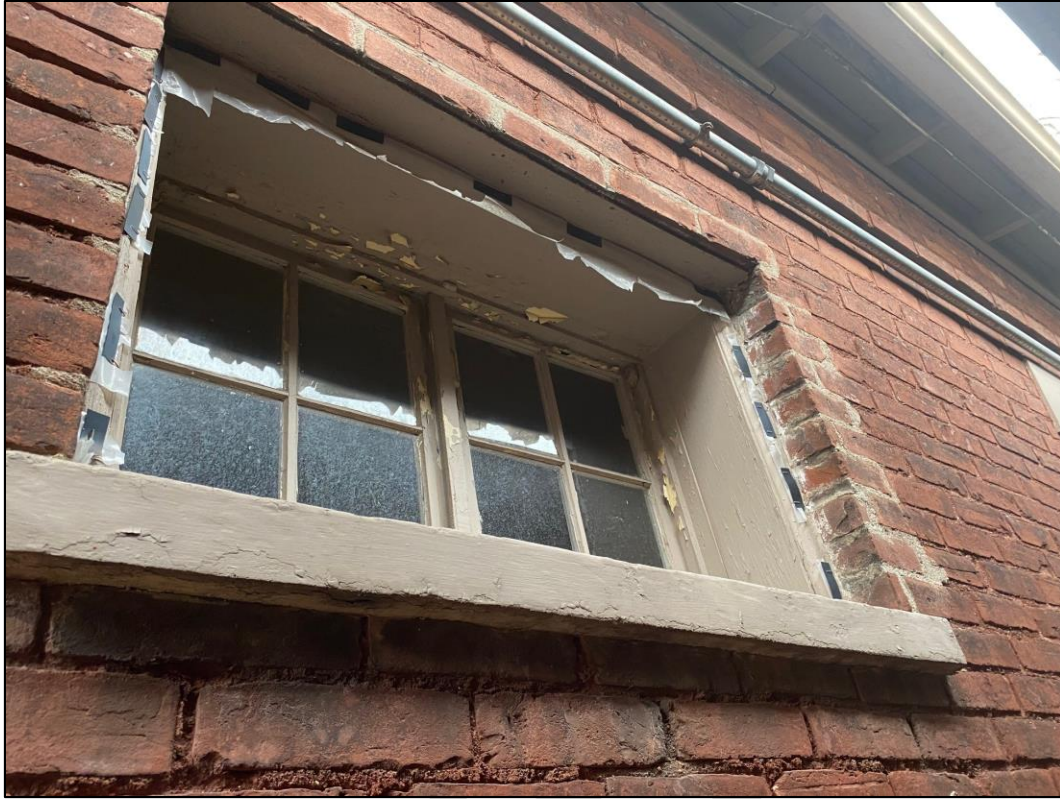
Figure 16. The east elevation, looking northwest.

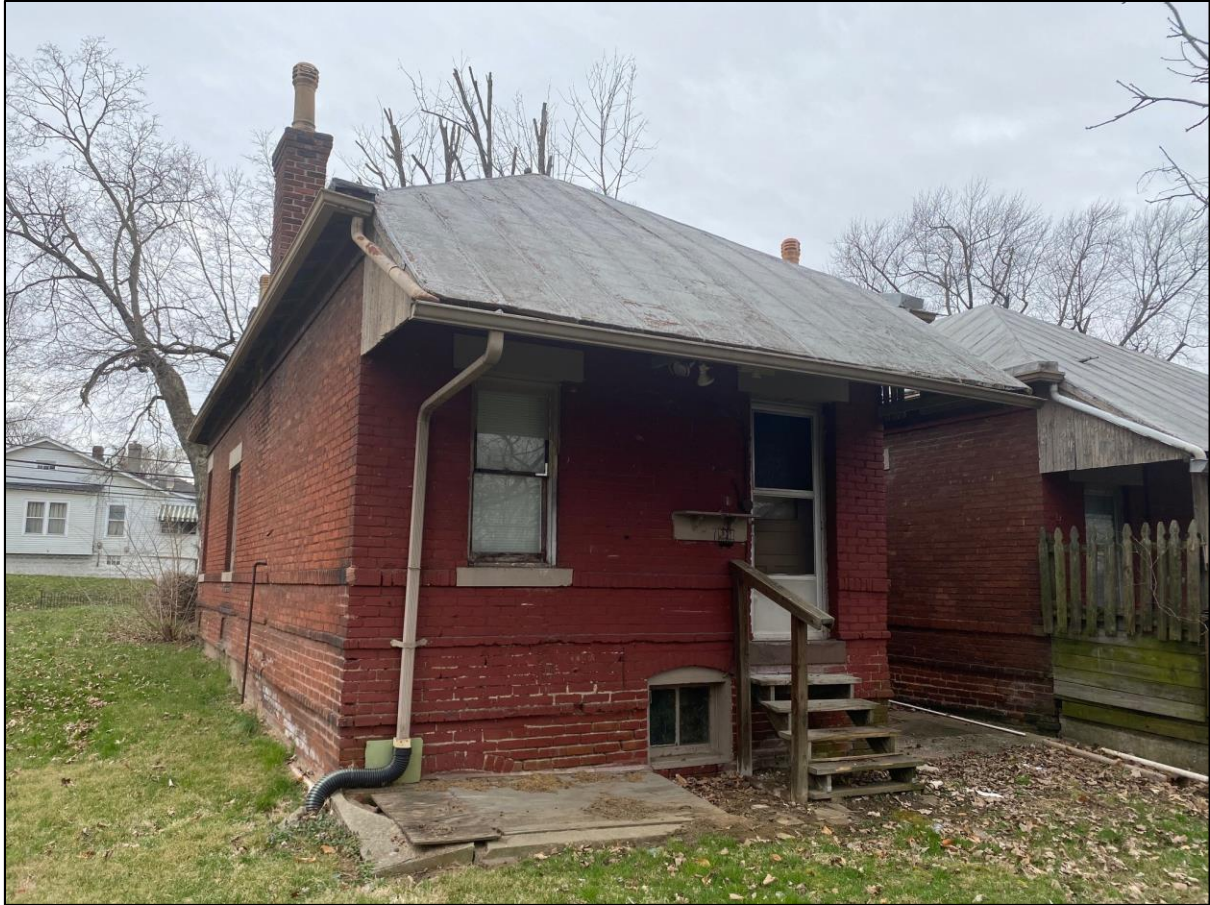
Figure 17. Rear (north) elevation, looking south.

The north, or rear, elevation contains one 1/1 double-hung wood window on the east side and a ½ lite entry door with a storm door on the east side. The rear portion of the roof extends down to become cover for the rear entry, accessed by a set of wooden stairs. There is a two-lite casement window at the basement level as well as an entry; however, it's covered with plywood (**Figure 17**).

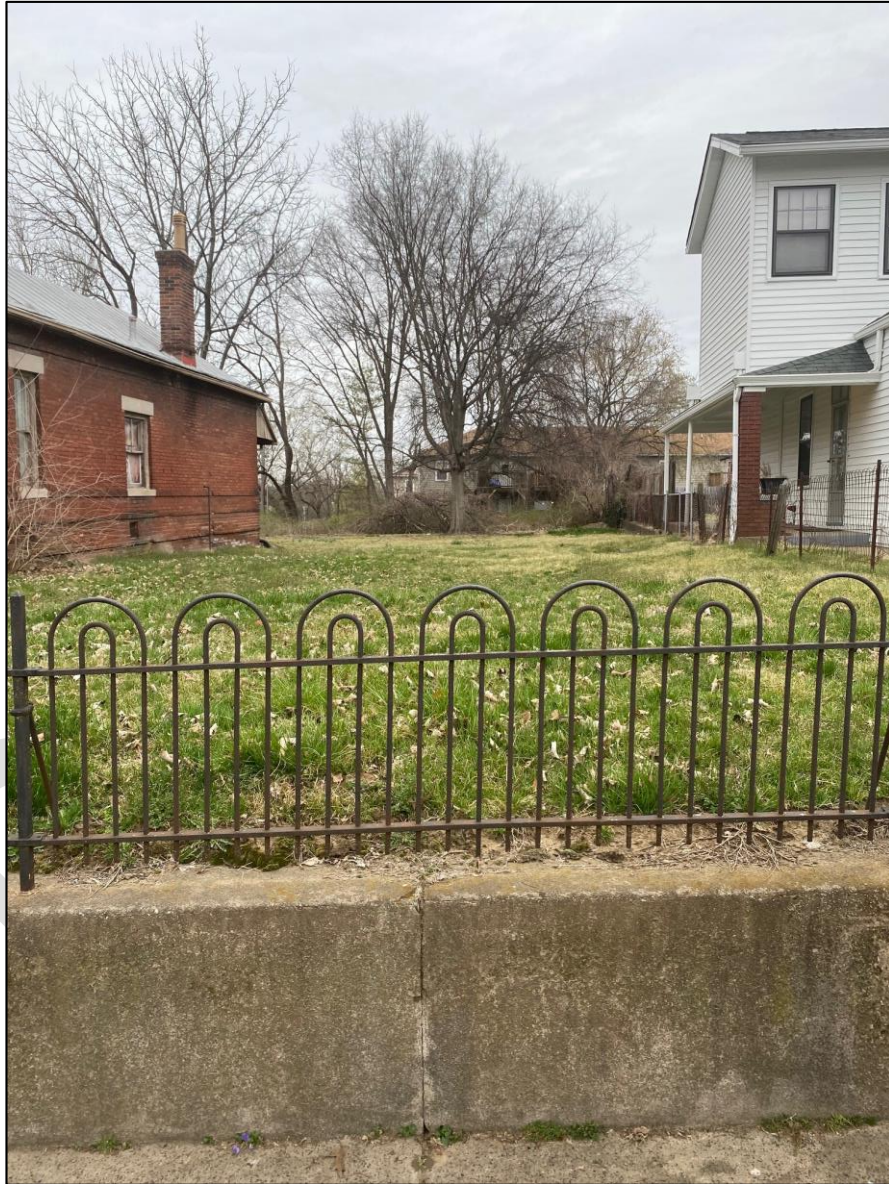
1833 Brownsboro Road is elevated from the street with a concrete retaining wall and iron fence that matches those in front of 1829 & 1831 Brownsboro Road. There are a set of concrete stairs leading into the lot from the public sidewalk. According to Sanborn Fire Insurance Maps there was a building on this lot historically. It was demolished around 1971, and the lot was left vacant (**Figure 18**). More information on the history of this lot is located in the **Historic Context** section.

Figure 18. 1833 Brownsboro Road Lot, looking north.

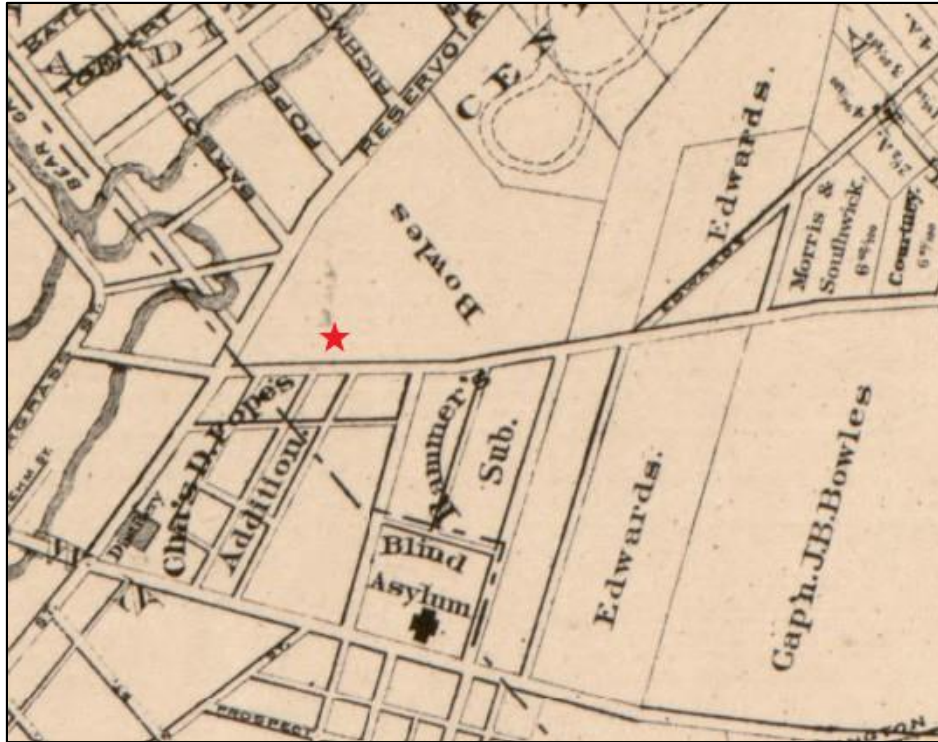
Figure 20. 1873 Map of city of Louisville, Kentucky, New Albany & Jeffersonville, Indiana showing the property of Captain J.B. Bowles (red star is general location of requested designation property) (German & Bro. 1873).

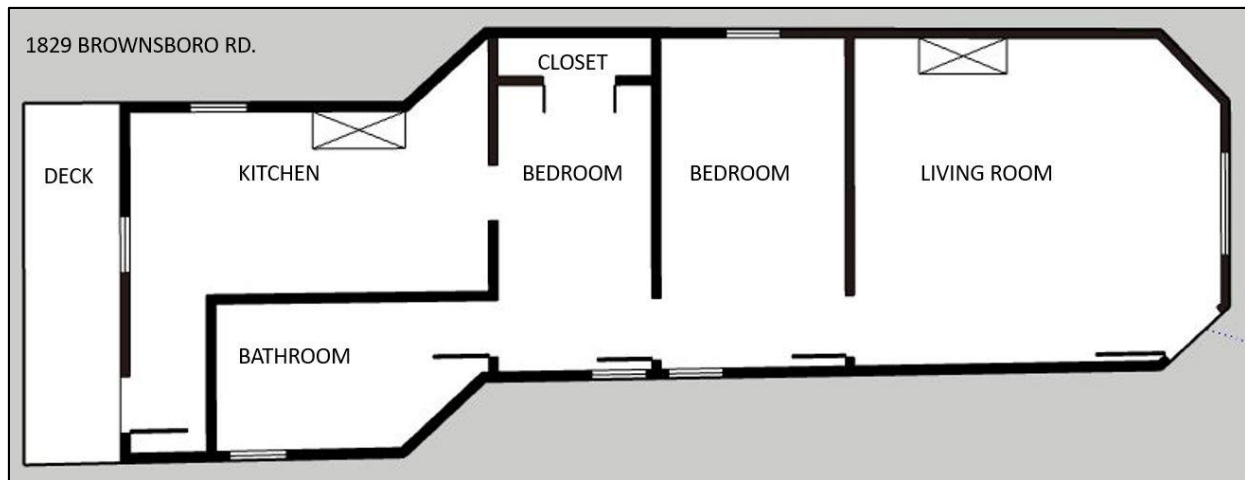
Figure 26. Floor Plan of 1829 Brownsboro Road.

The homes located at 1829 & 1831 Brownsboro Road fit the above description of a shotgun style home. Each house is four rooms deep with no hallways as the rooms are lined up, one behind the other (**Figure 26** and **Figure 27**). However, the form of these houses is unique and differing from the standard rectangular shotgun fun. Each of these houses has a front that is angled as well as the rear portion, which are not straight, but have slight bump outs. Per Samuel W. Thomas, most shotgun houses had gable roofs or low hipped roofs with Italianate cornices. He noted that shotgun houses that differ from these norms have been rare in Louisville (Thomas 2009).

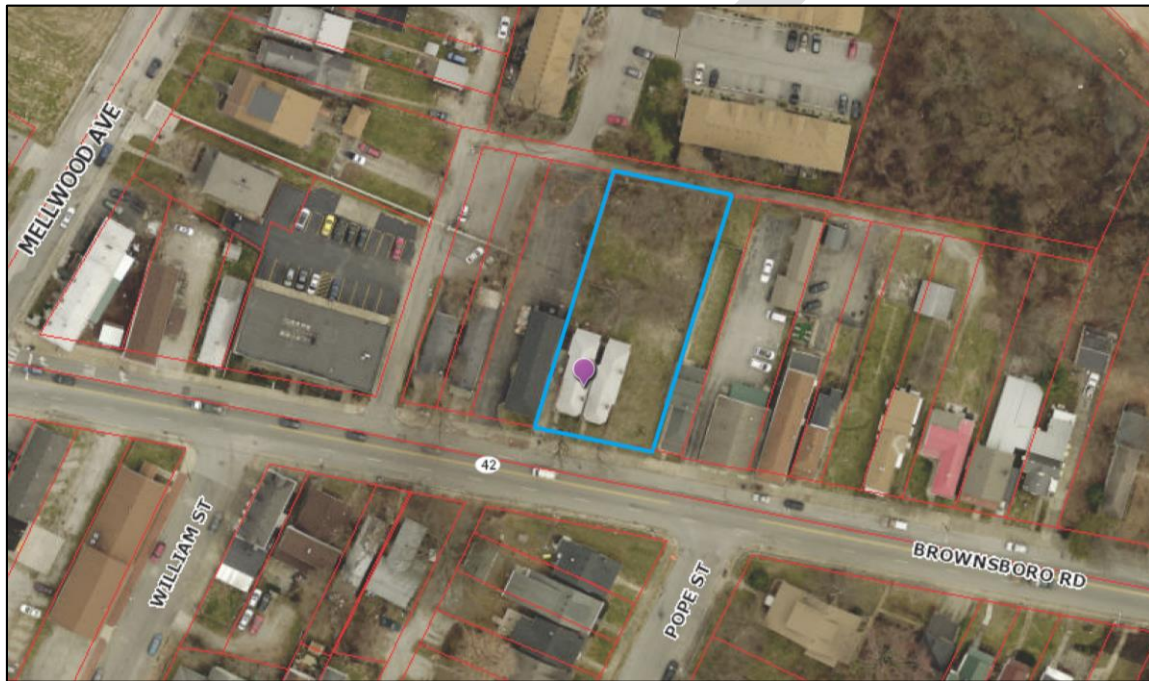
Figure 28. LOJIC map showing location of the designation boundary for the 1829 & 1831 Brownsboro Road Houses in blue.

The 1829 & 1831 Brownsboro Road Houses as well as the vacant lot to the east (formerly known as 1833 Brownsboro Road) are located on one parcel known as 1829 Brownsboro Road. According to the Jefferson County Property Valuation Administrator (PVA), the property (parcel number 088A00270000) contains a total 0.3971 acres of land. The proposed boundaries for the 1829 & 1831 Brownsboro Road Houses Individual Landmark designation area include the total parcel. The owner requested this designation boundary, which is represented on the LOJIC map below (Figure 28).
