Docket No. 22-VARIANCE-0094

Variance on properties located at 8410, 8412, 8414, 8416, 8418, 8420 and
8422 Gateway Run Road

Re: REVISION TO: Karst Feature Exploration and Remediation Consulting Services
Residential Subdivision, Parkside at Mt. Washington, Section 2
Louisville, KY
ATC Project No. LOUCM20085

Karst Feature Exploration and Remediation Services
ATC Project No. LOUGE20085

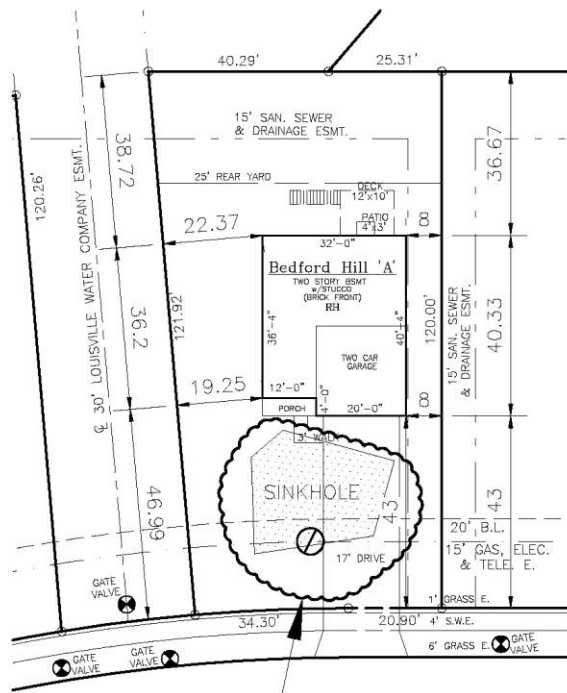
PLOT PLAN

**RECOMMENDED NON-BUILDABLE
AREAS/OFFSETS FOR RESIDENTIAL
STRUCTURES**

8416 Gateway Run Road 7270 SQ.FT.

Parkside at Mt. Washington UNIT
LOT-136, BLK- SEC- 2
LOUISVILLE, KENTUCKY

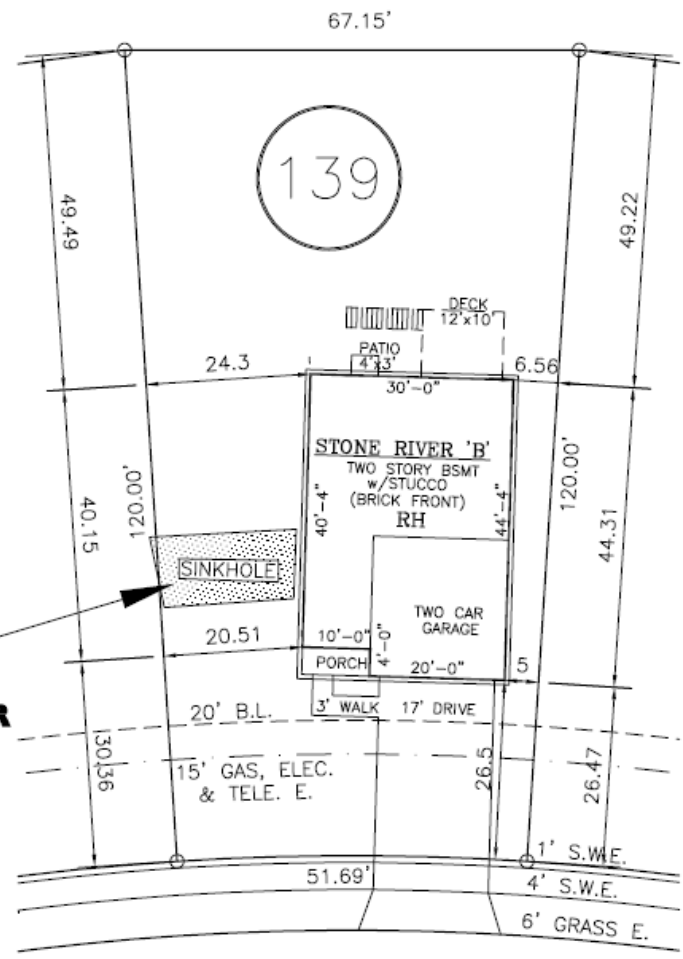
PLOT PLAN

**RECOMMENDED
NON-BUILDABLE
AREA/OFFSET FOR
RESIDENTIAL
STRUCTURES**

8422 Gateway Run Road

Parkside at Mt. Washington UNIT
LOT-139, BLK- SEC- 2
LOUISVILLE, KENTUCKY

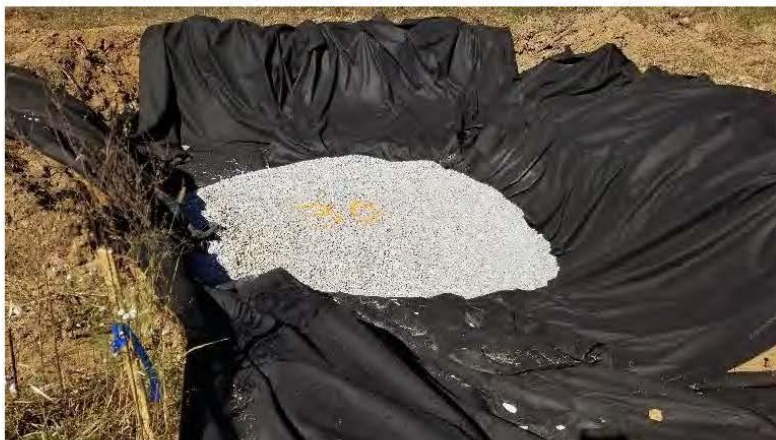
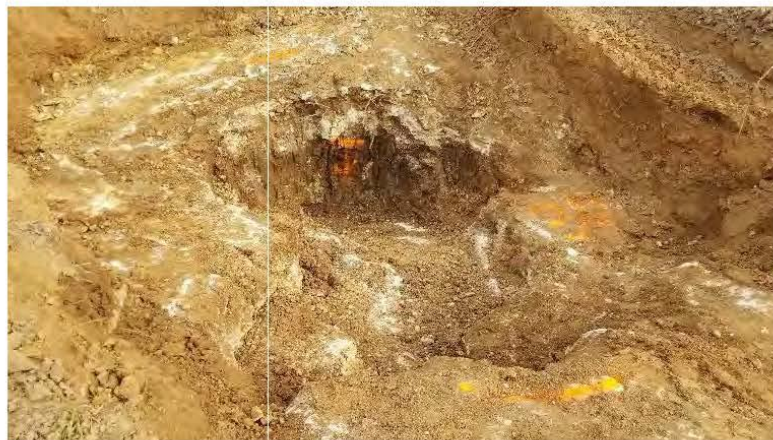
Feature 30 Lot 140

All locations were observed by an ATC geotechnical engineer or their designated representative. Photographs were used to document the features and any remediation. The remediation methods were recommended by ATC engineers including Travis Andres, PE, Senior Geotechnical Engineer and Ryan Ortiz, PE, Project Geotechnical Engineer, depending on the conditions encountered. All operations were observed by the engineer's representative. Although each feature required specific remediation methods tailored specifically for each feature, it typically included excavation of the soil extents to sound bedrock, installation of a concrete plug or graded filter consisting of a non-woven geosynthetic fabric wrapped envelope of graded stone, and backfilling with clay placed and compacted in 8-inch lifts with a sheepsfoot compaction roller.

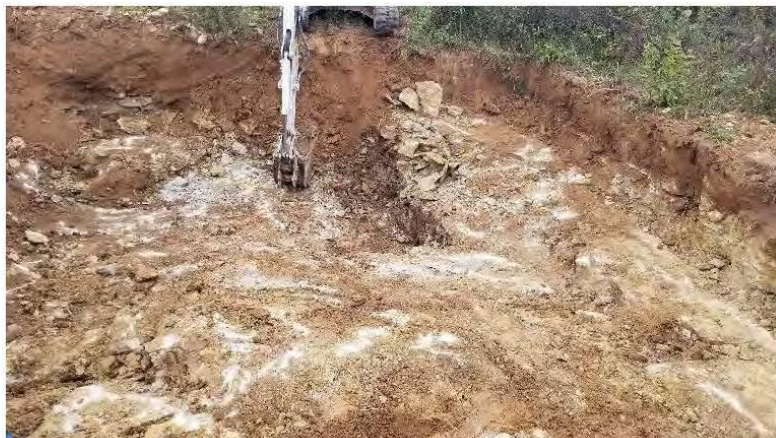
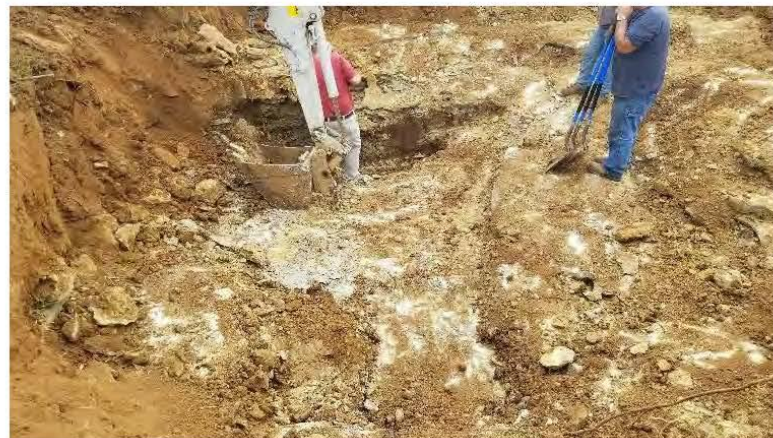
Feature 37 Lot 136

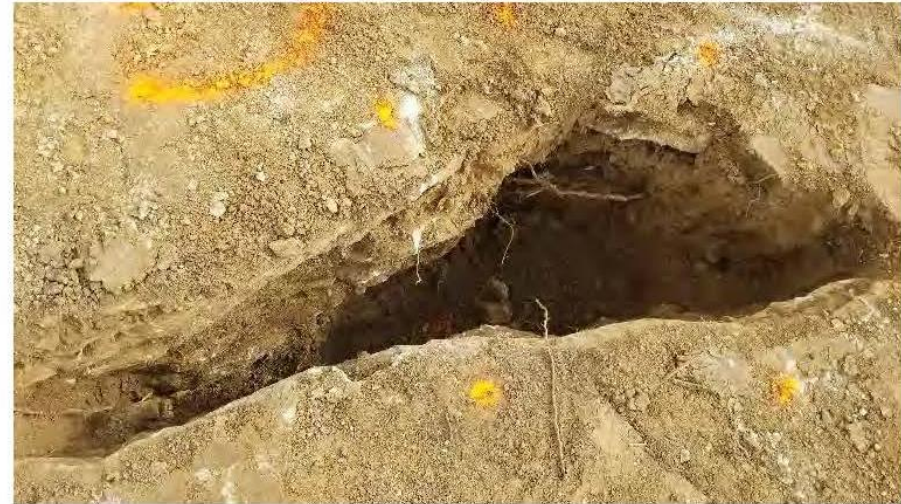
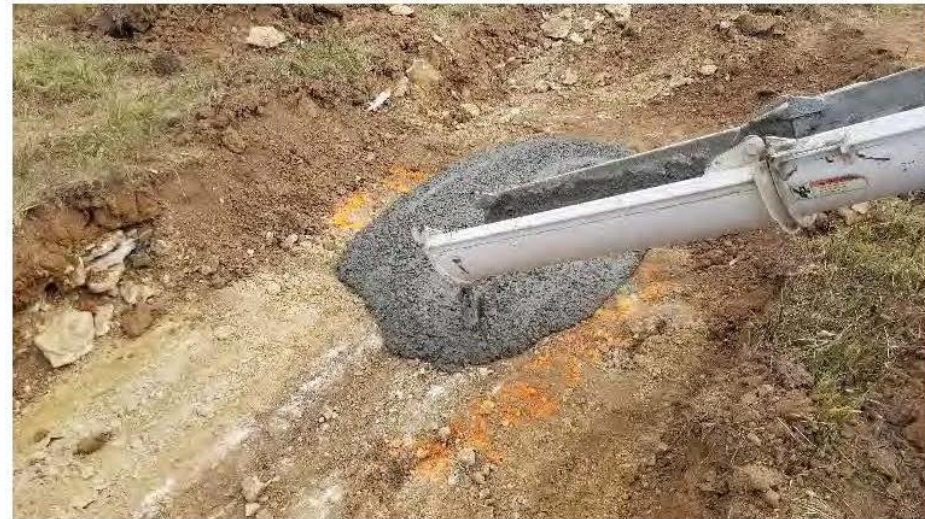
Feature ID	Width (ft)	Length (ft)	Depth (ft)	Effected Lot Areas	Notes/Remediation
5	8	8.5	2.5	189	Isolated Depression in Bedrock / Concrete Plug
25	1.5	5	3	149-150 Sidewalks	Isolated Depression in Bedrock / Concrete Plug
26 ²	6	9	3	150-151 Bldg Pads	Isolated Depression in Bedrock / Graded Filter
27	-	-	-	157-158 Bldg Pads	Large drainage feature, dimensions not measured / Graded Filter
28/41	-	-	-	148, 158, 159 Rear of Lots	Large drainage feature, dimensions not measured / Graded Filter
29/49 ¹	3	5	2	162 Bldg Pad	Isolated Drop Out / Concrete Plug
30 ¹	8	14	5	140 Rear of Lot	Large Depression in Bedrock / Graded Filter
37 ¹	12	11	5	136 Front of Lot	Large Depression in Bedrock / Graded Filter
39 ¹	3	3	1.5	131-132, Rear of Lot	Isolated Depression in Bedrock / Concrete Plug
40 ¹	8	20	4	129-130, Rear of Lot	Drainage Feature / Graded Filter
54 ¹	1.5	2.5	1	139 Bldg Pad	Isolated Depression in Bedrock / Concrete Plug

Feature 54 Lot 139
