Historic Landmarks and Preservation Districts Commission

Report to the Committee

Case No: 23-COA-0231
Classification: Committee Review

Property Address: 643 W. Main St.

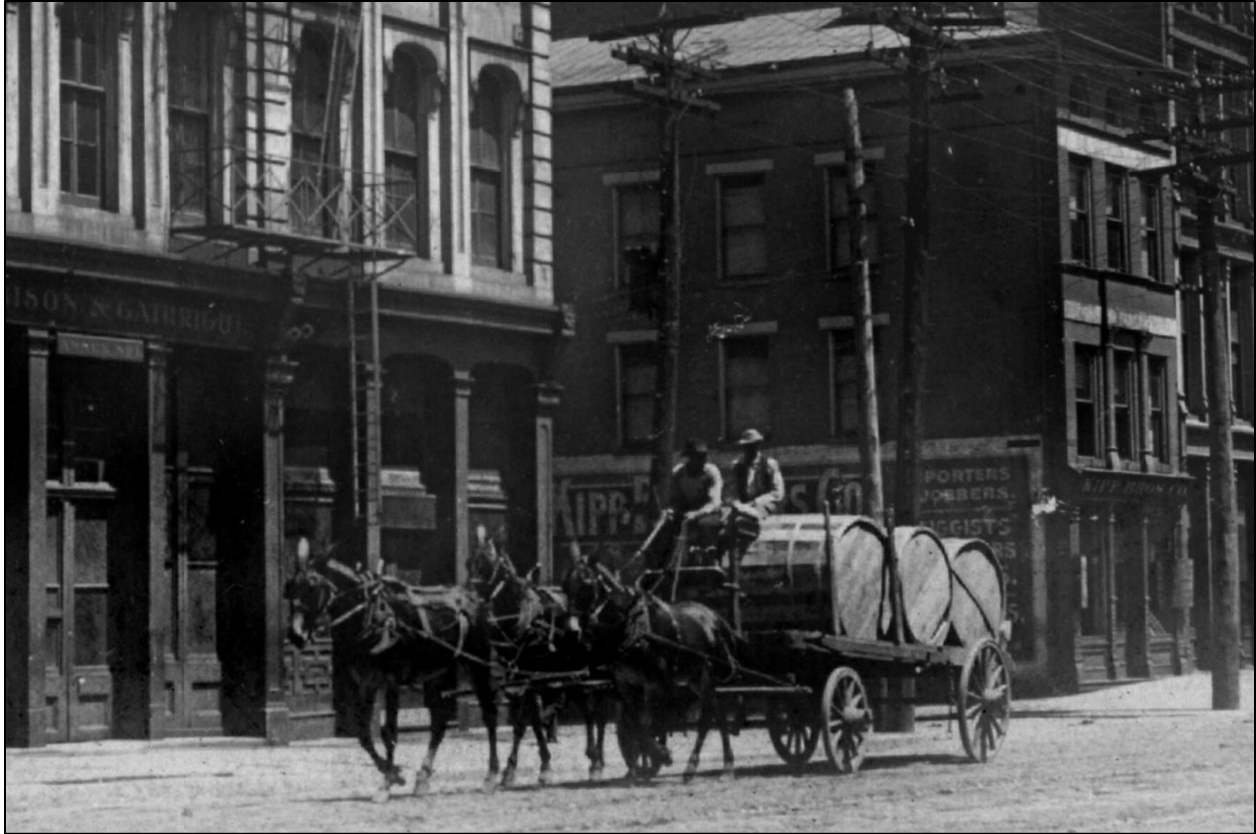
1907 photograph showing 643 W. Main Street with the large Kipp Bros. Co. painted sign where windows are located today.

The North 7th Street (west facing) façade is simple in design with 28 historic 1/1 double hung windows with stone sills and lintels, and a fire escape. This façade has seen changes over time with two window openings that have been infilled with brick and a door opening that has been converted to a window. These changes are on the first floor. The historic photograph below, dating to 1907, shows that there are no window openings on the first floor near West Main Street. This is also evident when looking at the brick headers above the now existing windows. The bricks are laid in different pattern than the other two floors or even the first floor windows located toward the rear.
