Historic Landmarks and Preservation Districts Commission

Report to the Committee

Case No: 17COA1090
Classification: Committee Review

Property Address: 965 S. 7th Street

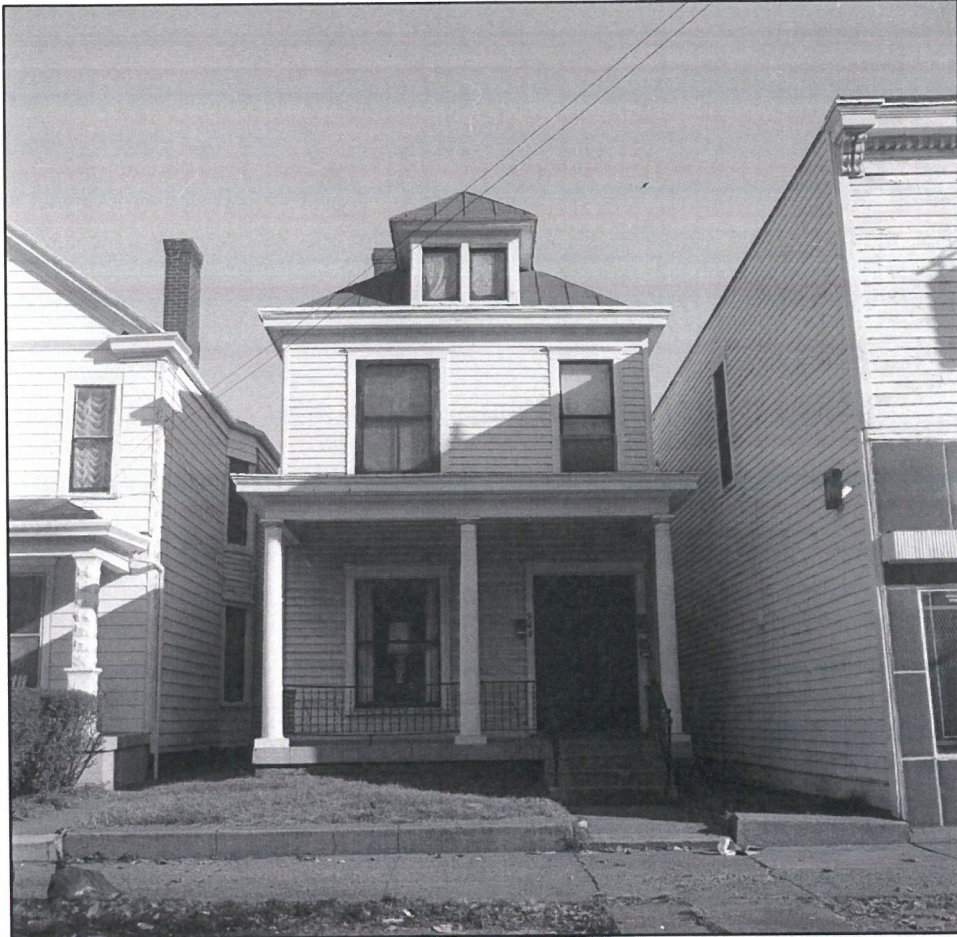
1979 Designation Photograph.

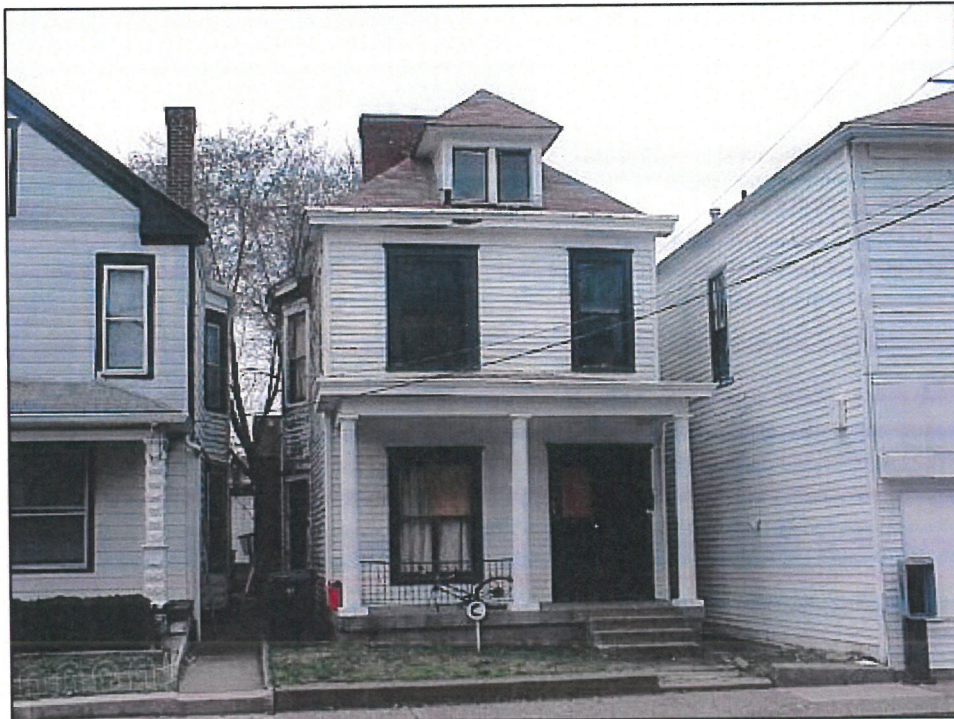
Undated PVA Photograph.

The TNZD zoned property in the Traditional Neighborhood Form District is located on the east side of S. 7th Street, one lot north of W. Kentucky Street. The two-story frame, residential building was constructed circa 1913 for Louis Franconia, who owned grocery next door. Franconia remained in the house until 1919 when it appeared to become a rental as it had many different tenants over time. Some of those tenants include Nelson Brown, stockman for Prince Wells Co. (1924); Julia Brown, widow of W.K. Brown (1924); Robert W. Jones, switchman for L&N Railroad (1926); W.J. Lowman, policeman (1927); Eugene R. Culver, helper for L&N Railroad (1927); and Coy L. Borders, employee of Mengel Co. (1929). The 1979 designation photograph of the building shows wood lap siding, wood double hung windows, double front doors, and a standing seam metal roof (see attached). An undated, older PVA photograph shows the house similar to how it appears today except the roof now has asphalt shingles.
