**20-COA-0192**  
**1334 S. 2<sup>nd</sup> St.**

**Old Louisville Architectural Review Committee**  
**Public Hearing**

**Bradley Fister, Historic Preservation Specialist**  
**February 17, 2021**

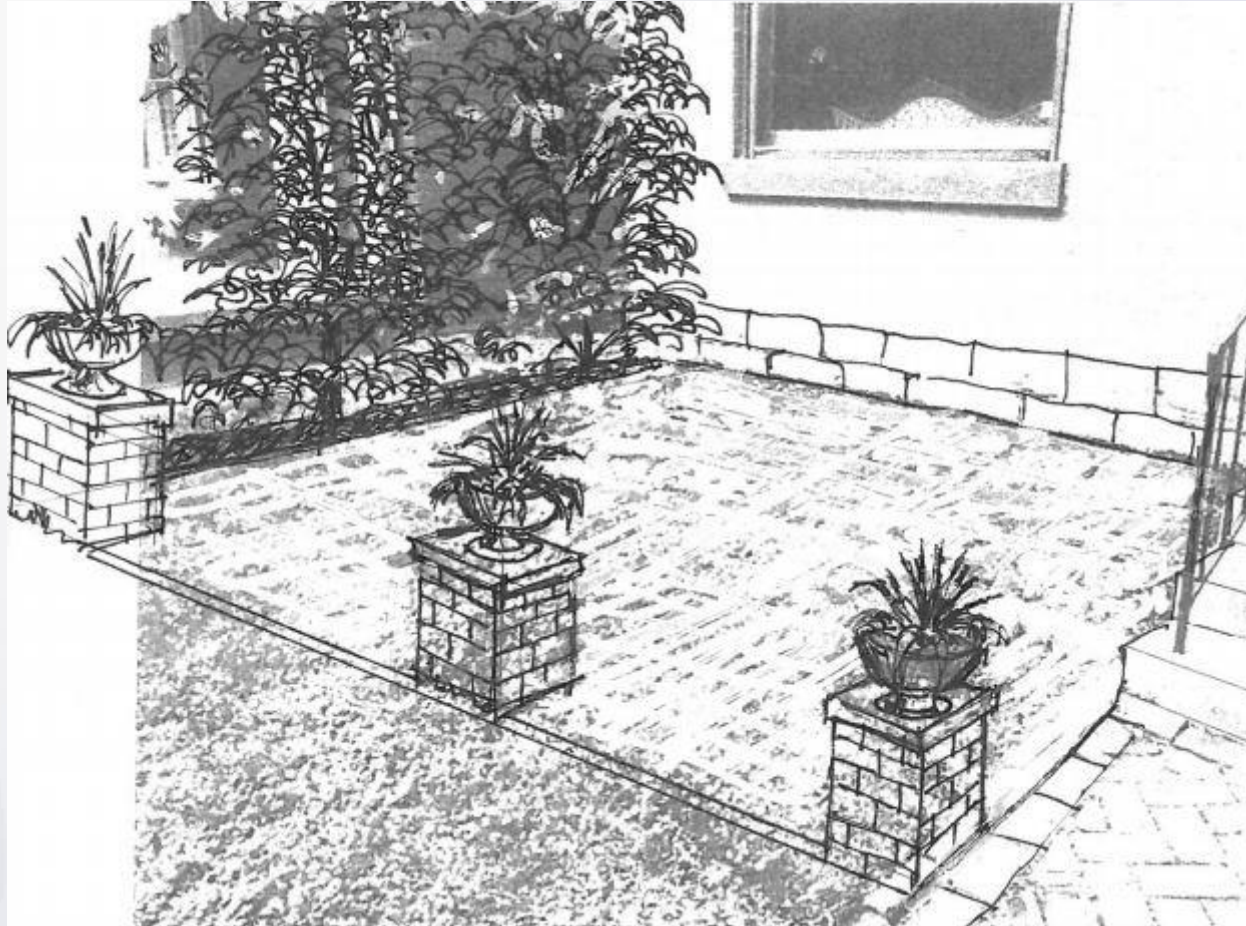
# Site Photos

The applicant is seeking after-the-fact approval to erect three brick risers. The risers are approximately 32” in height, and constructed of brick and mortar and set atop brick pavers. The applicant intends for the risers to be used to place seasonably appropriate plantings. The risers were designed not to be affixed to the ground, which allows for them to be moveable, and not a permanent fixture in the front of the building.

The applicant also seeks after-the-fact approval for two sections of black metal decorative fencing approximately 3' wide x 28" high that have been attached between the three brick columns.

The applicant also seeks approval for an after-the-fact brick terrace placed in the front of the home on either side of the stairs leading to the stoop. The terrace extends outward from the stairs to the north approximately 9' toward the property line; the terrace extends outward from the stairs to the south approximately 15' toward the opposite property line. The terrace extends outward from the foundation of the building on both sides approximately 6' toward the direction of S. 2<sup>nd</sup> St., and abuts the existing brick walk on either side.

- The terrace is flush with the ground and not visible from the street. The fencing that is along the terrace and between the risers is below 2.5' and serves more as a landscaping border feature than an actual fence. The proposed brick risers generally do not meet the Old Louisville Design Guidelines for **Site**.

- The primary conflict with the Design Guidelines relates to **ST10** which states that masonry walls should not be in street-visible locations unless there is a need for earth retention, screening, or historic precedent, and **ST14** which states not to install front yard fencing when there is no precedent for it.

- The proposed location of the masonry risers and fencing is along the front of the building. In this case, the masonry piers are not secured to a foundation and are moveable. While visible from the street, the proposal would be seen primarily from S. 2<sup>nd</sup> Street, 1<sup>st</sup> Street.

On the basis of the information furnished by the applicant, Staff recommends the application for a Certificate of Appropriateness be **denied**.

On the basis of the information furnished by the applicant, Staff recommends the application for a Certificate of Appropriateness be **approved** with the following conditions.

- 1. The terrace in the front yard shall not be extended further without staff approval.**
- 2. No additional fencing shall be installed beyond the terrace.**
- 3. If the design or material changes, the applicant shall contact staff for review and approval.**
