RE: Karst Survey and Sinkhole Remediation Proposed Aiken North Subdivision

Louisville, Ky

RE: Slope Stability

Subject: Water/Wetland Reconnaissance Summary Report

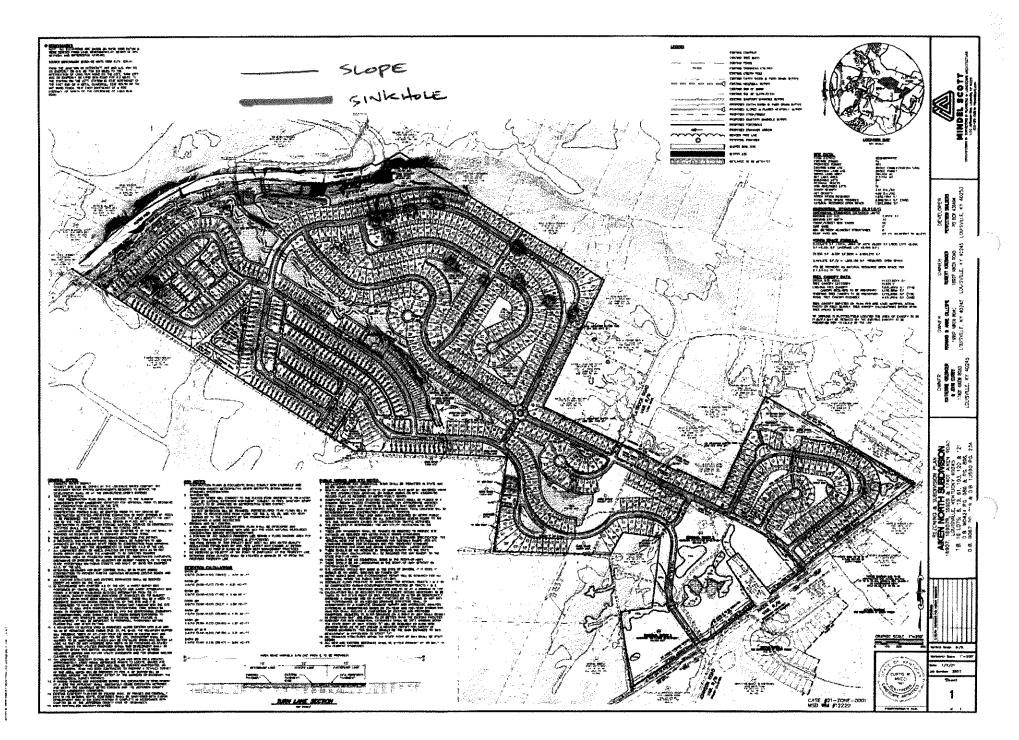
The subject site is underlain by the Louisville Limestone formation, which is susceptible to dissolution and the formation of sinkholes. Eleven depressed areas / possible sinkholes were noted and mapped during our site visit (see attached sketch). Still, these areas and the rest of the site can be made suitable for development with house lots and paved roads provided the site is inspected by a Geotechnical Engineer during construction. This inspection would include a visual observation of the soil subgrade after the site has been stripped of grass and topsoil. A proofroll with a loaded dump truck would be conducted to identify any soft areas in the soil subgrade. If depressed areas and/or sinkholes are identified during the construction inspection, recommendations would be made for stabilizing the sinkholes with inspection of the remediation by the Geotechnical Engineer.

The sinkhole area would be cleaned of all soft, re-deposited soil down to bedrock. A nonwoven geotextile fabric would be placed in the bottom and sides of the excavation. The excavation would be backfilled with clean (limited fines) crushed limestone to stabilize the area and allow water to flow. The stone would be overlain by smaller stone (Ky No. 3s or Ky No. 57s), with the geotextile fabric placed over the stone. Soil fill could then be placed and compacted to finish subgrade.

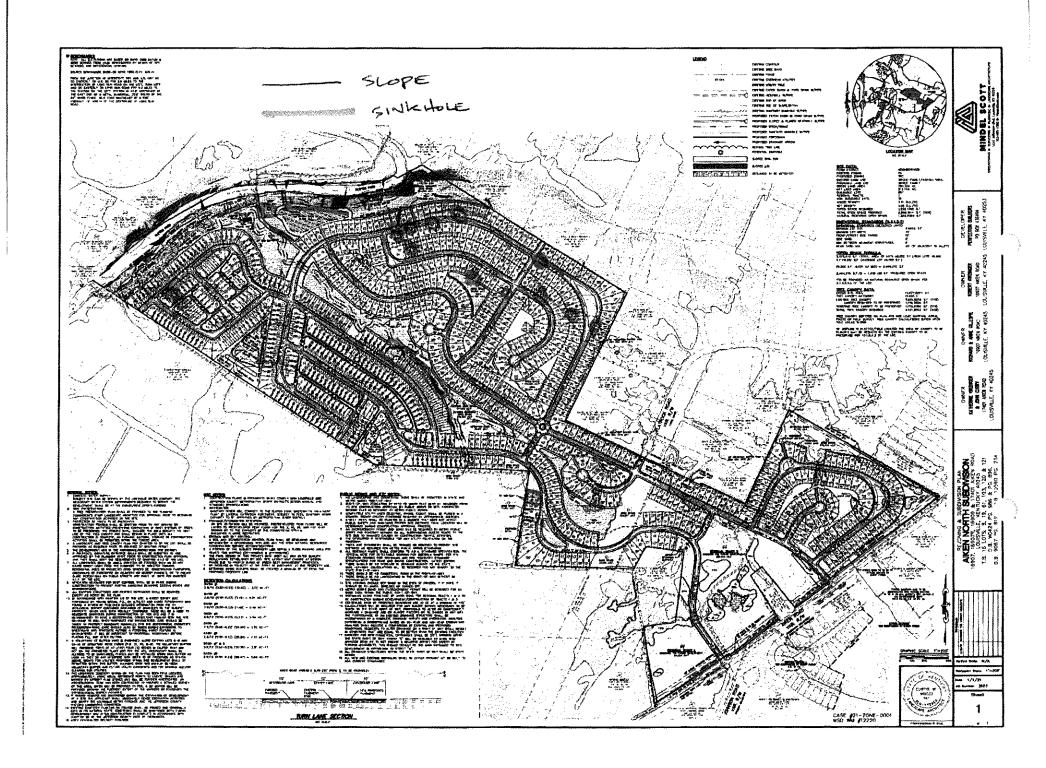
While no slope failures were noted during our site visit, there are several areas designated as house lots and paved roads that have steep slopes. These lots and road areas (see attached sketch) must be inspected by the Geotechnical Engineer during the earthwork portion of the site and site development, and inspected during construction of the new house foundation.

The subsurface conditions at the site consist of clayey soil underlain by limestone bedrock. Placement of any fill in sloped areas must be inspected by the Geotechnical Engineer. Soil fill must be benched into the slope and placed horizontally, and compacted to 98 percent of the Standard Proctor (ASTM D698). Field density tests would be conducted to confirm that the specified compaction was achieved. Some lots may require additional efforts to insure positive drainage away from the house foundations. This may include perimeter and subfloor drains connected to a sump or French drain. Lot yards should be graded such that water drains away from structures. Any such recommendations would be made at the time of house construction.

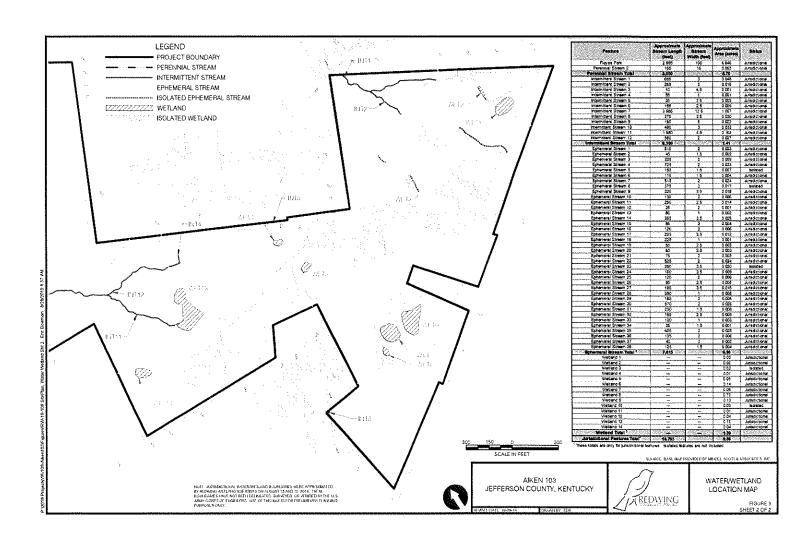
The 250-acre site is located on the northwest side of Aiken Road at the Aiken Road and Johnson Road intersection in Jefferson County, Kentucky (Figures 1 and 2). The site consists primarily of old field with medium-aged woods throughout, along fencelines, drainageways, and scattered woodlots (Figure 2). The water/wetland features identified on site are depicted on Figure 3, listed in Table 1, and summarized below.

- two perennial streams (including Floyds Fork) totaling approximately 3,050 linear feet
- 12 jurisdictional intermittent streams totaling approximately 8,100 linear feet
- 35 jurisdictional ephemeral streams totaling approximately 7,615 linear feet
- 12 jurisdictional wetlands totaling approximately 1.37 acres
- three isolated, non-jurisdictional ephemeral streams measuring 820 linear feet
- two isolated, non-jurisdictional wetlands totaling approximately 0.05 acre

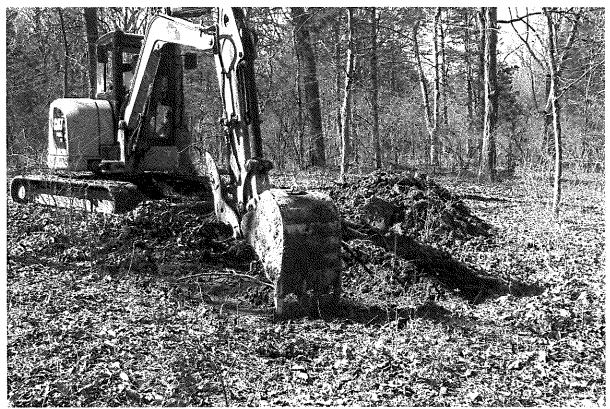
Figure 7. Excavation in progress at Cemetery 2.

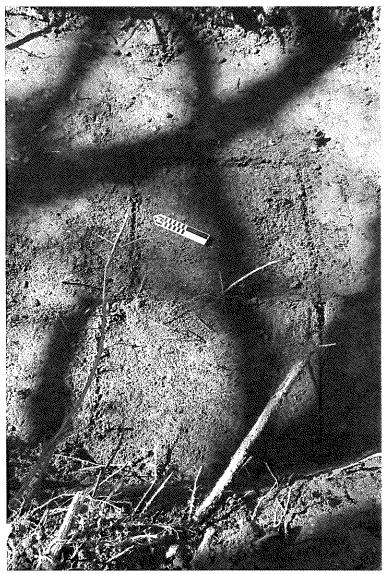
Figure 9. Burial shaft located along western cemetery wall in Trench 1, facing west.

At Cemetery 1, four trenches were excavated around the perimeter of the extant dry-laid stone wall, leaving a space of 1 to 1.5 m away from the wall so as not to undermine its integrity. These trenches were numbered Trench 1 through 4 and upon completion were contiguous (**Figure 8**). The trenches measured between 4 and 5 m wide and 75 and 116 cm deep. Upon identification of one burial in Trench 1, just outside the northwest corner along the west wall, a fifth trench was excavated to the west of Trench 1. No further interments were observed in the excavations at Cemetery 1.

One unmarked grave was exposed at Cemetery 1. This presented as a rectangular shaped area of darker soil, oriented east to west just outside the extant dry-laid stone wall in the northwest corner along the west wall. The current landowners recall seeing a headstone "just outside the west wall" and "near the gate" when they were children. All three recall that the name on the headstone was "Kennedy" but do not recall what happened to the stone. One of the only obviously displaced headstones within the wall of Cemetery 1 belongs to Henrietta Kennedy. Its style and material is also inconsistent with all the other grave markers within the stone wall and its date of 1904 is the most recent. It is likely that this stone is the headstone the landowners recall as being outside the wall and belongs to the interment recorded during this investigation.

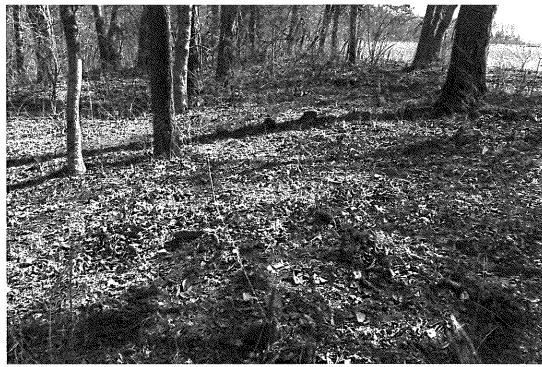
Figure 10. Cemetery 2, each flag marks a location of fieldstones. String marks in-situ headstone and associated foot stone.

Excavations at Cemetery 2 were constrained by its location in a wooded area with numerous trees measuring well above 4 inches in diameter. Prior to excavation, the area was subjected to ground surface survey and near-surface probing with a tile probe to locate fieldstones. Each fieldstone, whether in-situ, displaced, or naturally occurring, was marked with pin flags to aid in determining the boundary of the cemetery (**Figure 10** and **Figure 11**). Excavations then proceeded, with placement of the trenches to avoid intersection with interments and/or in-situ burial markers. A total of 8 trenches were excavated at Cemetery 2: three at the northwest extent of ground surface stones; one along the western extent; three along the southern extent; and one along the eastern extent (**Figure 12**). Two sinkholes were present along these extents as well and were avoided by the heavy machinery. As few stones were present along the northern edge and the presence of a steep slope down to a tributary of Floyds Fork, no excavations were conducted in the northeastern area.

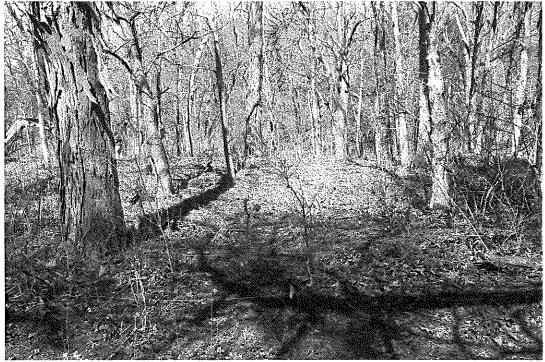
Figure 11. Cemetery 2. Pin flags mark fieldstones, strings mark an in-situ headstone and associated footstone.

Both cemeteries should be protected by a 30-ft "no disturbance" buffer. Cemetery 2 should also be enclosed, as should the unmarked grave outside of Cemetery 1. The fencing should be sympathetic to the period of the graves. The fencing is not intended to keep viewers away, but rather to protect the cemetery from future inadvertent damage. Ideally, the fencing should be permanent and require little maintenance. Wrought iron fencing is a recommended choice as it is attractive and was commonly used on historic cemeteries.

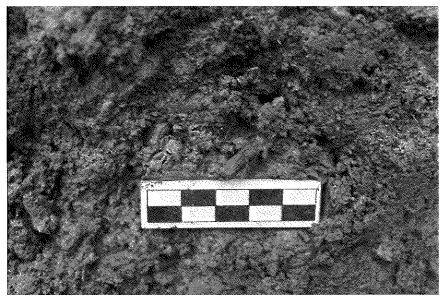
Figure 13. Nail fragment found at 688 cmbs in north wall Trench 5.

No evidence of burials or sub-surface fieldstones was found in Trenches 1, 2, 3, 4, 6, 7, or 8. Evidence of a burial (a nail fragment (**Figure 13**) and small bits of coffin wood (**Figure 14**) was observed in the north profile wall of Trench 5. This trench was placed south of a row of in-situ fieldstone grave markers, with the northern end of the trench excavated as near as possible to the in-situ stones without displacing them. Just beneath the ground surface (ca. 3-5 cm), a cluster of fieldstones was uncovered that appear to be present along the length of the burial, between the in-situ headstone and foot stone. The nail and coffin wood observed in the north profile of Trench 5 were found at 68 cm and 74 cm below the surface (cmbs), respectively.

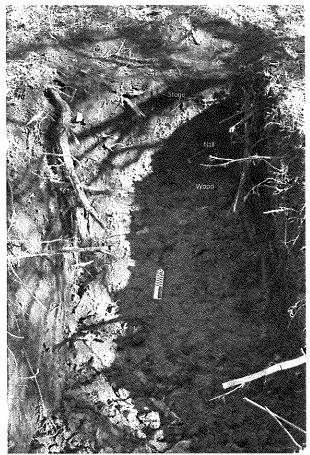
Figure 15. Trench 5 facing north.

No burial shafts were identified in the eight trenches excavated at Cemetery 2, though a nail fragment and coffin wood were exposed in the north wall of Trench 5. As no burial shafts were observed during the excavations, the presence of both in-situ and displaced fieldstone grave

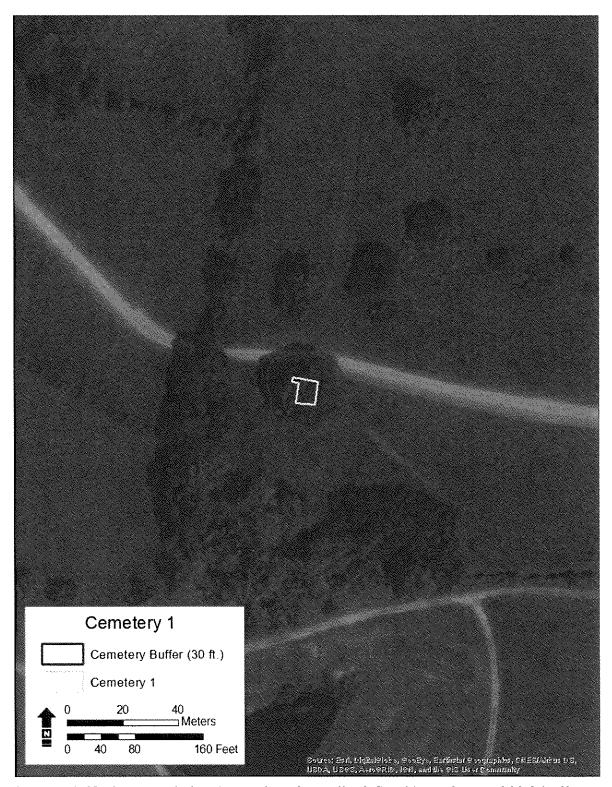
Based on the findings, the boundary of Cemetery 1 is estimated to be the dry-laid stone wall along the north, east, and south edges. The western boundary of the cemetery should be extended to include the single burial identified in the northwest corner (**Figure 16**).

Figure 16. Modern aerial showing archaeologically-defined boundary and 30-ft buffer at Cemetery 1.

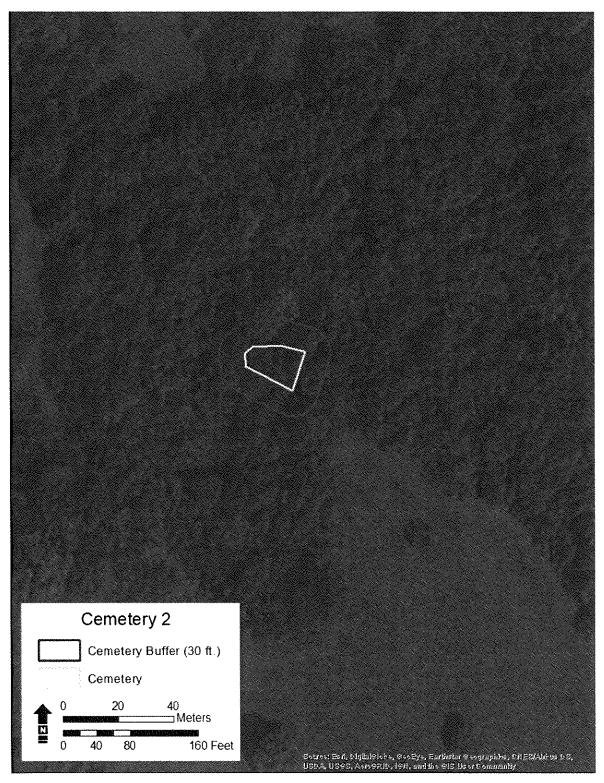
The extent of Cemetery 2 measures approximately 15 m (49.21 ft) north to south by 20 m (65.62 ft) east to west. The estimated boundary of Cemetery 2 is shown in **Figure 17**.

Figure 17. Modern aerial showing archaeologically defined boundary and 30-ft buffer at Cemetery 2.
