Historic Landmarks and Preservation Districts Commission

Report to the Committee

Case No: 21-COA-0155
Classification: Committee Review

Property Address: 1600 Story Ave.

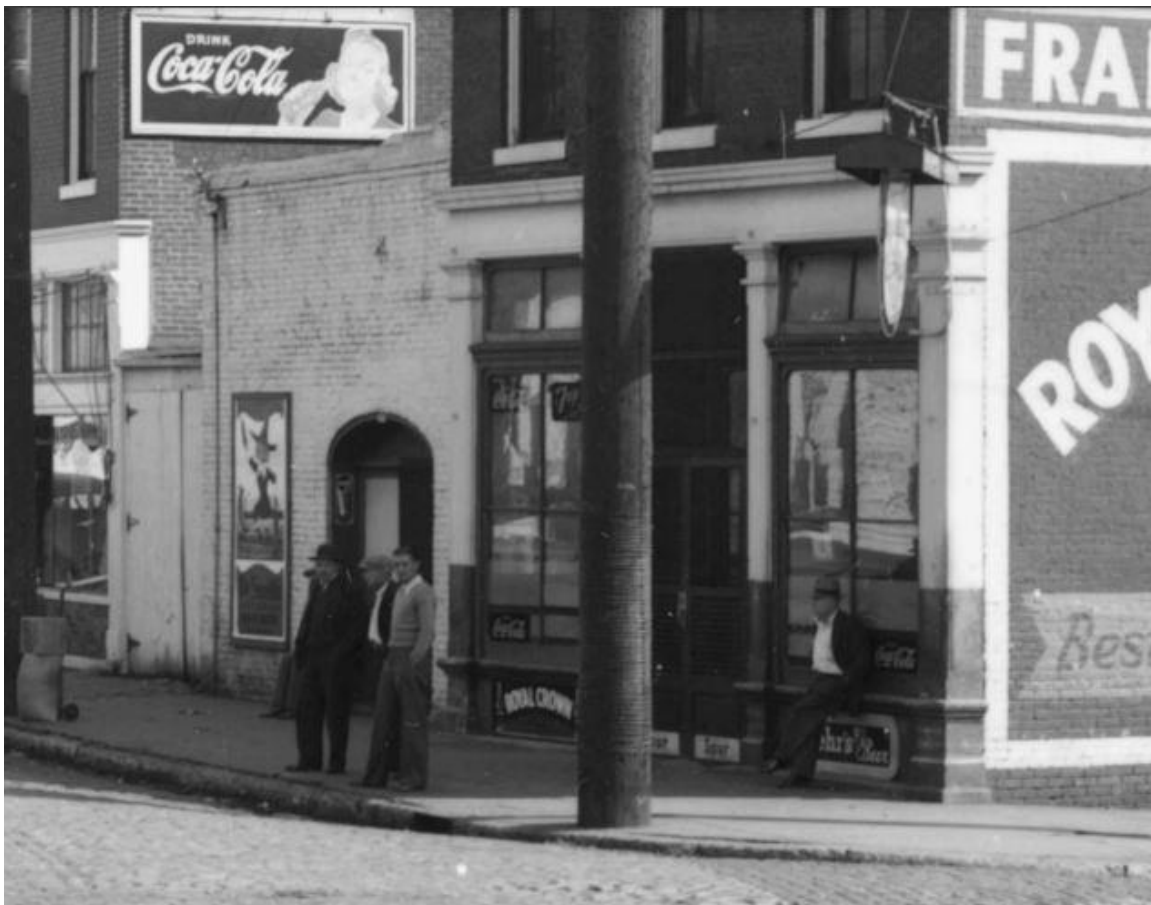
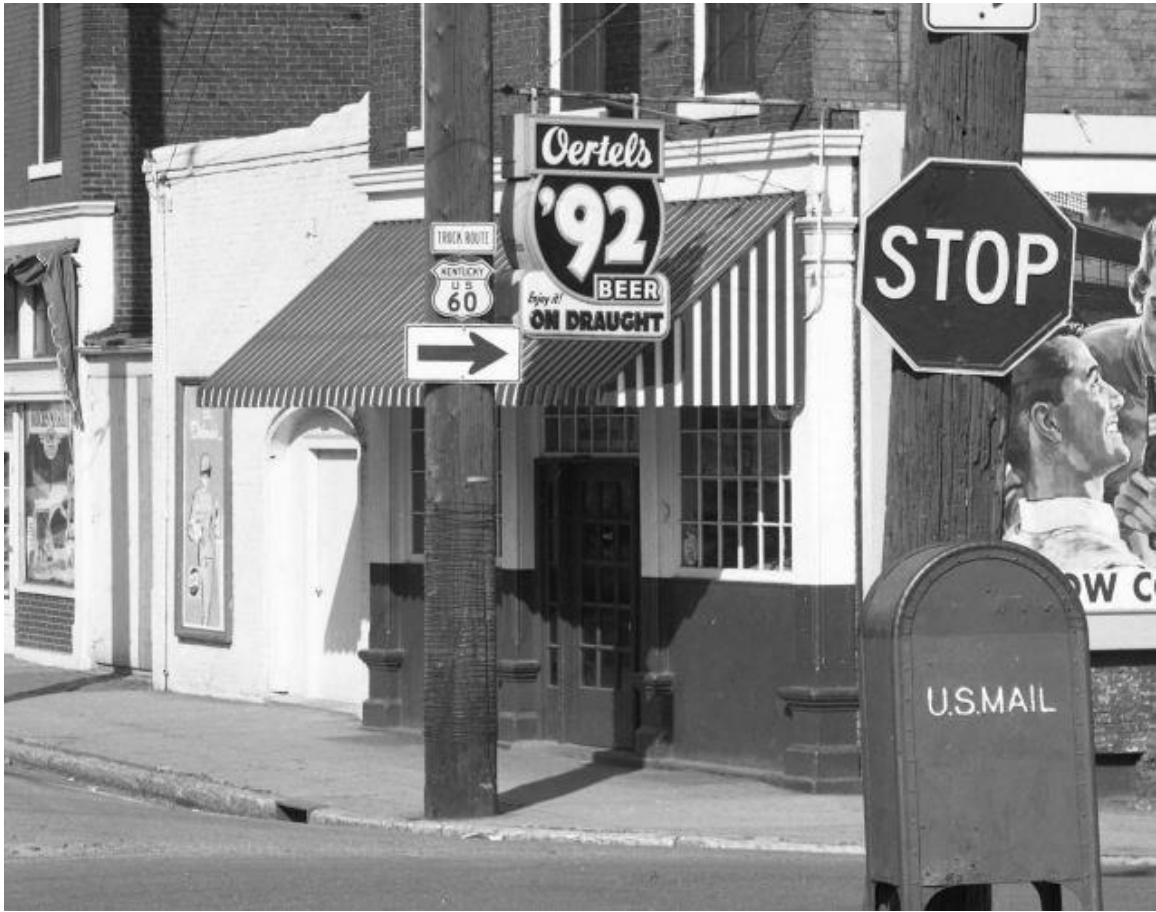
Overall the two projects are generally appropriate for the district. The proposed window generally meets **W1** and **W2**. The window opening though historic in its own right, was not original to the building. This is evident in the historic photos of the property (see below). The proposed single-lite window would generally tell a clearer story of the building's history, and not be visually read as conjectural, or falsely historic. The proposed window would fit in the existing opening per **W4**. However, the proposed window would not meet **W5** or **W7**. The window would be considered a picture window, and it would also not operate the same as the existing window. The existing double-hung window was replaced previously in 2009. Given the corner commercial context of the building however, a fixed single-lite window would read as a storefront window.
