JOB# 20149
DATE: 8-19-2021

SITE VISIT: 8/19/2021

SMYRNA PARKWAY APARTMENTS
EXISTING TREE CANOPY EXHIBIT (1/3)

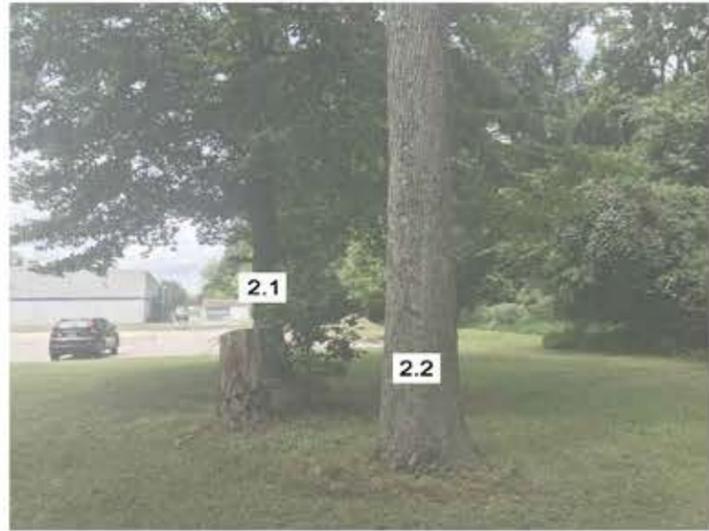
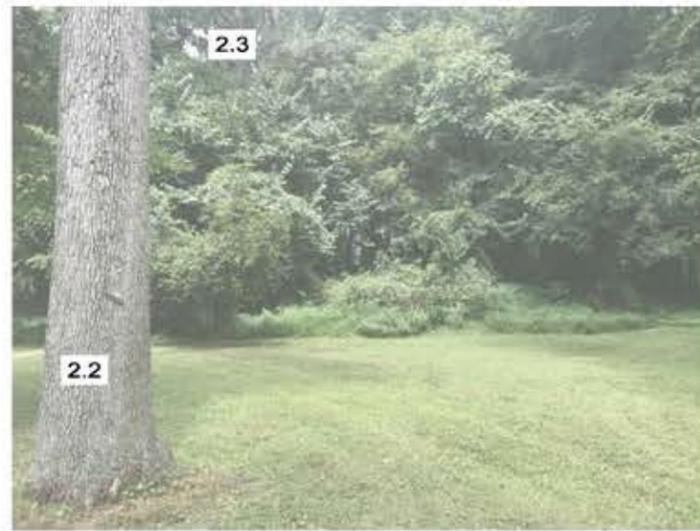
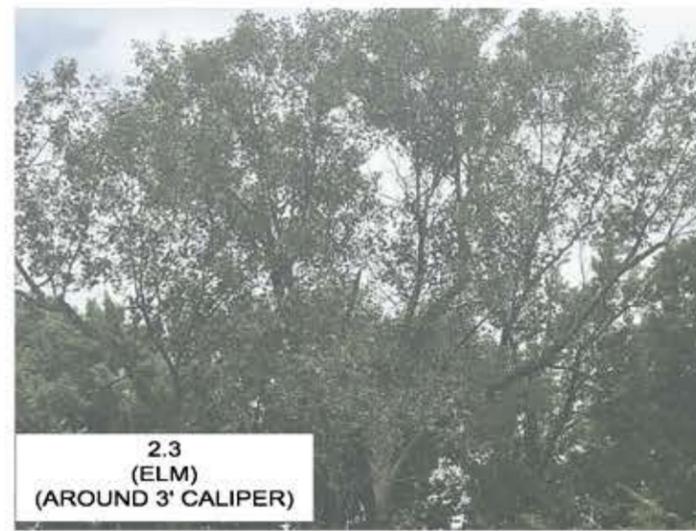
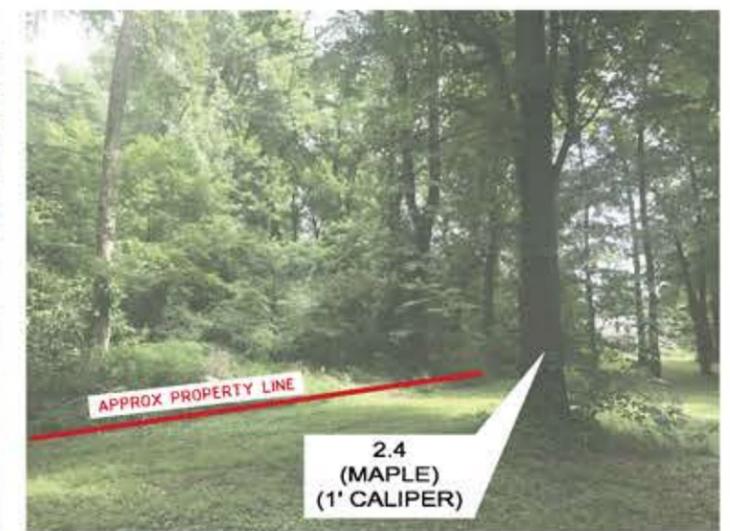
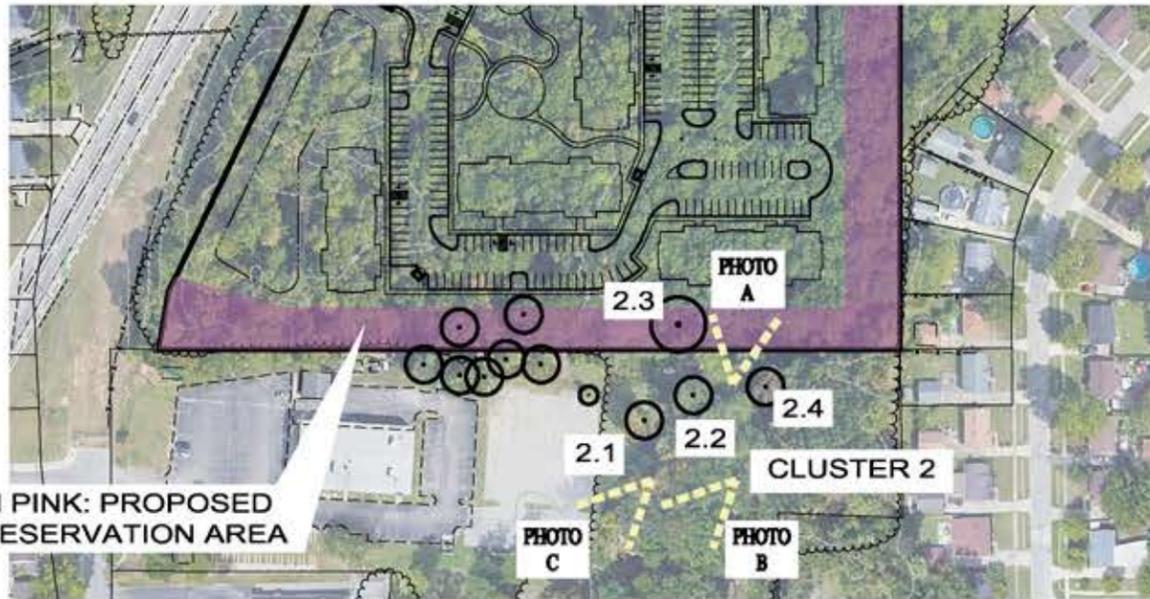
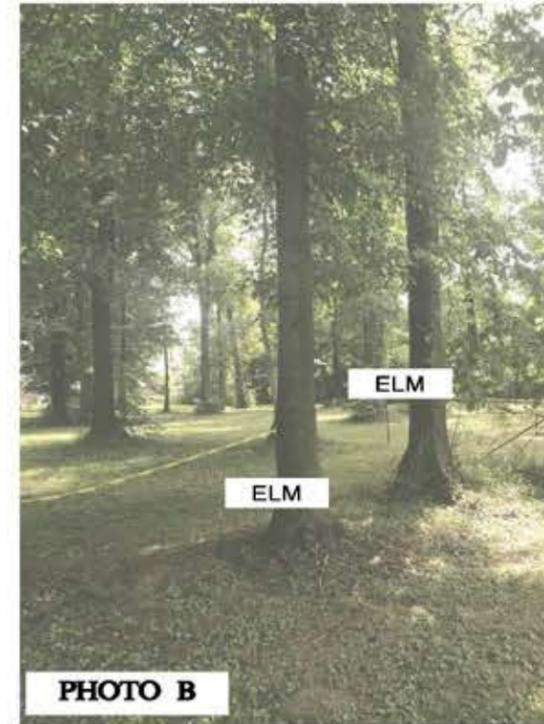
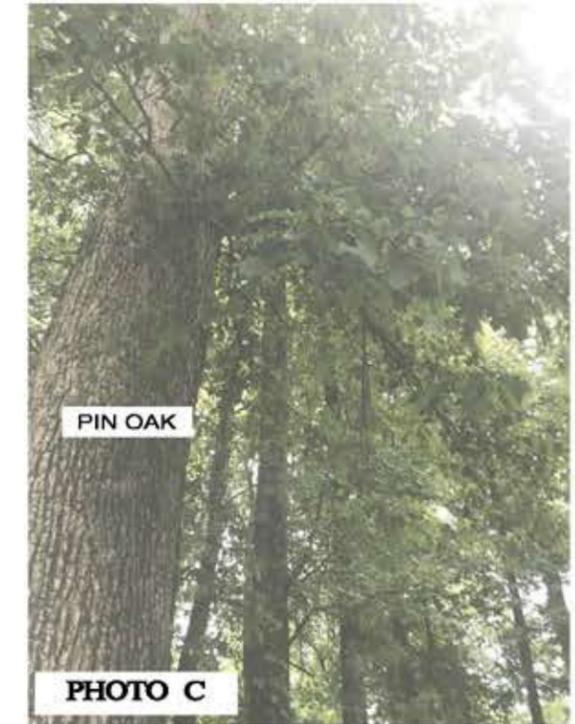
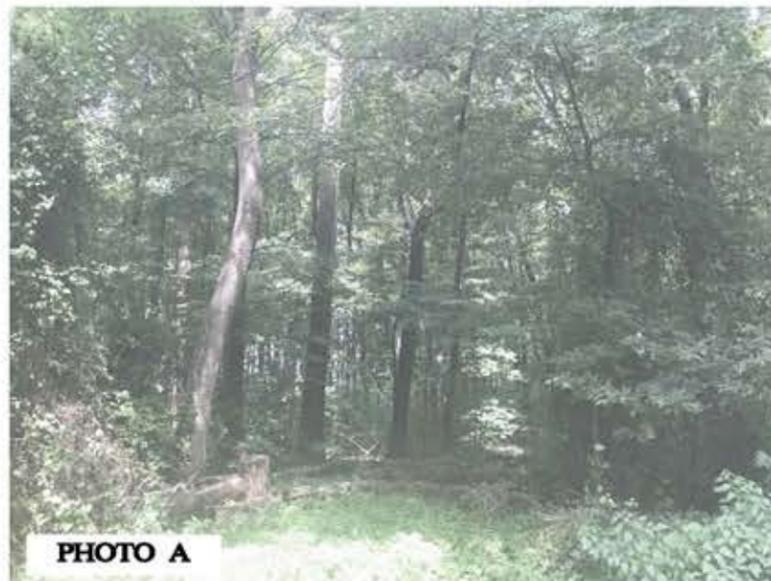
EXISTING TREE CANOPY EXHIBIT (2/3)

AREA DENSELY VEGETATED.

PRESENCE OF MATURE TREES BEING SEVERAL WITH CALIPER BIGGER THAN 2' DIAMETER

IMPOSSIBLE TO APPROACH THE TREES AT THIS TIME DUE TO INVASIVE SHRUBS LIKE SUMAC AND HONEYSUCKLE.

SOME OFF-SITE TREES HAVE BEEN PICTURED SINCE LOOKS LIKE SPECIES ARE SIMILAR TO THE NON ACCESSIBLE AREA.

OUR EXPECTATION IS THAT THE AREA WILL HAVE OAKS, ELMS, MAPLES AND SWEETGUMS AMONG OTHERS.

FURTHER INVESTIGATION AFTER CLEANING OF THE SITE IS SUGGESTED.
