May 20, 2022

Reference: **Preliminary Slope Evaluation & Karst Survey – Johnson Road Residential**
1614 Johnson Road
Louisville, Jefferson County, Kentucky 40245
ECS Project No. 61-2735

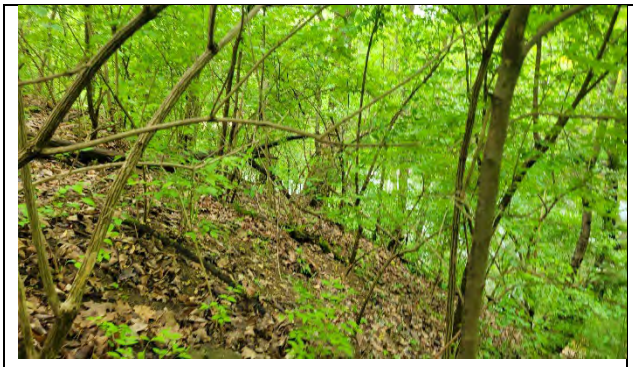
Some visual indications of minor slope instability and evidence of creep were observed in the north and east portions including: displaced rock fragments (gravel, cobbles, and/or boulders); unusual tilting, bowed, and fallen trees; minor eroded soil; and mounding of the eroded soil at the slope base and upslope of larger trees. No indications of large, wide-scale or deep seated slope movements were noted. However, minor slope movements (wedge, bowl, or disk shaped failures) were observed in isolated areas (typically at slope areas > 20%). For the remainder of the site (low lying portion), the slopes appeared to be stable (excluding stream and drainage swale banks). In general, signs of slope failure became rare or absent in areas south and west of the steep slopes. See below for photos at each area observed as shown on the attached **Site Reconnaissance Plan.**

Photo 1: View of slope and tilted trees (Slope Area 1).

Photo 2: View of drainage swale (Slope Area 1).

Photo 3: View of displaced cobbles (Slope Area 2).

Photo 4: View of slope and tilted trees (Slope Area 2).

Photo 5: View of slope and outcropping (Slope Area 3).

Photo 6: View of outcropping and Floyds Fork (Slope Area 4).

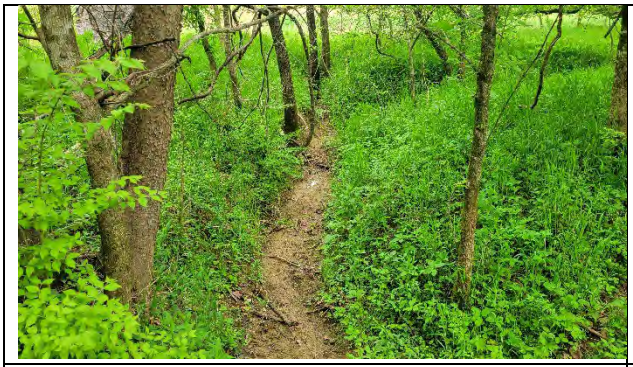
Photo 7: View of drainage swale (Slope Area 5).

Photo 8: View of drainage swale (Slope Area 5).

Photo 9: View of pond (Slope Area 6).

Photo 10: View of soil mounding (Slope Area 6).

Photo 11: View of soil mounding, displaced cobbles, and minor erosion (Slope Area 7).

Photo 12: View of soil mounding and slope (Slope Area 7).

Photo 13: View of displaced cobbles (Slope Area 7).

Photo 14: View of tilted trees and slope (Slope Area 8).

Photo 15: View of soil mounding (Slope Area 8).

Photo 16: View of bowed trees and slope (Slope Area 8).

Photo 17: View of drainage swale and slope (Slope Area 8).

Photo 18: View of soil mounding and minor erosion (Slope Area 9).

Photo 19: View of minor erosion and slope failure "wedge shaped" (Slope Area 9).

Photo 20: View of minor erosion and tree tilting (Slope Area 9).

Photo 21: View of pond (Slope Area 9).

Photo 22: View of slope (Slope Area 10).

Photo 23: View of soil mounding, displaced cobbles, and minor erosion (Slope Area 10).

Photo 24: View of soil mounding, displaced cobbles, and minor erosion (Slope Area 10).

Photo 25: View of soil mounding (Slope Area 10).

Photo 26: View of minor erosion, mounding, and "wedge shaped" slope failure (Slope Area 10).

Photo 27: View of soil mounding, displaced cobbles, and minor erosion (Slope Area 10).

Photo 28: View of culvert and drainage swale (Slope Area 11).

Photo 29: View of bowed trees and slope (Slope Area 11).

Photo 30: View of slope (Slope Area 12).

Photo 31: View of culvert and drainage swale (Slope Area 12).

Photo 32: View of "bowl shaped" slope failure (Slope Area 13).

Photo 33: View of "bowl shaped" slope failure (Slope Area 13).

Photo 34: View of tilted trees and drainage swale (Slope Area 13).

Photo 35: View of slope (Slope Area 13).

Photo 36: View of soil mounding and minor erosion (Slope Area 13).

Photo 37: View of drainage swale (Slope Area 13).

Photo 38: View of drainage swale (Slope Area 13).

Photo 39: View of slope (Slope Area 14).

Photo 40: View of apparent spring (upslope).

Photo 41: View of apparent spring (downslope).

Photo 42: View of central stream (upstream).

Photo 43: View of central stream (downstream).

Photo 44: View of central stream (downstream).

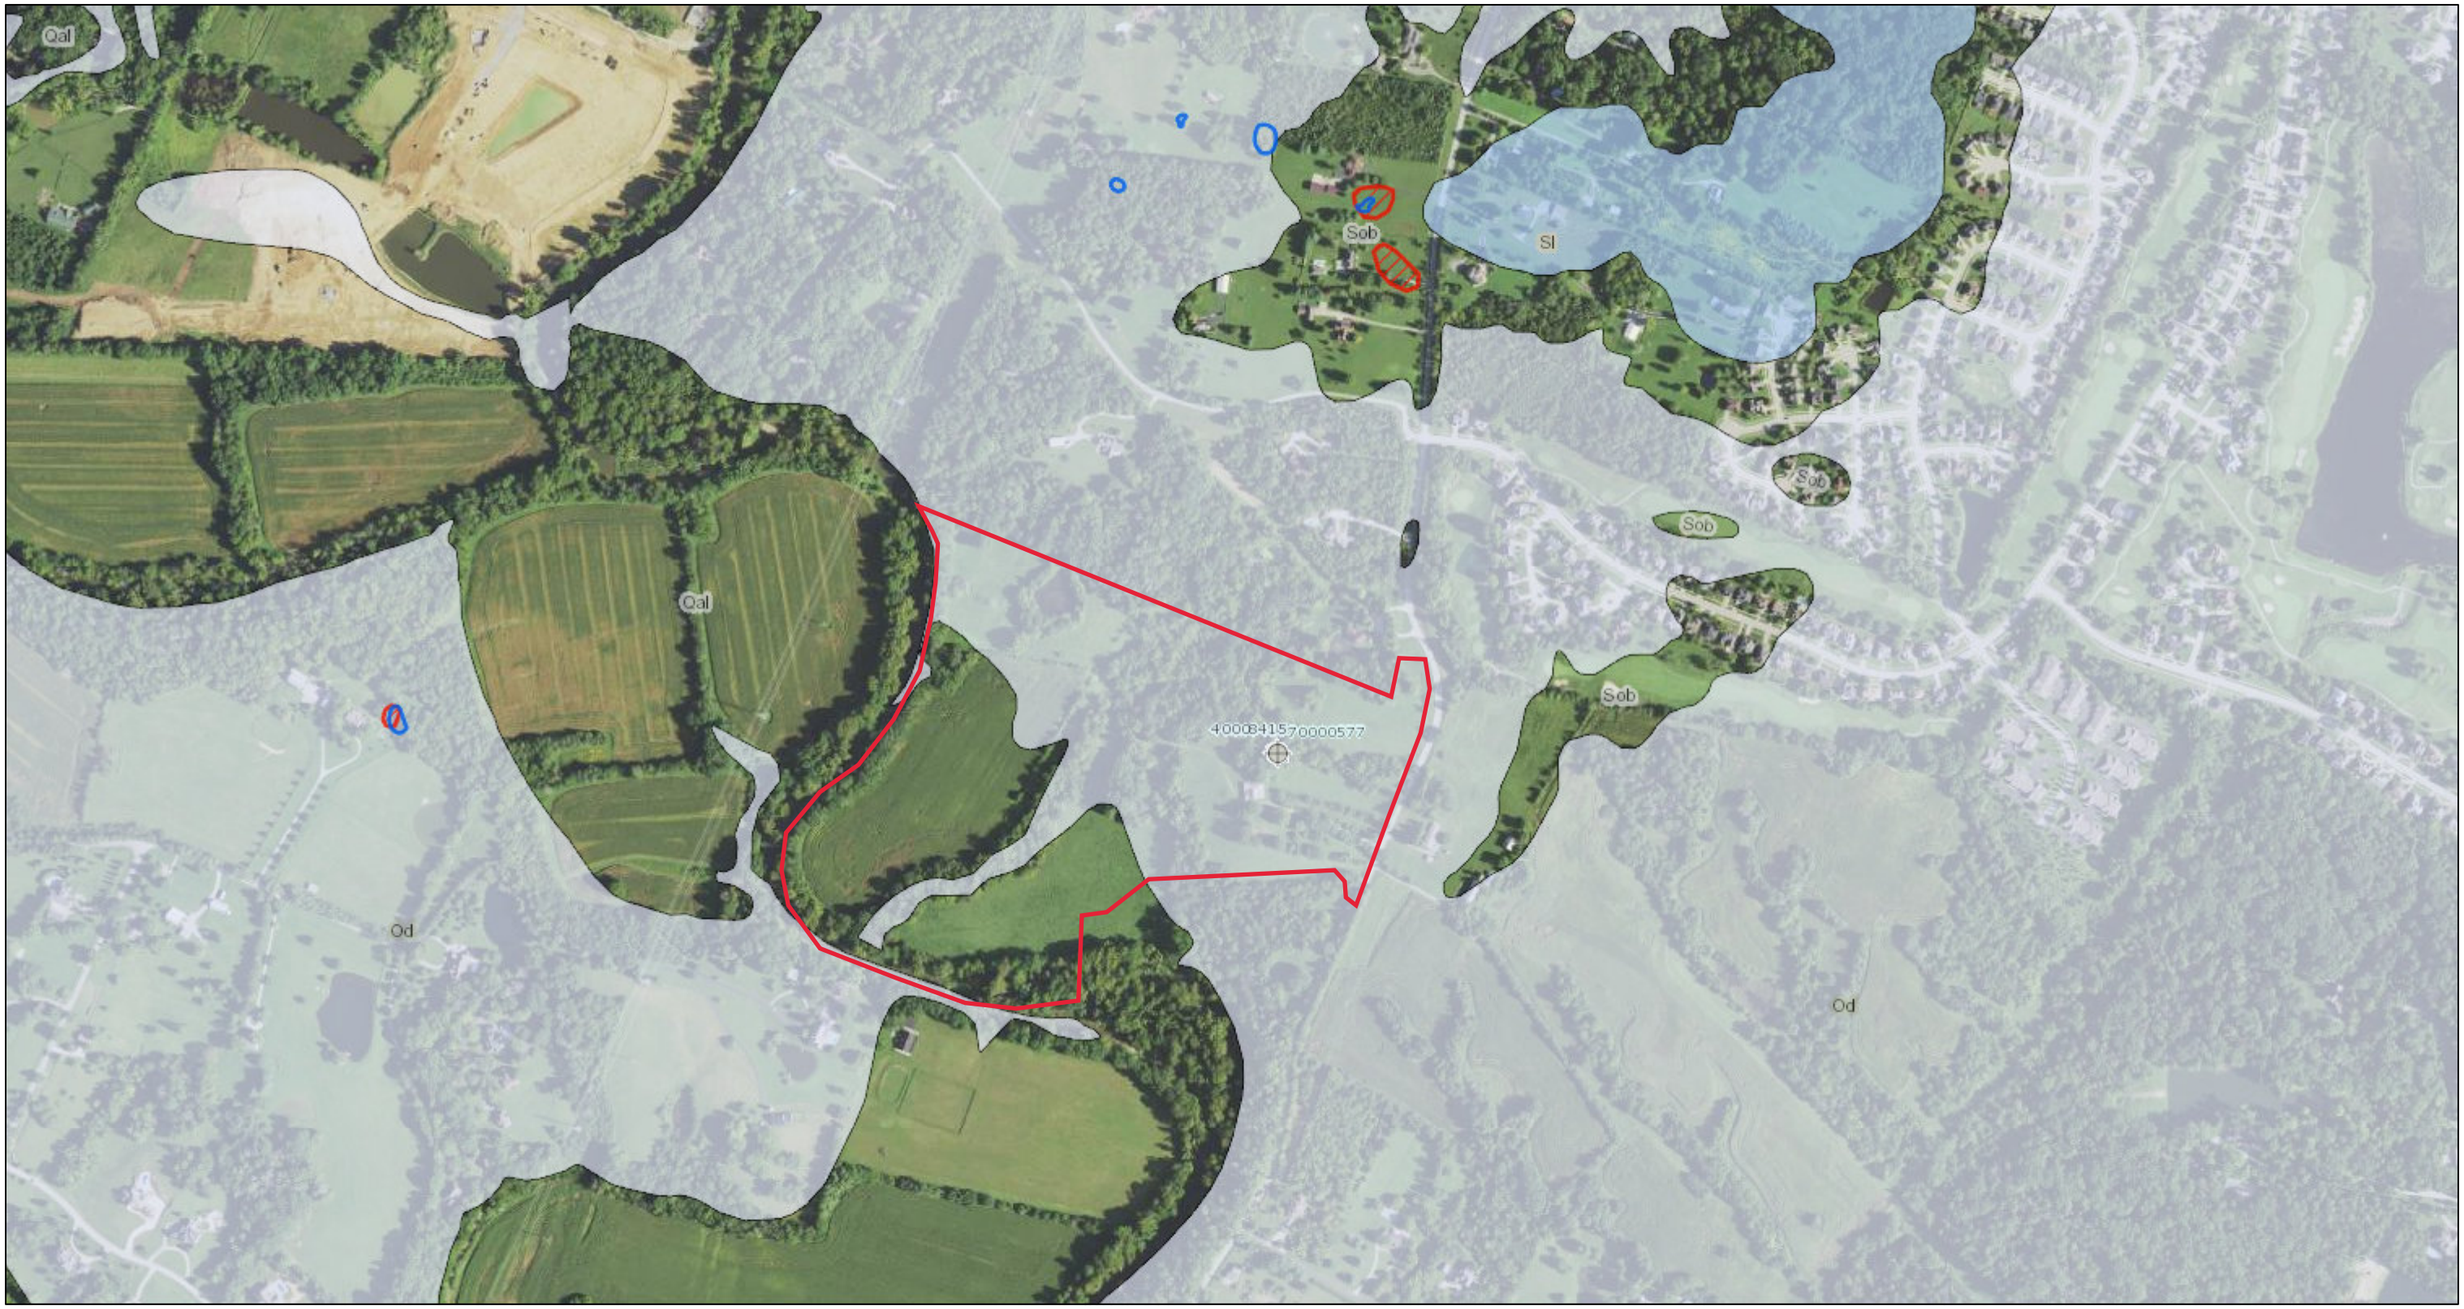
Site Reconnaissance Plan
Preliminary Slope Evaluation & Karst Survey
Johnson Road Residential
1614 Johnson Road
Louisville, Jefferson County, Kentucky 40245

Based on our review of the above reference observations and information, and on our past experience with site development for similar conditions in Jefferson County, our opinion is that most of the on-site slopes (excluding small, localized erosion features along swales and streams) in the observed areas were generally stable at the time of our reconnaissance. Evidence of minor instability was observed in isolated areas in the north and east portions of the site (Slope Areas).

The current, on-site localized slope instability observed likely is related to the following factors:

- Relatively thin depths of soil in slope areas
- Cohesive (clayey) soil matrix
- Rocky soil texture
- Limestone, dolomite, and or shale bedrock
- Numerous trees and other vegetation

The north and east portions of the site, as shown in the shaded ("Observed Slope Areas" and "Minor Failure Areas") where minor instability was observed should be further investigated during the construction phase of the project once the location and planned elevation of the proposed structures and related improvements are known.
