King Louis XVI Update

Title: *Louis XVI*
Date: c. 1816-1827
Artist: Achille-Joseph-Étienne Valois (1785-1862)
Medium: Carrara marble statue, Limestone base
Dimensions: Weight: 6.5 tons (pedestal), 9 tons (statue)
Height: 6’10” (pedestal), 10' (statue)

COMMISSION ON
PUBLIC ART

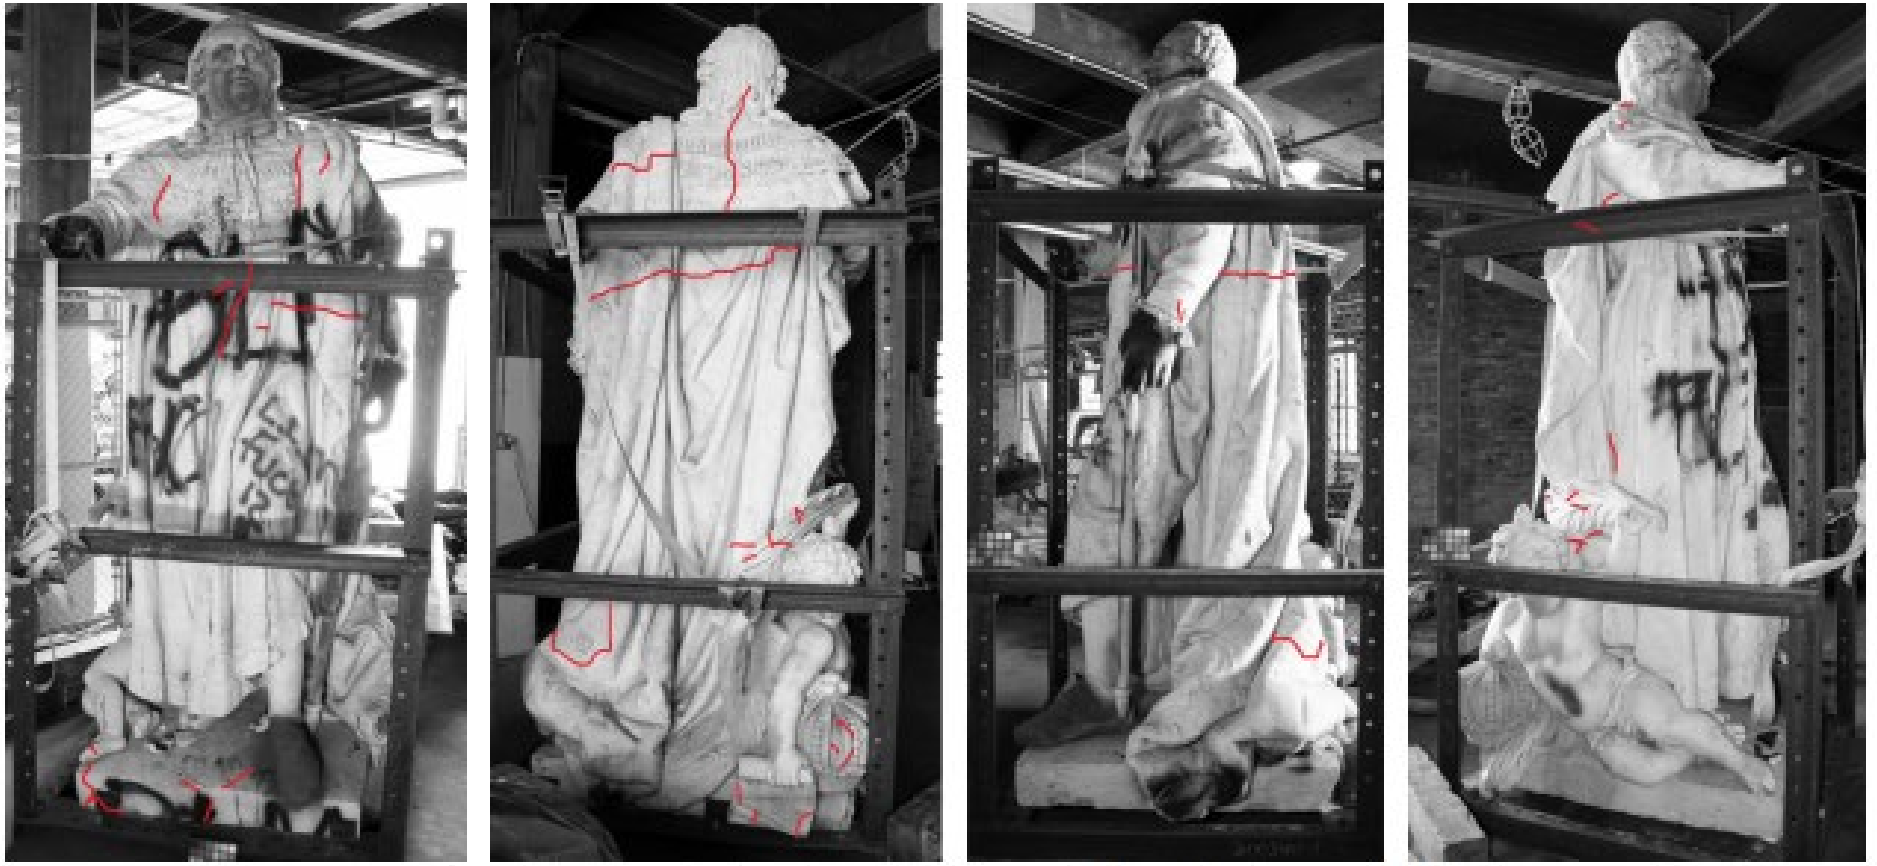
Conservator noted structural cracks and recommended **consolidation** repair. This repair was not performed.

Some surface and structural cracks were aesthetically filled, but do not appear to have had consolidation treatment to address structural integrity.

Conservators noted significant cracking throughout the sculpture, specifically along the back. Conservator expressed concern for potential catastrophic failure within the cloak element and potential severe injury to bystanders.

Red annotations indicate preliminary mapping of cracks and break edges.
