RE: Hogan's Fountain Teepee Pavilion, Cherokee Park

**Re.** Cherokee Park Hogan's Fountain Pavilion

**Subject:** Cherokee Park, Hogan's Fountain Teepee Pavilion Reassessment

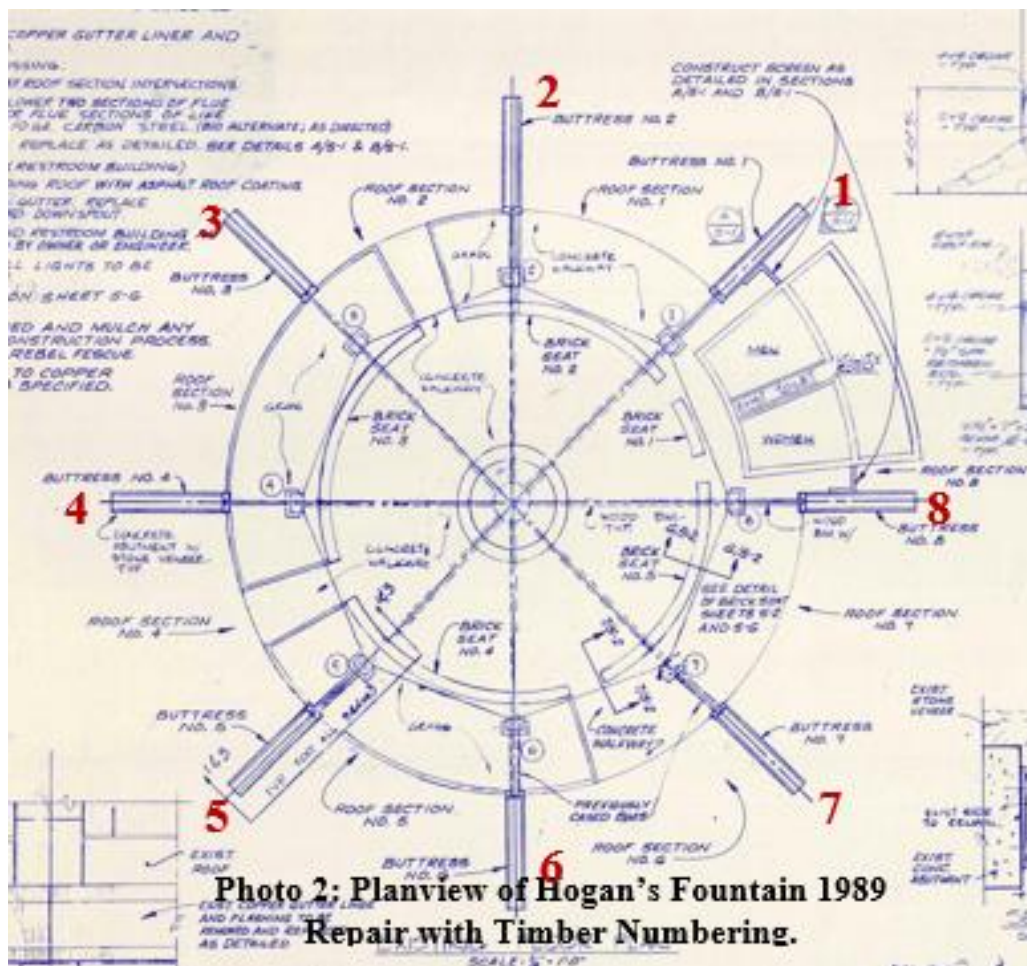
**Photo 1: Hogan's Fountain- Eight timbered legs encased in ½" steel.**

throughout. Due to the recent movement of the structural timbers, Wood was requested to evaluate the condition of the encased timbers and to determine if the timbers have experienced deterioration. Wood hired subcontractor, Concrete Coring & Cutting, to drill 2-inch diameter holes in the ½-inch steel casing to evaluate the wood condition. The following provides a brief overview of our results. For this evaluation, Wood used the same naming nomenclature used on the 1989 plans.

Based on our evaluation, the wood encased in the steel has experienced severe deterioration and therefore is not structurally sound. Repair options should not utilize this section of wood as a structural component. In addition, in several areas, the wood above the steel is showing signs of distress (delamination, darkening of the wood from possible water damage, etc.).

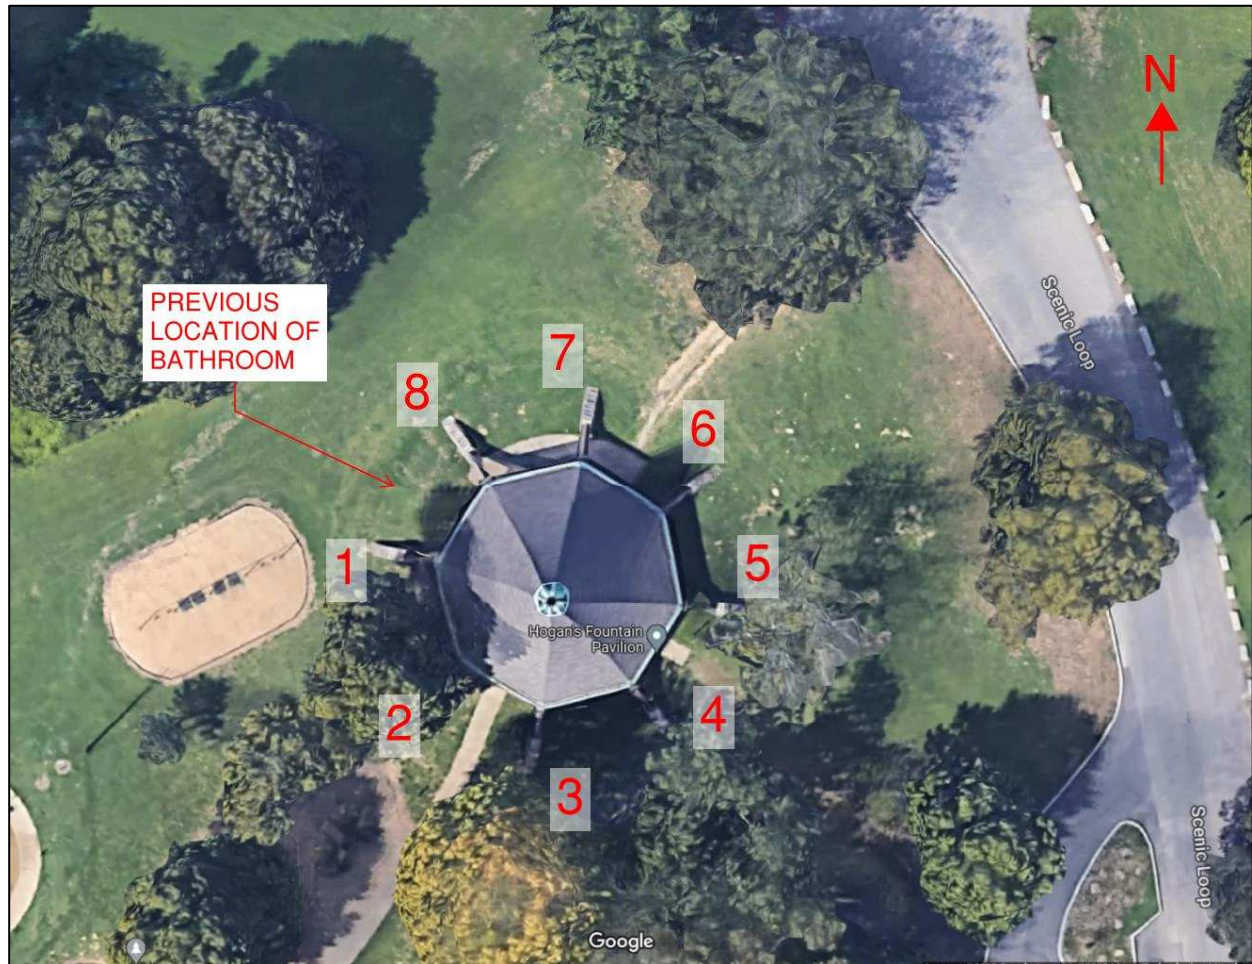
**Photo 1: Pavilion and Beam Orientation**

On August 17, 2022, Scott Jenkins and Jason Burkett met with Dave Wilding at the pavilion to review the current condition, look inside the 2-inch diameter viewports on the steel casings, and compare these findings with our original assessment on May 10, 2022. Our previous letter, dated May 12, 2022, should be referenced for additional information and the history of the pavilion. The location of each glue laminated support beam has been identified in **Photo 1**, to correspond with the original repair drawings.

Because the wood is so deteriorated or non-existent within the steel casings our recommendation is that the pavilion needs to either be shored or demolished as soon as possible, to prevent an unexpected or uncontrolled collapse. Shoring a structure of this type is more complicated than a normal column supported structure due to the outward thrust forces of the curved beams and the necessity of circumferential or radial tension ties around the structure. Add to this, the deteriorated state of the glue laminated beams and instability issues, the condition of this structure makes shoring a very dangerous operation that should only be done by a reputable company under the direction of a structural engineer experienced in shoring design. Although shoring and repair is an option, it is our opinion that shoring and repairs to this structure would neither be economical nor preserve the architectural design of the pavilion.
