May 4, 2022

Reference: **Oak Grove Subdivision – Karst Survey**
10212 & 10302 Oak Grove Road
Louisville, Jefferson County, Kentucky 40291
ECS Project No. 61-2724

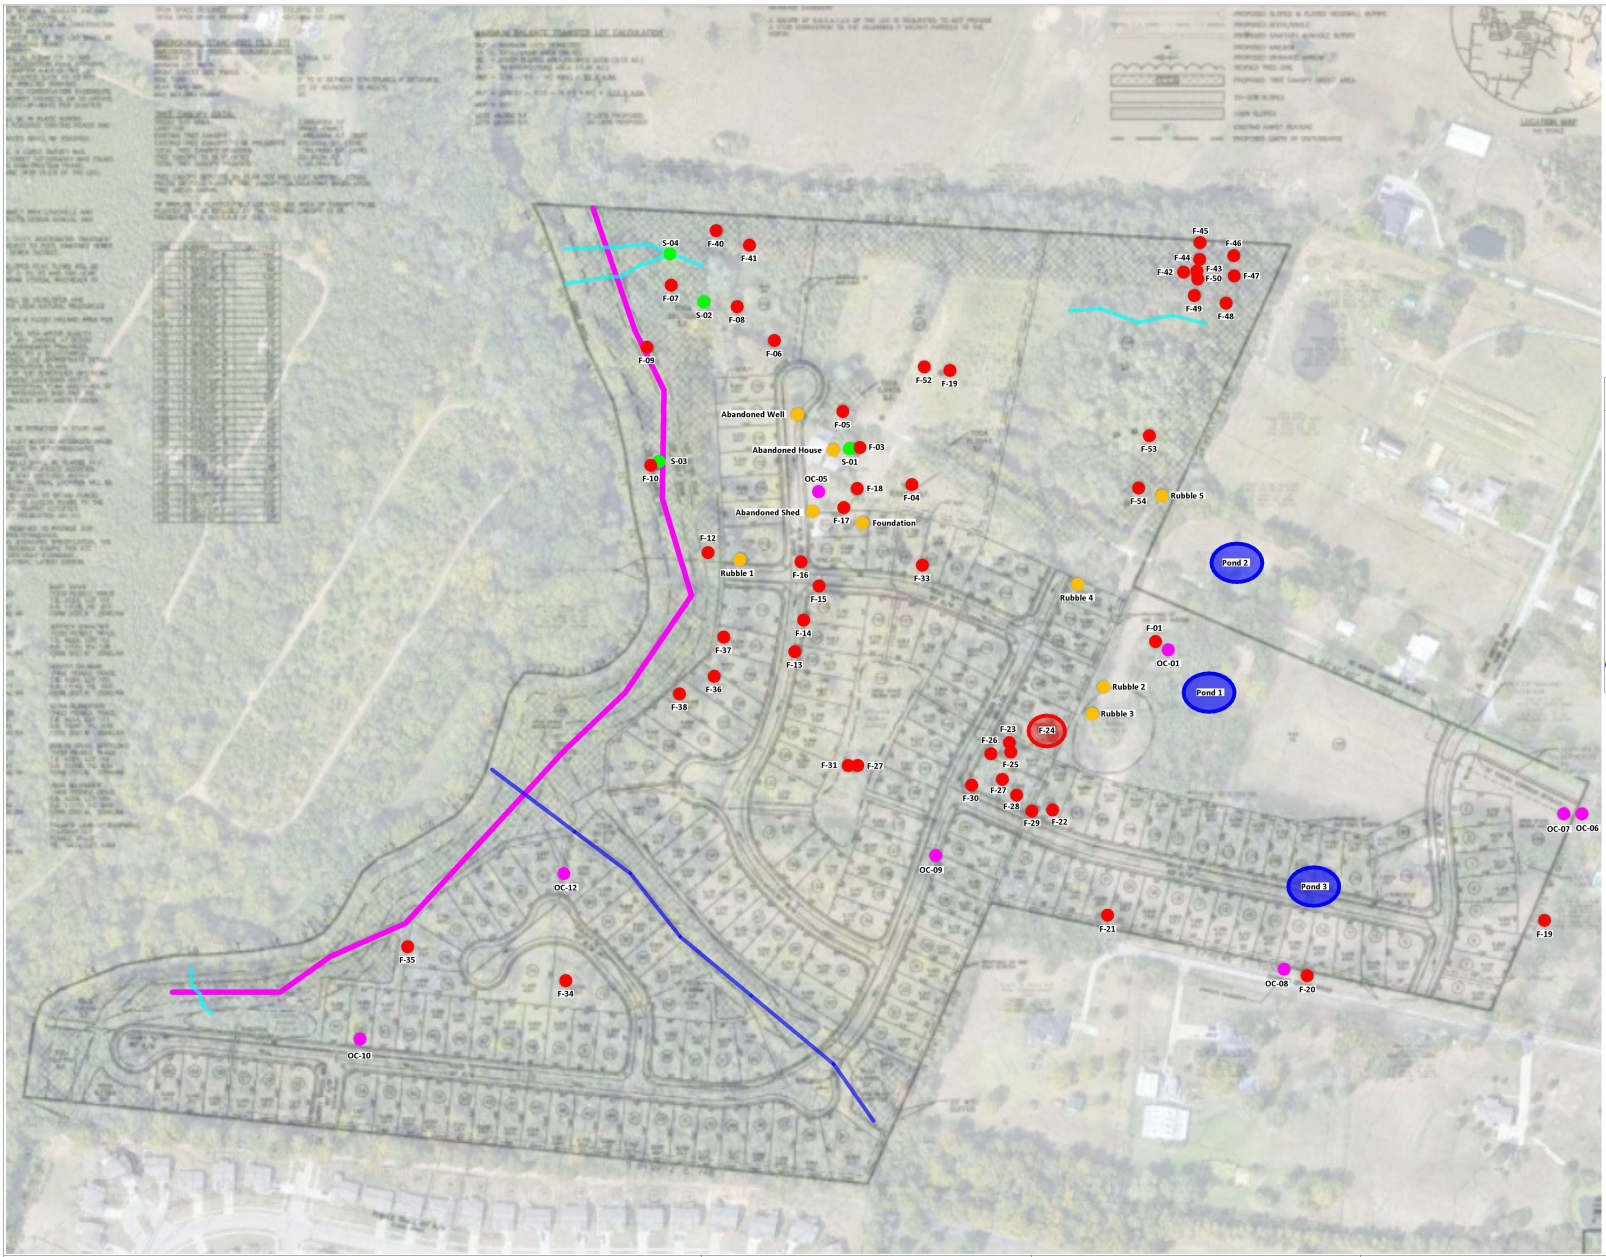
Feature Location Plan - Overview
 Oak Grove Subdivision - Karst Survey
 10212 & 10302 Oak Grove Road
 Louisville, Jefferson County, Kentucky, 40291

Fifty-four (54) possible karst-related features were identified onsite. Refer to the attached **Karst Feature Location Plan** and **Site Photos** for the approximate location of observed site features and photos of selected features. Brief descriptions of the features are provided in the table below. Areas and/or features with multiple designations (A, B, C, etc.) represent a series of linear features which appeared to be related to a common joint or similar lineation.

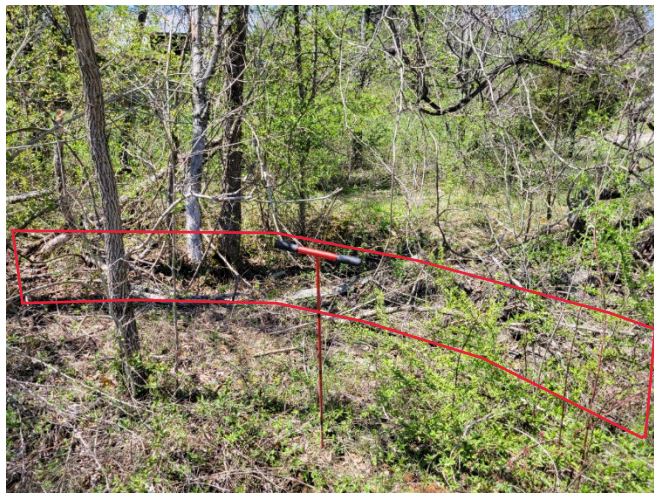
Photo 3 – View of F-3.

Feature	Description	Approximate Dimensions	Approximate Depth
F-1	Oval-shaped closed depression containing three (3) smaller closed depressions. Soil sidewalls, no visible throats.	30' Diameter	3'
F-2	Oval-shaped closed depression underlain by an apparent spring. Audible running water observed below soil bottom. Soil sidewalls observed. Three (3) open throats encountered.	35' Diameter	3'
F-3	Trenchlike closed depression with soil sidewalls and a partially closed throat encountered at the bottom of the depression.	3' Wide 25' Long	3.5'
F-4	Oval-shaped closed depression with soil sidewalls and two partially closed throats encountered at the bottom of the depression. Exposed metal pipes observed at the bottom of the depression.	17' Diameter	2.5'
F-5	Oval-shaped closed depression with soil sidewalls and a partially closed throat encountered at the bottom of the depression. Probe rod extended to apparent rock approximately 3 feet below the bottom of the depression.	7' Wide 17' Long	4'

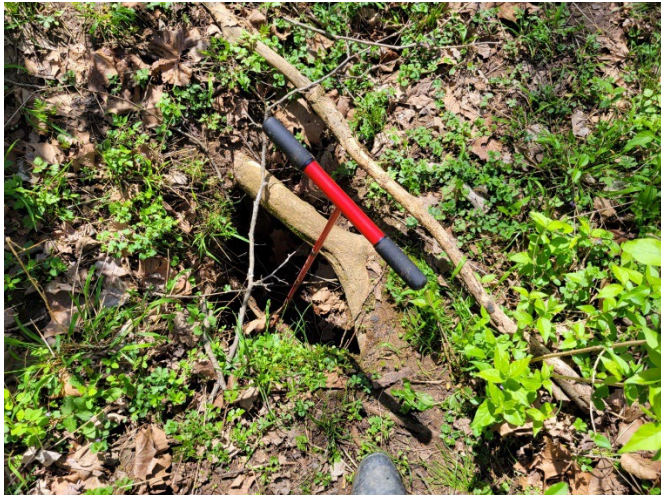
Photo 9 – View of F-10

Feature	Description	Approximate Dimensions	Approximate Depth
F-6	Small opening with rock sidewalls/bottom. Visible water observed at the bottom of the opening.	1' Diameter	> 4'
F-7	Small opening with rock sidewalls/bottom. Visible water observed on the walls of the opening.	2' Diameter	> 4'
F-8	Spring, surrounded by outcropped rock, observed in a hillside. 1-2" of running water observed.	6' Wide 11' Long	3'
F-9	Small opening with soil sidewalls. Visibly wet.	1' Diameter	3'
F-10	Oval-shaped closed depression with soil sidewalls.	2' Diameter	2'
F-11	Spring observed in a hillside. Spring forks into 2 separate drainage channels, which drain to Cedar Creek approximately 40-50 feet to the west. 1'2" of running water observed.	5' Wide 20-30' Long	6'
F-12	Oval-shaped closed depression with soil sidewalls. Outcropped rock visible within the center of the depression.	12' Diameter	4'
F-13	Oval-shaped closed depression with soil sidewalls. Outcropped rock visible within the center of the depression.	16' Diameter	3'

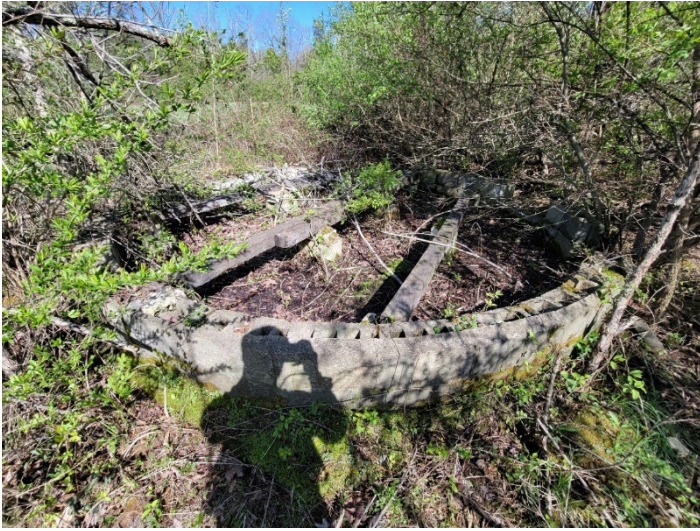
Photo 55 – View of remnant foundation

Several remnant structures were observed throughout the site, including an abandoned home, a remnant foundation, an abandoned well, an abandoned shed, and several piles of discarded rubble. Remnant structures were in close proximity to one another in the north-central cleared portion of the site. Several drainage swales were observed extending downslope on the western portion of the site (toward Cedar Creek). Swales ranged from 3 to 10 feet wide and were frequently observed to contain exposed apparent rock and moist soils. Four (4) existing springs were observed in the western portion of the site, approaching Cedar Creek. Springs were typically observed to contain 1 to 2 inches of running water that would subsequently flow downslope from the spring to form additional drainage swales.

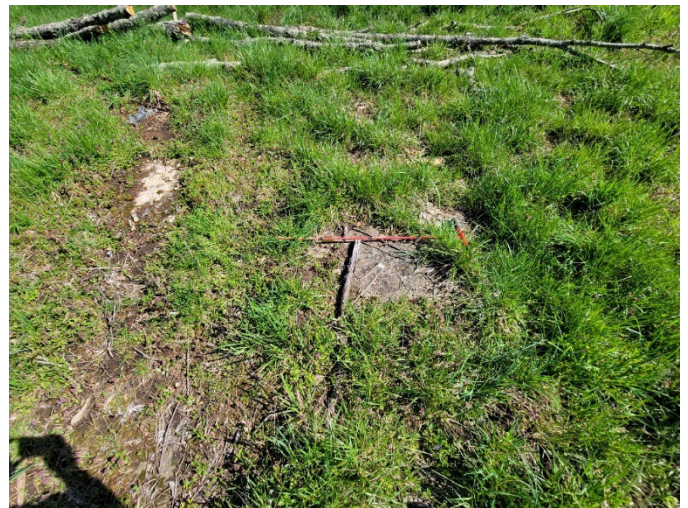
Photo 60 – View of outcropping near remnant structures

Rock outcroppings typically consisted of isolated boulders, gentle slopes, and/or flat, at-grade exposures of approximately 1 to 8 feet in height with defined jointing, fractures, and pitting. Outcroppings were typically observed in areas of steep relief (typically EL 580 to 600). Most outcroppings occurred along ridgelines running parallel to Cedar Creek. Boulder to cobble-sized rocks were observed at the base of most outcrops, and solution channels were observed within the exposed apparent rock faces. Fracturing of the upper geologic formations was also observed throughout the western wooded portion of the site. These fractures within apparent rock outcropping are typical in karst terrain.
