Fuller  
Mossbarger  
Scott &  
May

August 14, 1997

Re: Sinkhole Review  
Lots 21, 22, 23 and 28  
Blankenbaker Commerce Centre  
Jefferson County, Kentucky

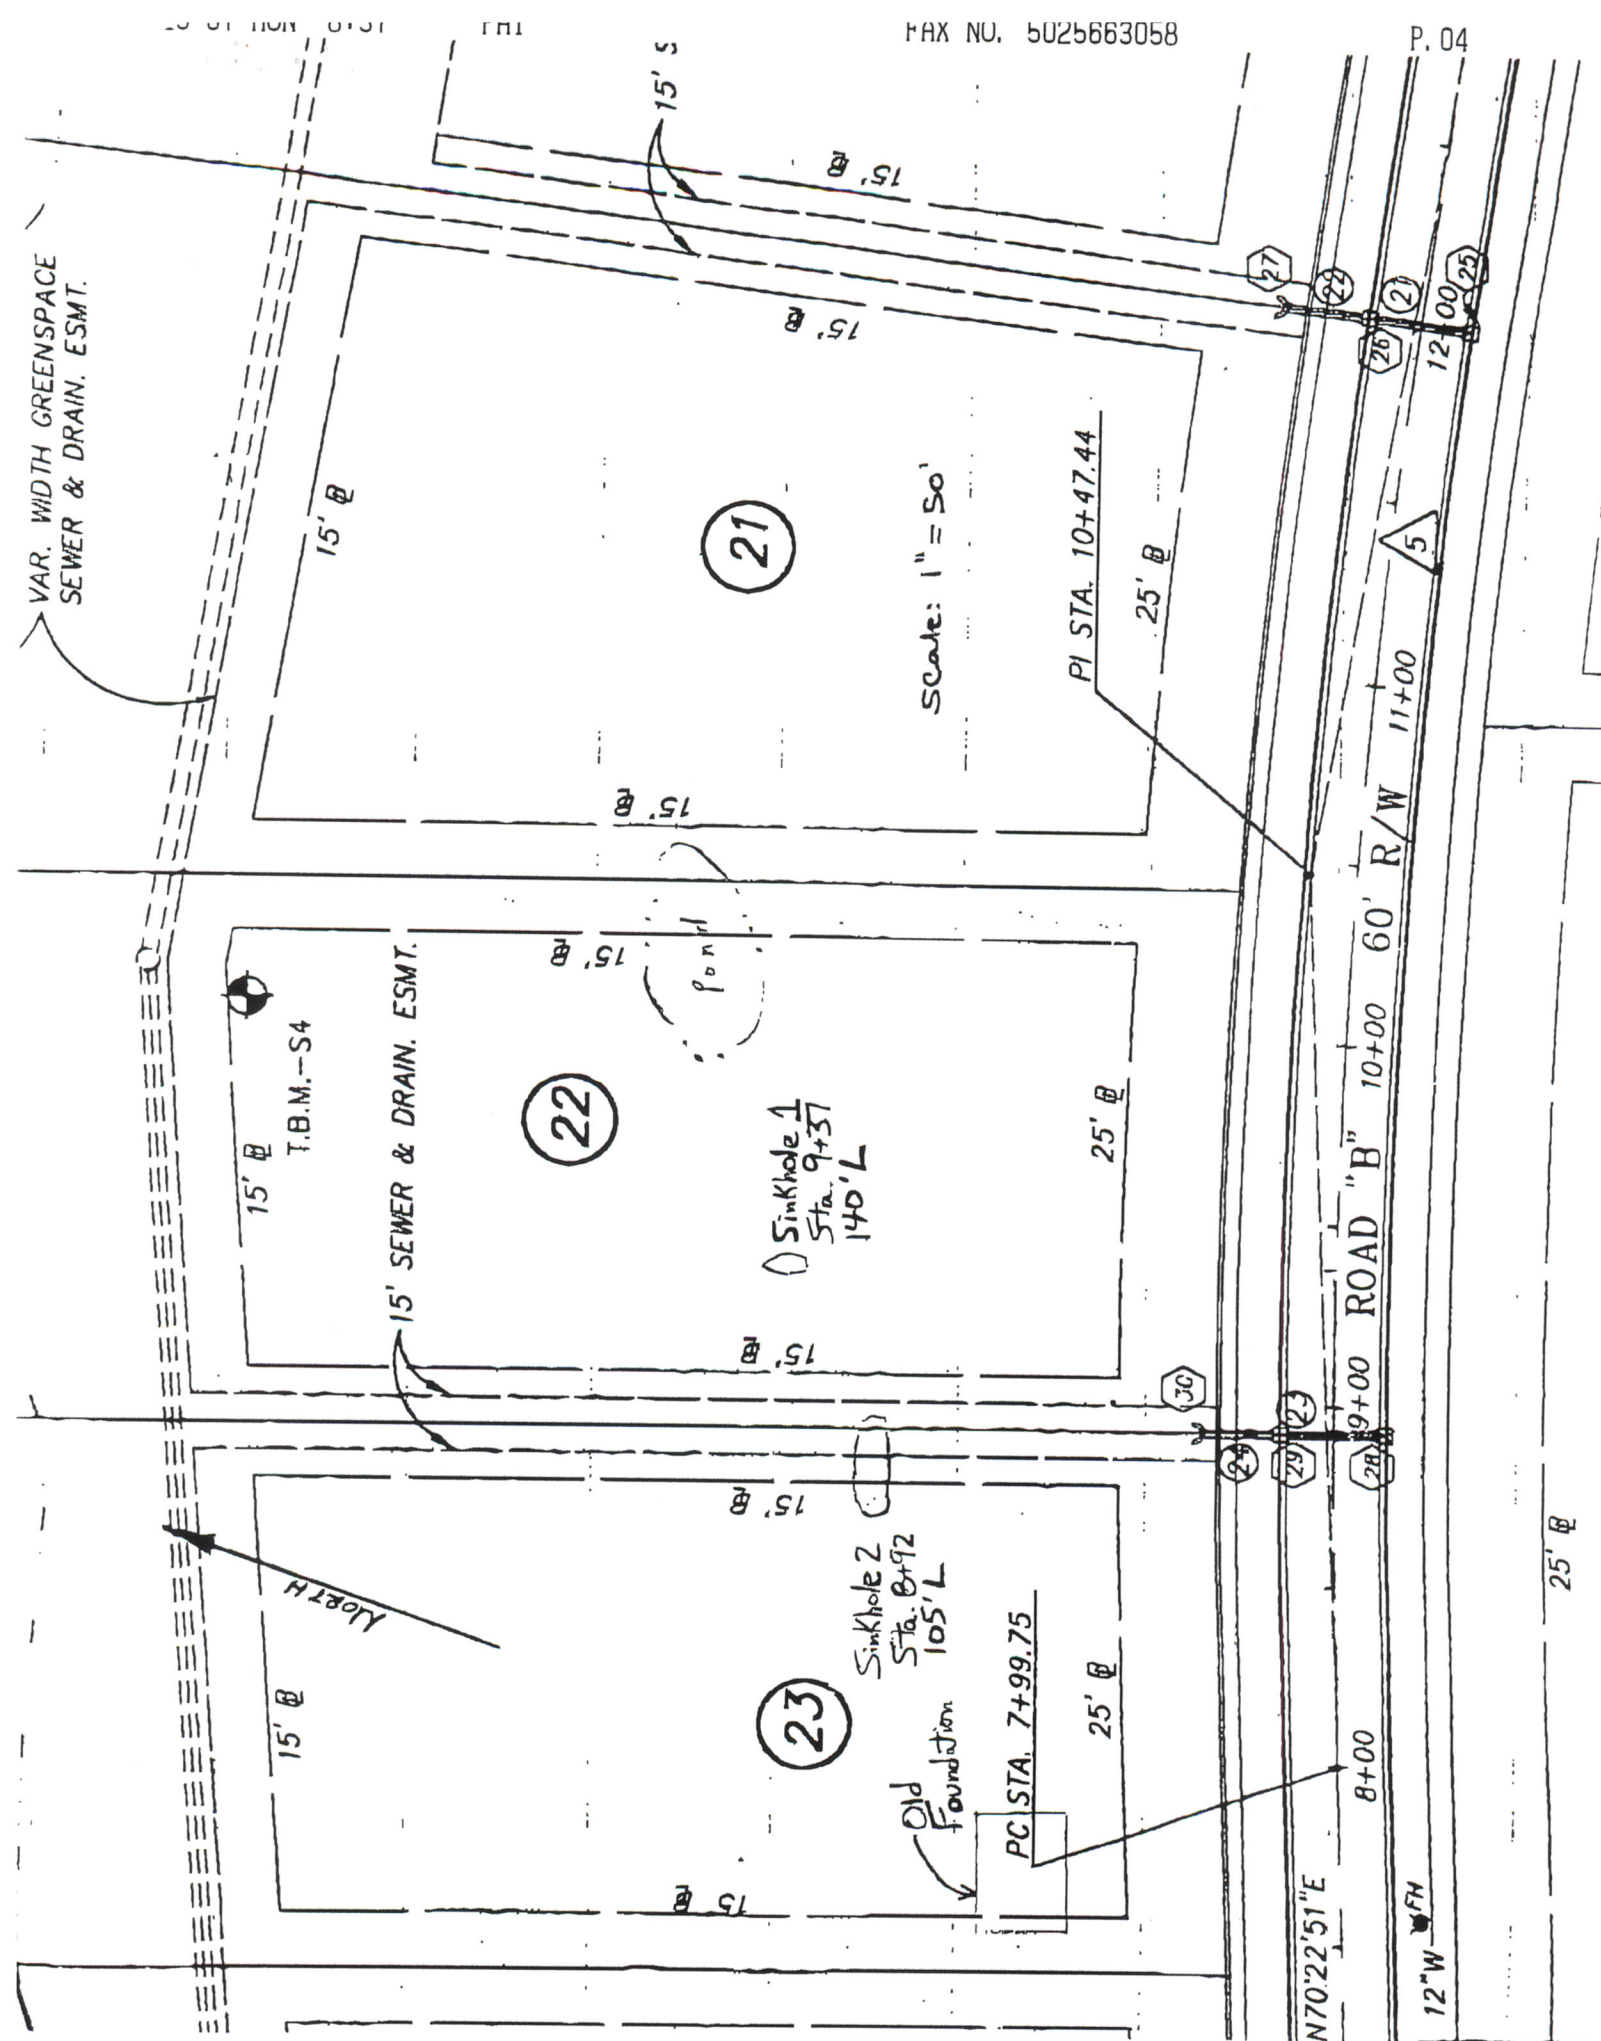
An approximate 10-foot by 10-foot by 4-foot deep excavation had been made to the rock surface. This sinkhole is labeled as Sinkhole 1 on the attached portion of the plan view drawing. It is located at the south-central area of the lot. A one to two-foot wide crevice was observed in the rock surface running in a north-south direction. On the north side of the excavation, the crevice had been cleaned to a depth of about three feet and was clay-filled below this depth. The crevice had not been cleaned on the south side of the excavation. Prior to any treatment, the excavation will need to be extended to the south to determine the limits of the crevice.

An approximate 10-foot by 20-foot by 5-foot deep excavation had been made to the rock surface. This sinkhole is labeled as Sinkhole 2 on the attached portion of the plan view. It is located at the extreme east side of the lot. The eastern half of this sinkhole is located in a 15-foot wide sewer and drainage easement, and it appears to extend just into Lot 22. An approximate six-inch wide crevice is present in the sinkhole running in an east-west direction. This crevice was probed and an open throat extended to a depth of five feet below the rock surface in several locations. This excavation will need to be extended to the east and west to define the limits of the crevice prior to treatment.

An approximate 25-foot diameter sinkhole (Sinkhole 3) about 2 to 3 feet deep was observed 80 to 90 feet east of the southwest corner of the lot. A tree is present in this sinkhole. No excavation had been performed and an open throat was not visible.

From a geotechnical standpoint, sewers, pavements and buildings should be sited to avoid sinkholes because of an increased risk for damage caused by any future ground collapses. However, this will probably not be possible because Sinkhole 1 is in the central portion of Lot 22<sup>22</sup> where pavement or a building will likely be placed, and Sinkholes 2 and 3 are in sewer and drainage easements. Therefore, these sinkholes will need to be treated to help prevent future collapse.

The method of treatment for the sinkholes will require that the rock surface be exposed to identify any voids or crevice features in the bedrock (the rock surface has already been exposed at Sinkholes 1 and 2). The voids or crevices should be cleaned and filled with No. 2 or 3 crushed stone up to the rock surface. Additional crushed stone wrapped in KDOH Type IV geotextile fabric would then be placed to provide a cap or a seal over the void or crevice. Normal fill placement can then take place to reach final grades. A Geotechnical Engineer should be present to review treatment of the sinkholes in conjunction with the proposed construction and grades so that any changes or adjustments can be made.
