# Landmarks Certificate of Appropriateness & Overlay District Permit

Project Name: MARTIN GARAGE

Project Address / Parcel ID: 1524 - 1530 So 2nd St ; 40208  
033D 0090 0000

Subject: 1524 S Second Street Garages  
Louisville, KY 40203

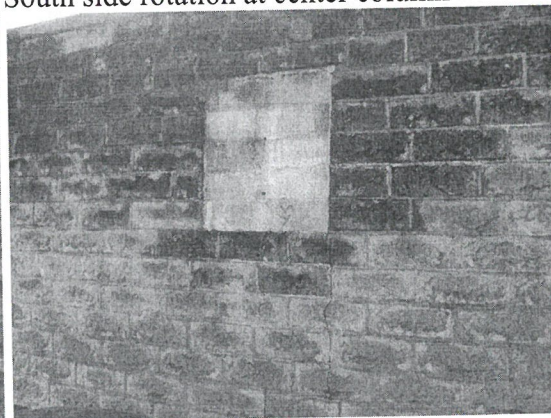
SE rear wall

1. The perimeter walls have various amounts of settlement which has caused stress cracking in the block. The most significant movement is at both sides. The movement is directly related to changes in moisture content of the soil at the footing level over the life of the structure. The likely shallow condition allows the changes to occur more readily. The walls are not considered unstable but have both vertical and lateral movements which have affected wall plumbness and caused cracking. The pictures indicate the most significant displacements noted in the building. The displacements affect the appearance which cannot be improved and require tuckpointing at numerous locations to close off the gaps at the mortar joints.

3. A membrane roof system is suggested over the concrete.
4. The cracked block and mortar joints in the walls can be tuckpointed both inside and outside. The crack repair will not repair the displacements that have occurred.
