## KARST RECONNAISSANCE SURVEY

HURSTBOURNE APARTMENTS DEVELOPMENT  
LOUISVILLE, KENTUCKY

SME Project No. 088601.00  
March 7, 2022

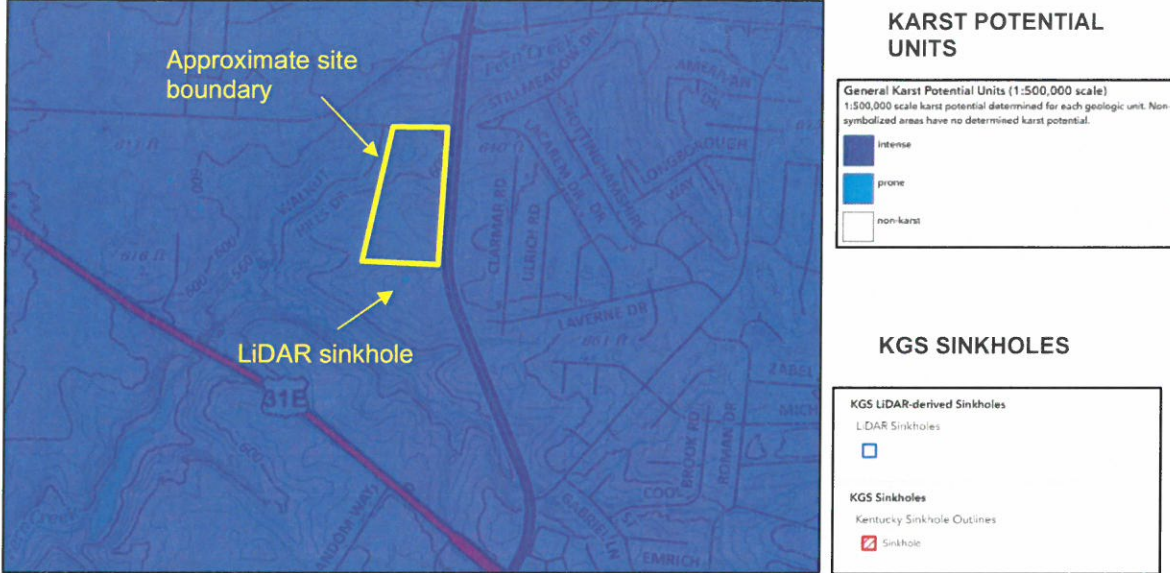
**FIGURE 6 - KARST POTENTIAL MAP <sup>(1)</sup>**

Our review of the referenced geological literature (including the KGS Karst Potential Map – see below) indicates the presence of a singular sinkhole as identified by LiDAR (represented by blue outline) directly adjacent to the southern parcel border. Older, well-defined sinkholes are defined by a red-hashed zone. However, the KGS map is a generalized tool for identifying sinkhole features and should not be considered as a suitable replacement for “boots on the ground” site evaluation.
