100 Distillery Commons

Owner Presentation in Opposition to Local Landmark Designation

12/17/2020

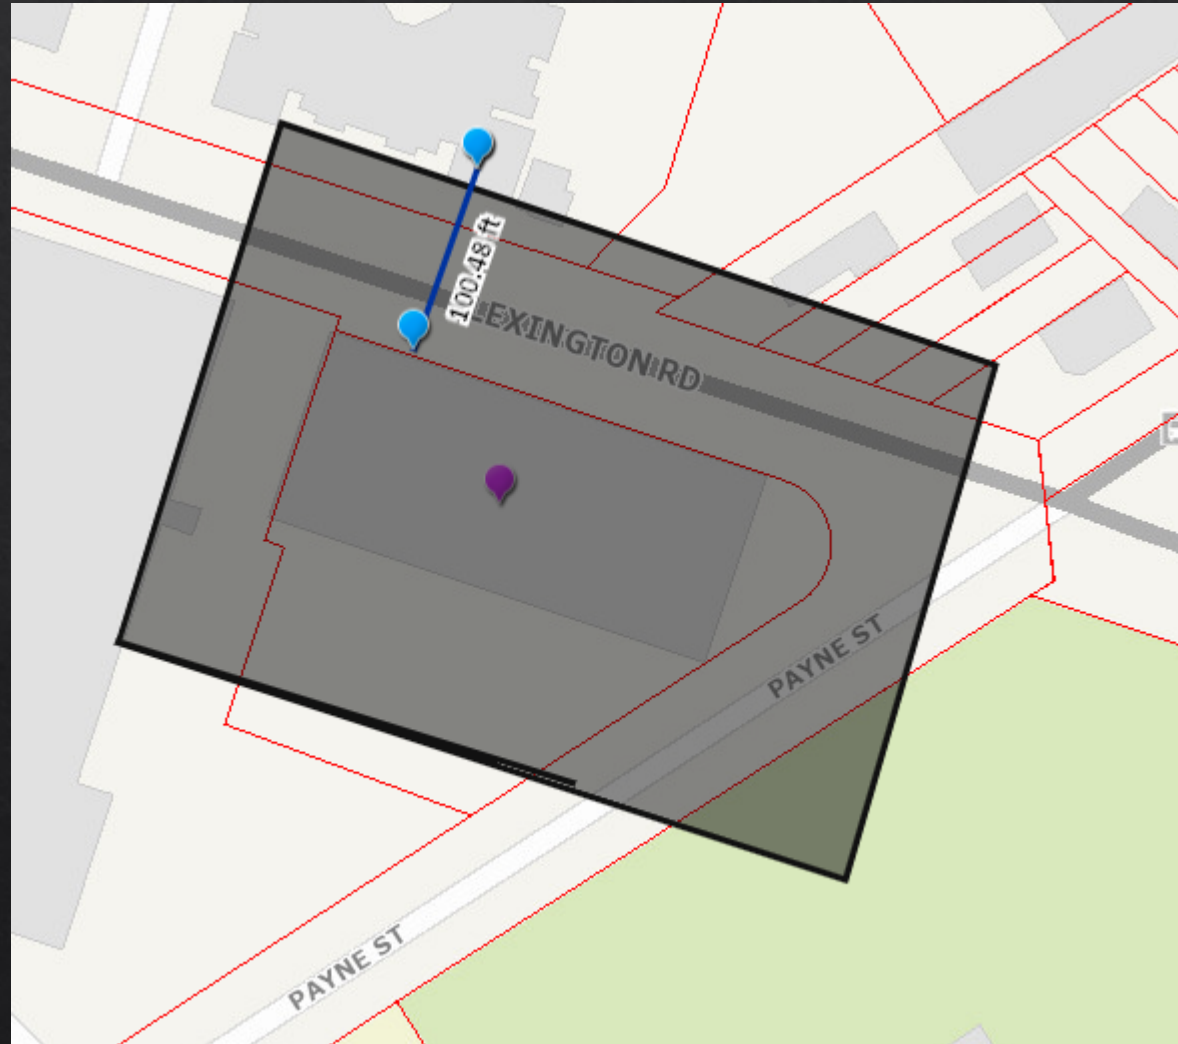
100' Distance Crosses Several Property Lines

430.5 Building location on property. The following *fire separation distances* shall be maintained between the barreled spirit storage buildings and any other buildings on the property and to the opposite edge of a street, alley or other public way or property line.

1. Non-sprinkled rack supported structures shall have a minimum separation distance of 200 feet.
2. Sprinkled pallet storage and sprinkled rack supported structures shall have a minimum separation distance of 100 feet.
