Subject: Geotechnical Slope Evaluation Report
Proposed Echo Trail Subdivision
2605 Echo Trail, Eastwood Fisherville Road
Louisville, Kentucky 40245
ECS Project No. 61-1893

Subject: Geotechnical Slope Evaluation Report – Addendum 1
Proposed Echo Trail Subdivision
2605 Echo Trail, Eastwood Fisherville Road
Louisville, Kentucky 40245
ECS Project No. 61-1893

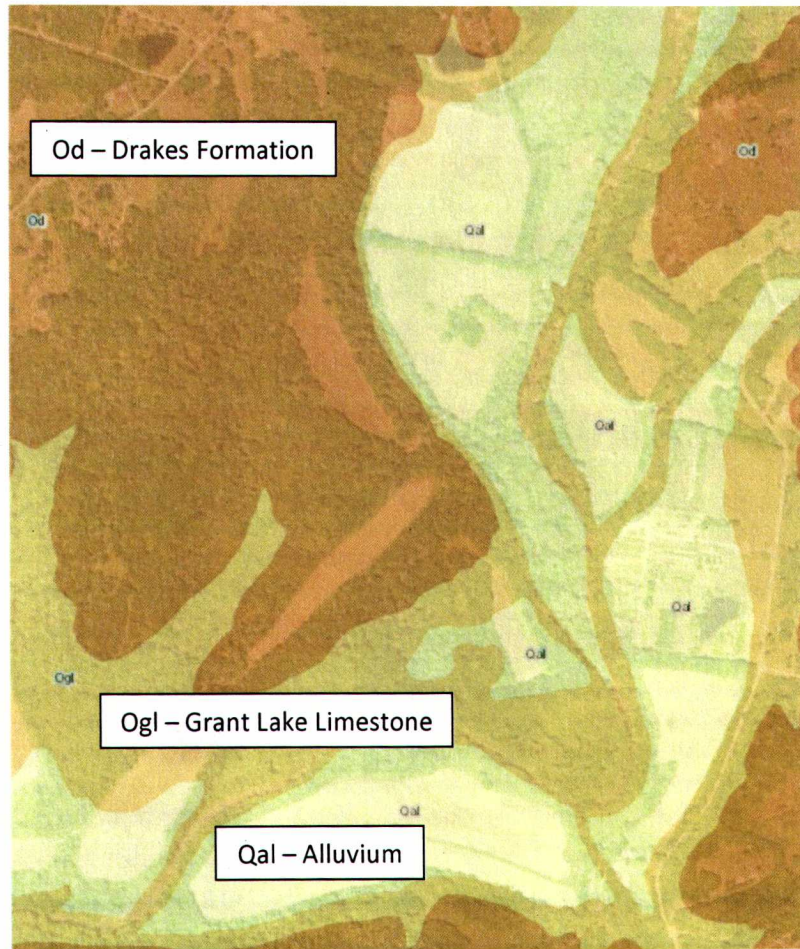
Figure 1: Reported Site Geology

The "Geologic Map of the Fisherville Quadrangle, Jefferson County, Kentucky" published by the U. S. Geological Survey and shown on the Kentucky Geologic Map Information Service indicated that the majority of the proposed development area (roughly above ~EL 620) was underlain by the Drakes Formation. The lower slopes were underlain by Grant Lake Limestone (roughly ~EL 580 to ~EL 620), with the remainder of the site mantled by alluvium (roughly below ~EL 580). The mapped extent of the bedrock formations is shown on Figure 1.

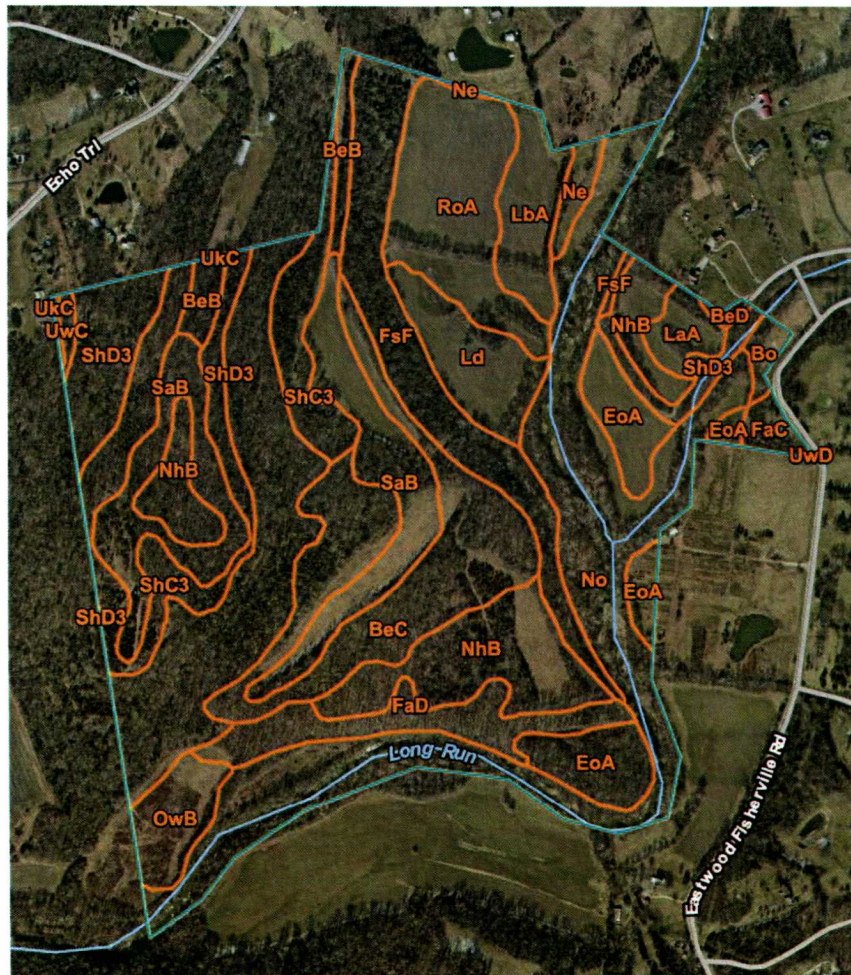
Figure 2: Reported Soil Data

The USDA Natural Resources Conservation Service "Web Soil Survey" website indicated 22 general soil types at the site as shown in Figure 2. Descriptions of these soil types are summarized below.

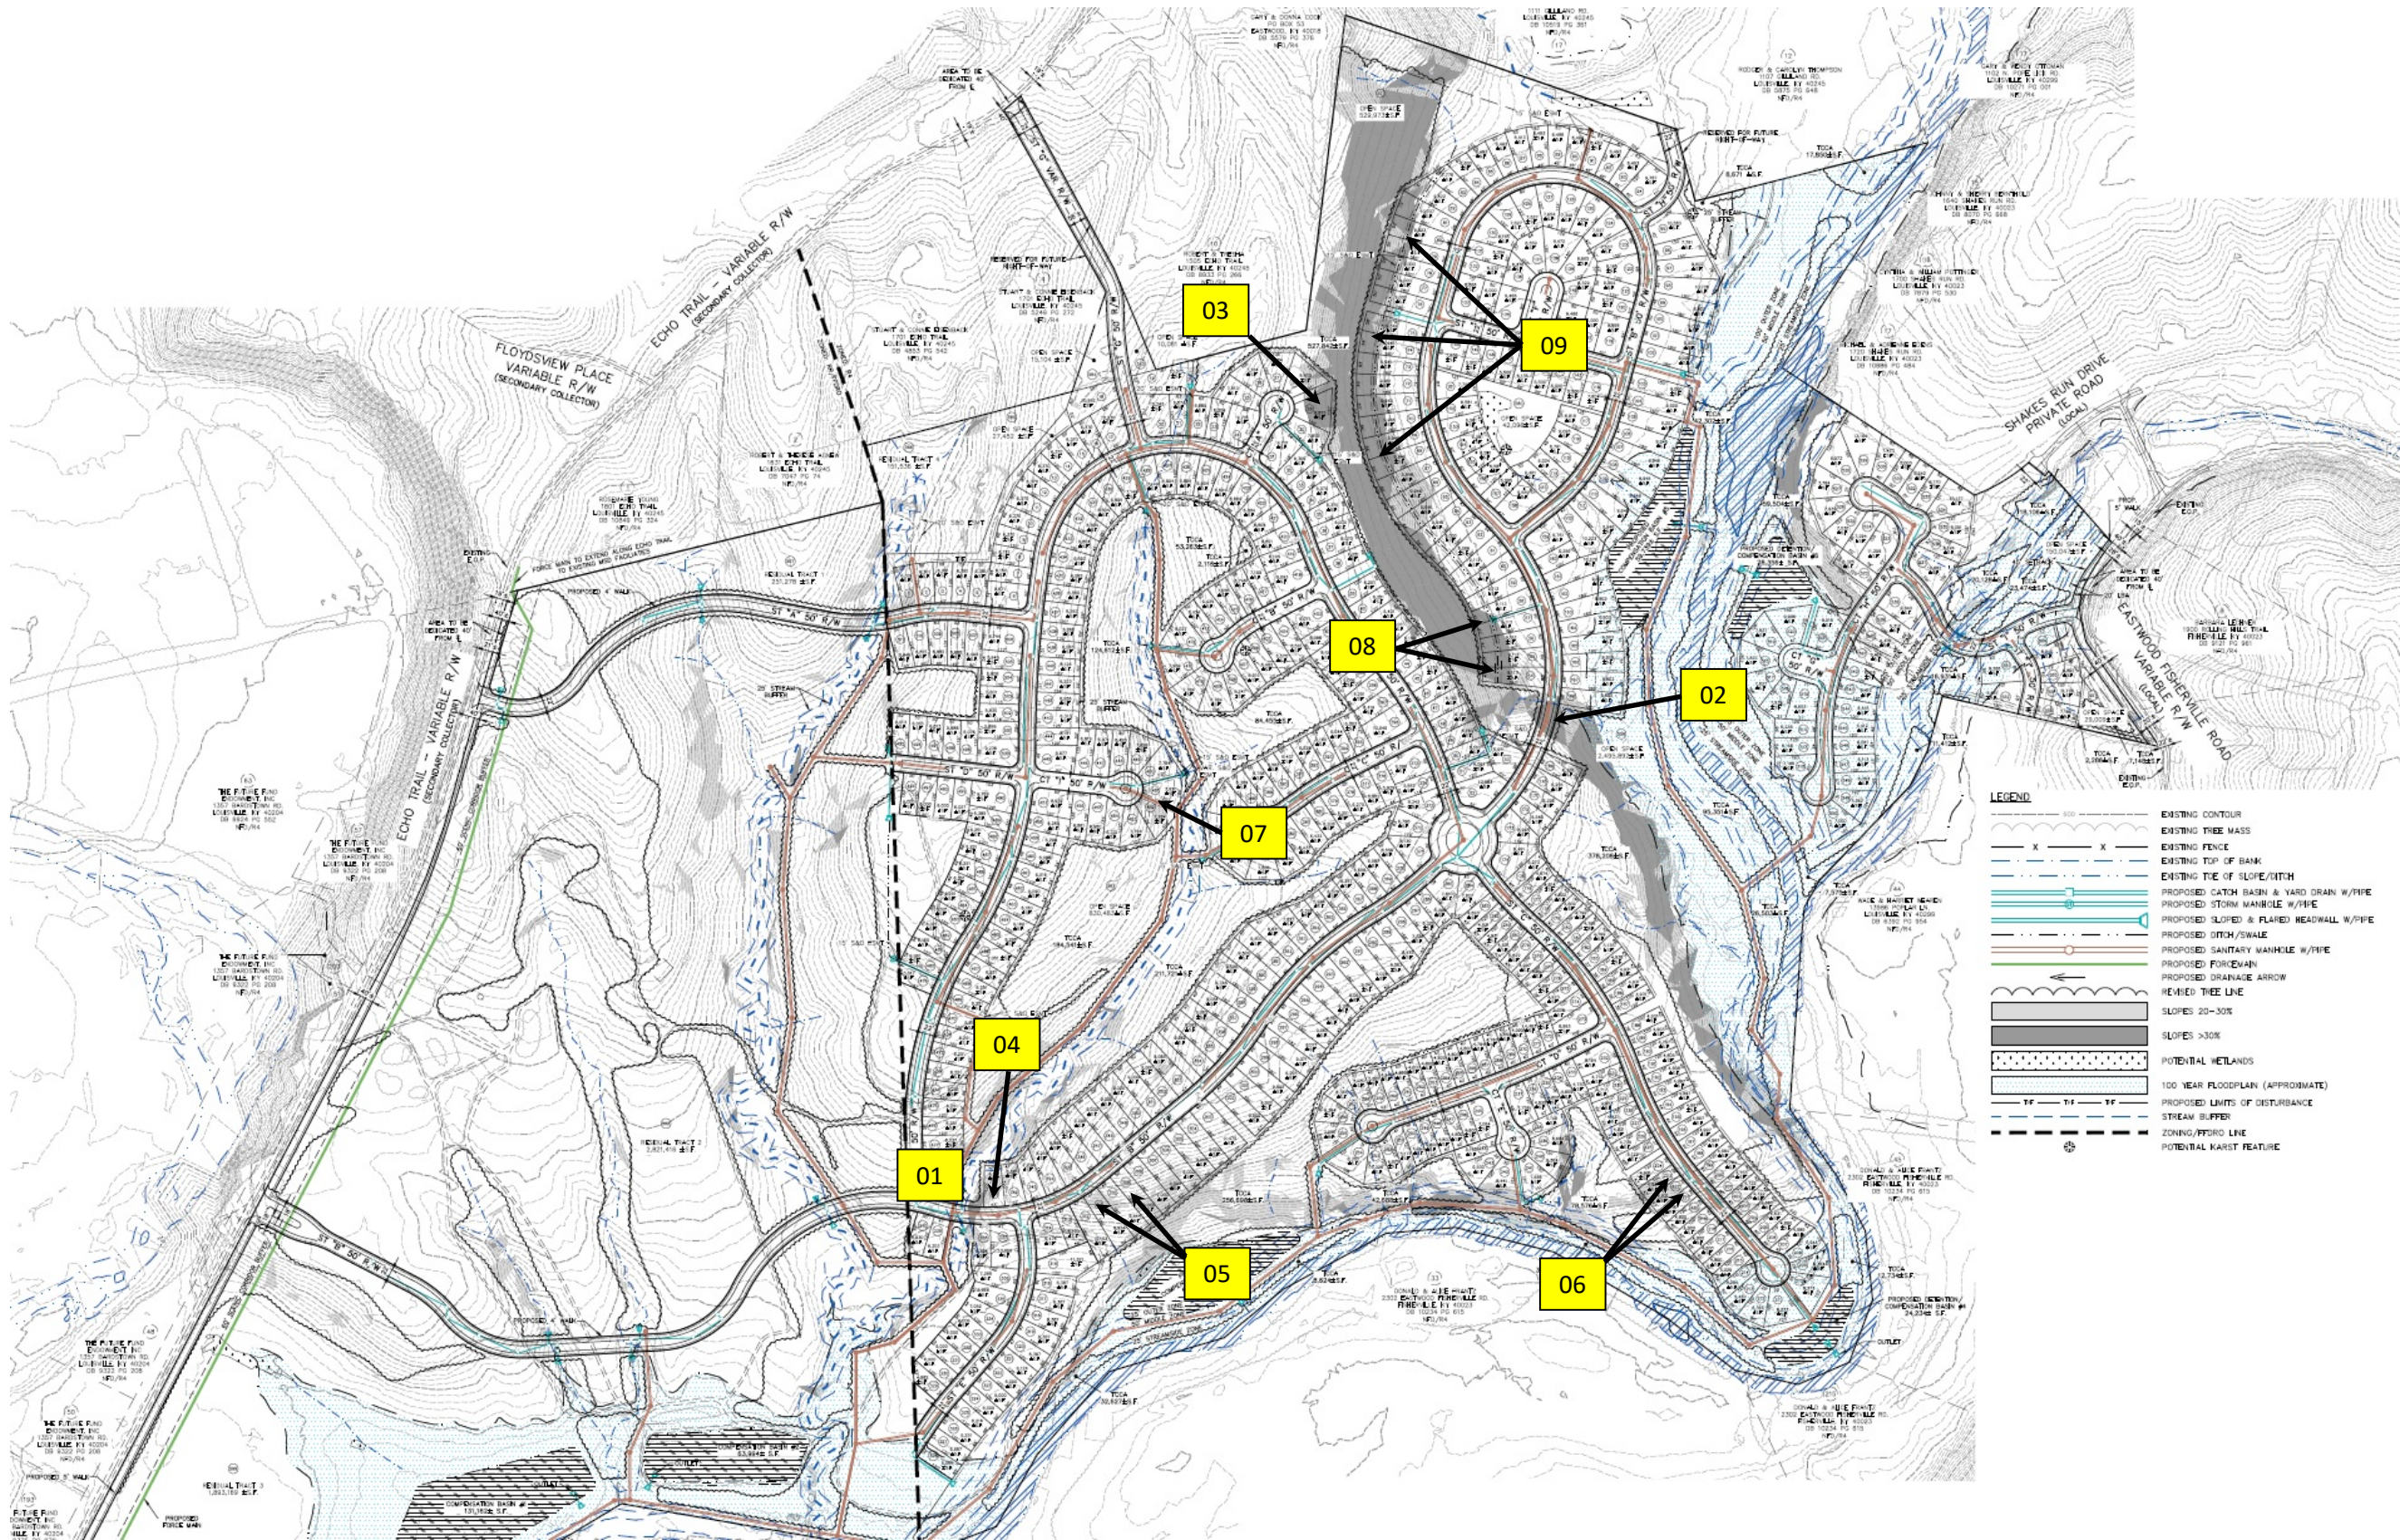
Visual Slope Reconnaissance Plan
 Proposed Echo Trail Subdivision
 2605 Echo Trail
 Louisville, Kentucky 40245
 ECS Project No. 61-1893

Three areas shown on the Plan as >30% slopes would be disturbed during site development for new road construction (Area 01 and 02) and new home construction (Area 03 / Lot 29). See attached Visual Slope Reconnaissance Plan for approximate locations. A visual reconnaissance of these areas was conducted on December 19, 2018. Photos of the conditions observed at these areas are shown below. Similar conditions were observed in most areas. The slopes primarily were wooded with many small to large trees. Brush, vines, and other low vegetation also was present. No rock outcrops were observed along hillsides with the exception of occasional, small, isolated cobbles and boulders. Flag stones were observed along the bottom and banks of swales and small streams. Some indications of erosion were observed including occasional patches of bare soil and small gullies, primarily along the swales and small streams. No indications of large, wide-scale scale erosion were noted. No visual indications of slope instability were observed. In particular, none of the following were noted: unusual tilting or fallen trees, tension cracks, scarps, displaced soil, or mounds of soil in lower areas.
