RE: Hogan's Fountain Teepee Pavilion, Cherokee Park

## Memo

**Re.** Cherokee Park Hogan's Fountain Pavilion

**Subject:** Cherokee Park, Hogan's Fountain Teepee Pavilion Reassessment

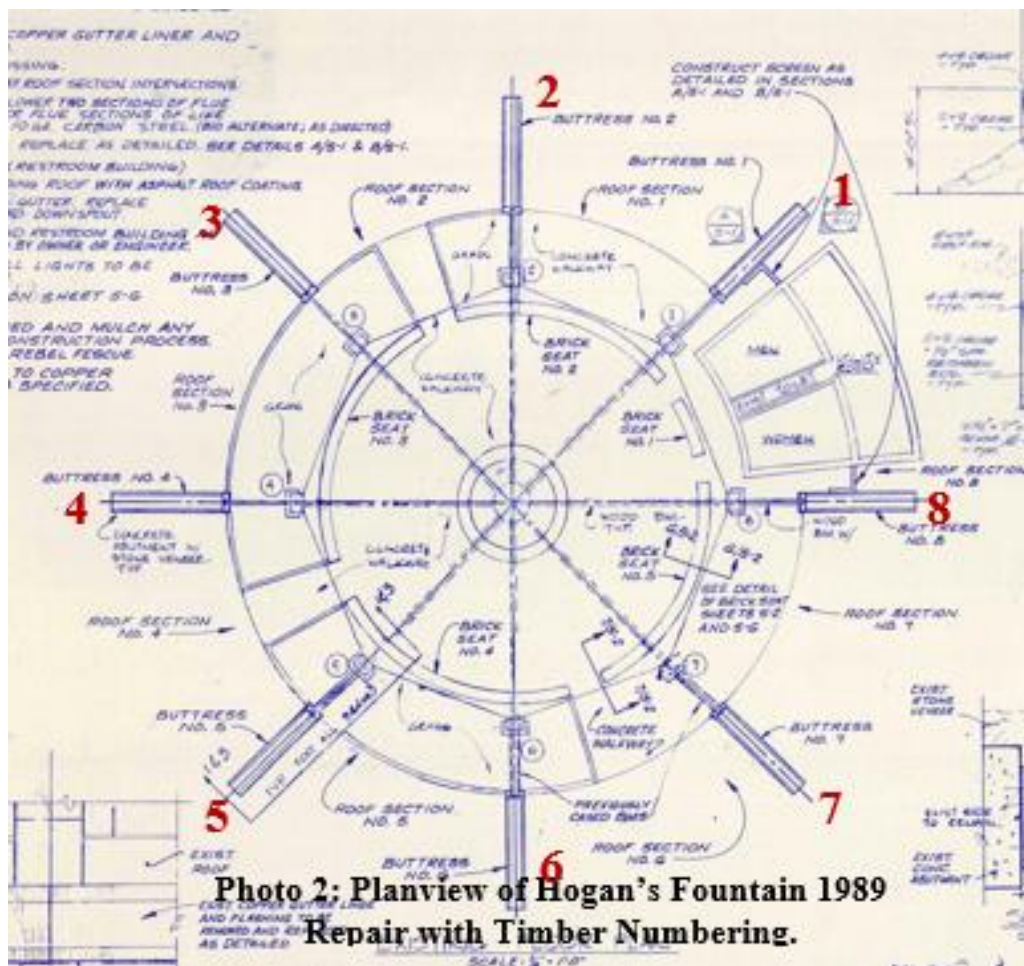
**Photo 1: Hogan's Fountain- Eight timbered legs encased in  $\frac{1}{2}$ " steel.**

throughout. Due to the recent movement of the structural timbers, Wood was requested to evaluate the condition of the encased timbers and to determine if the timbers have experienced deterioration. Wood hired subcontractor, Concrete Coring & Cutting, to drill 2-inch diameter holes in the  $\frac{1}{2}$ -inch steel casing to evaluate the wood condition. The following provides a brief overview of our results. For this evaluation, Wood used the same naming nomenclature used on the 1989 plans.

Based on our evaluation, the wood encased in the steel has experienced severe deterioration and therefore is not structurally sound. Repair options should not utilize this section of wood as a structural component. In addition, in several areas, the wood above the steel is showing signs of distress (delamination, darkening of the wood from possible water damage, etc.).

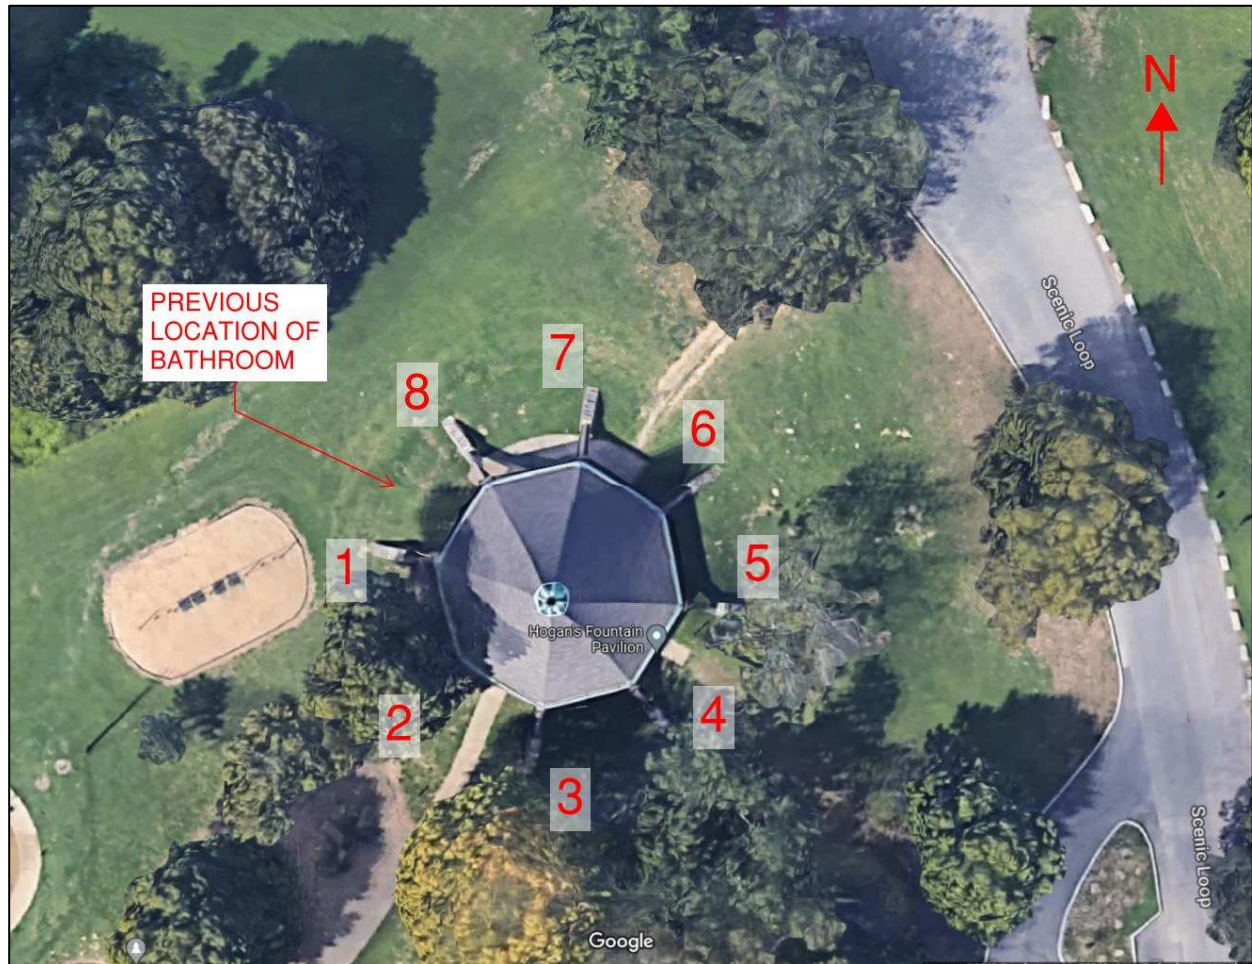
**Photo 1: Pavilion and Beam Orientation**

On August 17, 2022, Scott Jenkins and Jason Burkett met with Dave Wilding at the pavilion to review the current condition, look inside the 2-inch diameter viewports on the steel casings, and compare these findings with our original assessment on May 10, 2022. Our previous letter, dated May 12, 2022, should be referenced for additional information and the history of the pavilion. The location of each glue laminated support beam has been identified in **Photo 1**, to correspond with the original repair drawings.
