# Landmarks Certificate of Appropriateness & Overlay District Permit

Project Name: Demo 1310 S. Floyd St.

## STRUCTURAL ASSESSMENT REPORT

**Location:** 1310 South Floyd Street  
Louisville, KY 40208

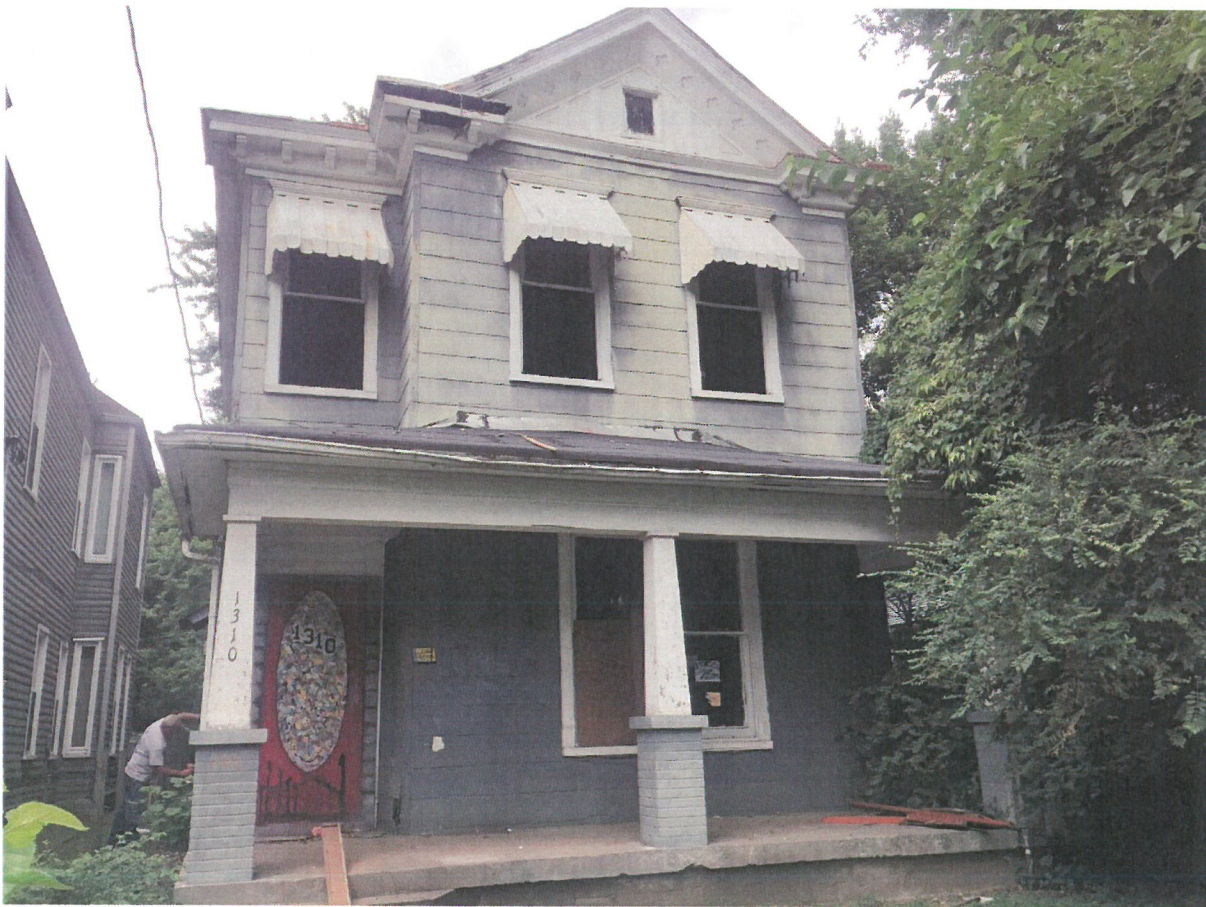
1. The home was an abandoned wood-framed structure with painted siding. The home was balloon-framed.
2. Almost all of the windows were either entirely removed or mostly removed/broken.

3. Only limited areas of the home were entered due to the amount of deterioration in the wall and floor framing.
4. The rear wall of the 1<sup>st</sup> Floor was found to have insufficient support of the 2<sup>nd</sup> Floor across the entire home. The right side had been shored at some point with a temporary wall and plywood sheathing.

5. The foundation walls consisted of multi-wythe brick masonry walls. The tops of some of the walls were visible due to the past removal of the floor boards on the 1<sup>st</sup> Floor. In many areas where the foundations were visible, the top courses of the masonry appeared to be loose and missing mortar in the joints.

6. A significant amount of the 1<sup>st</sup> Floor joist framing had deteriorated ends along the perimeter walls due to water intrusion and termite damage. The deterioration of many joists was so severe that several feet of the end of the joists was missing.

7. The sole plate and bottoms of the wall studs were severely deteriorated or missing entirely due to water intrusion and termite damage in many areas throughout the structure. Some of these areas encompassed most if not all of the length of the wall and many of these walls were load bearing walls. These areas were also observed on the 2<sup>nd</sup> Floor.

8. The siding in these deteriorated wall areas was severely deteriorated as well.
9. Several additions appeared to have been constructed on the rear of the home at various times. Most of these additions had either been demolished or were in extreme disrepair.

3. In order to rehabilitate this home, the entire structural system would need to be replaced from the inside out.
4. Extensive shoring would need to be installed to prevent accidental collapse of almost any area of the home during the reframing process to keep the construction workers safe. This shoring would certainly pose a problem with reframing efforts as the shoring structures would be in the way of placing the various new framing members.

5. After all of the work is completed in the reframing of the house, the foundation would need to be pointed at the least and most likely rebuilt in many areas.
