**REPORT OF KARST FEATURE SURVEY**

**PROPOSED BALL HOMES DEVELOPMENT  
ST. JOSEPH ORPHANAGE SITE  
FACTORY LANE  
LOUISVILLE, JEFFERSON COUNTY, KENTUCKY**

**CARDNO ATC PROJECT NO. Z027000112**

**JUNE 4, 2015**

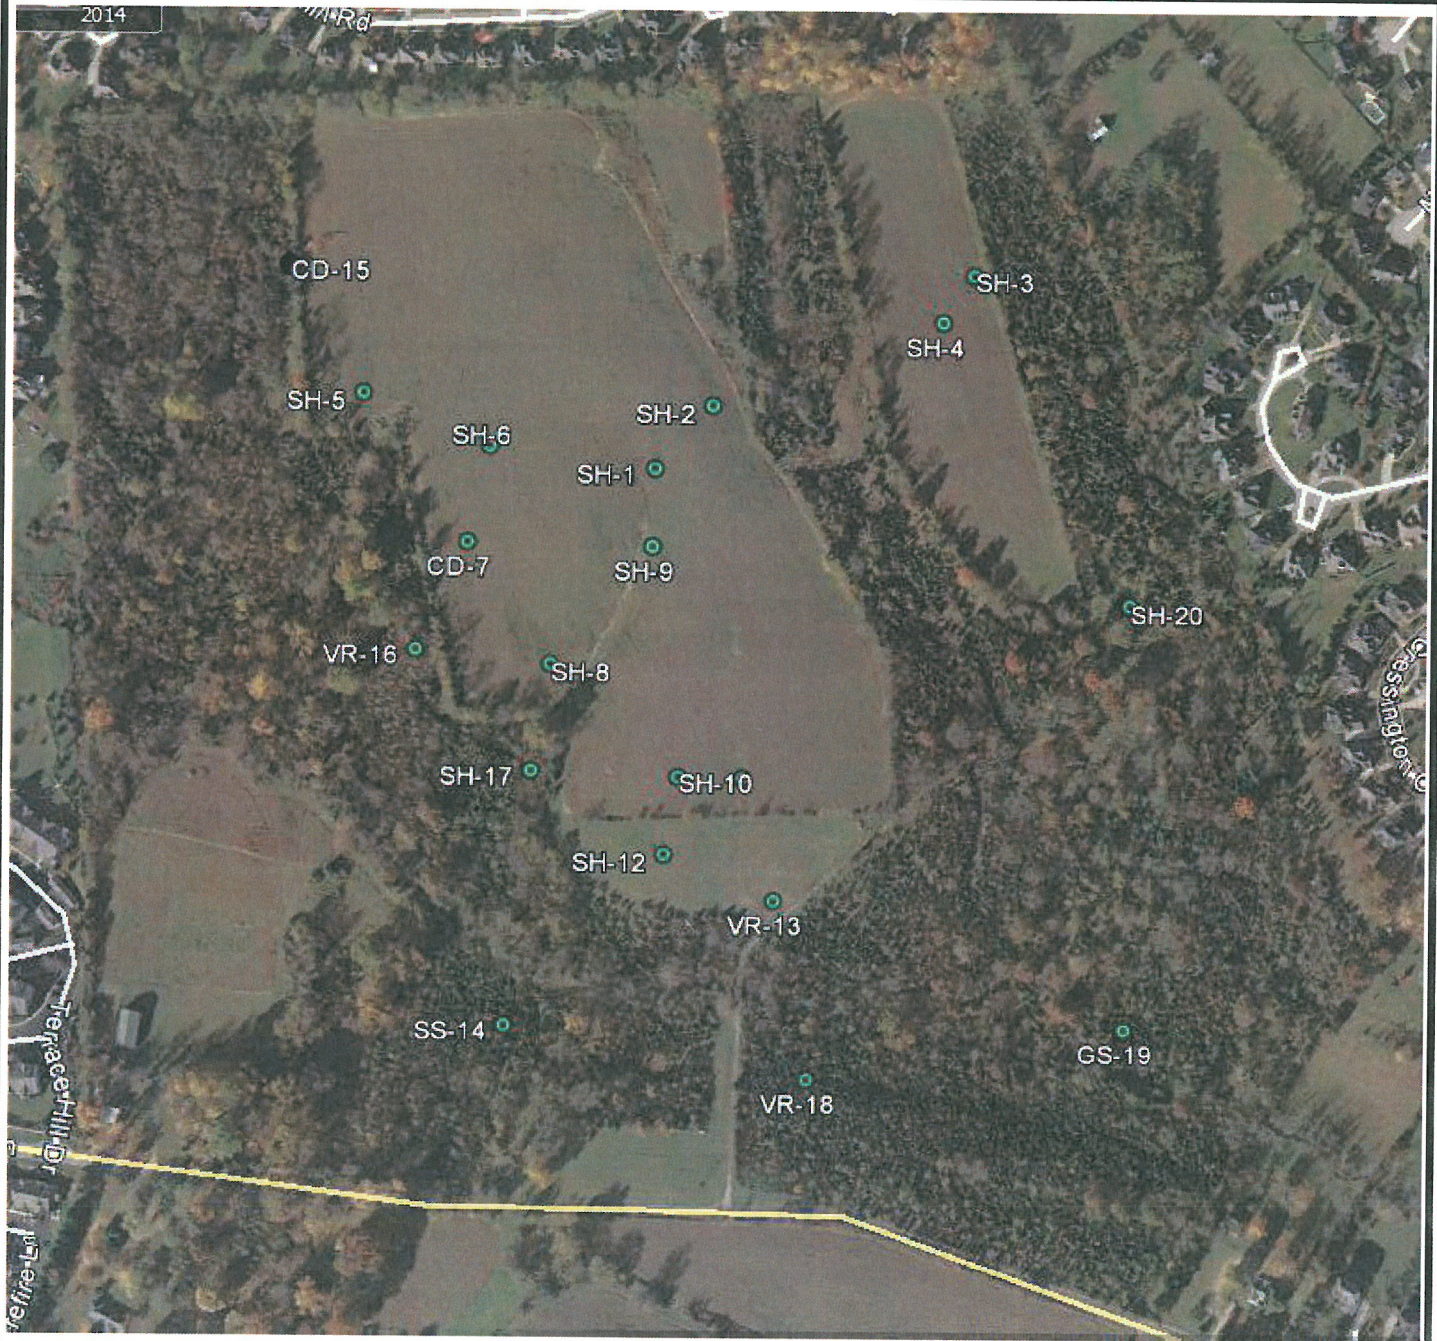
## KARST FEATURE LOCATION PLAN

Several common indicators of Karst activity such as springs, sinking streams, sinkholes, closed contour depressions, and vuggy rock outcrops were observed during our site reconnaissance. These features appeared concentrated near and along the alignments of the two small drainage swales and perennial stream noted above, on the west and southern halves of the property. Additional features were noted near and along the alignment of the large drainage swales noted previously, on the east half of the property. None of these swales were observed to have flowing water and may be associated with Karstic features in the underlying rock units. Subsurface conditions in the area of observed karst features likely have a ground water table influenced by an internal “plumbing” system in the rock. Surface water collected by closed depressions and sinkholes is often routed internally through discontinuities in the underlying limestone toward seeps and springs. Springs and seeps are common and typically flow when perched water sources daylight in drainage swales, creek corridors, and tributaries. Flow may be intermittent depending on the weather. Observed features were generally of small horizontal dimension and depth. Several features appear to have been addressed either by the previous owner or farmer in an effort to control further erosion by the addition of large gravel to the feature. These features are designated as Feature numbers 1 to 20 in the Geologic Feature Reconnaissance Table and Karst Feature Location Map provided in the Appendix.

We recommend all solution features noted on the property in this report or discovered during site earthwork operations be located by surveying methods and flagged in the field. Features with a defined throat should be repaired individually as described below. The features with no discernible throat should be stripped of topsoil and vegetation. The exposed subgrade in the closed depression should then be proofrolled in the presence of the geotechnical engineer to locate areas of soft, wet soil or incipient dropouts. Proofrolling should be performed using a loaded dump truck, or similar equipment judged acceptable by the geotechnical engineer, after a suitable period of dry weather to avoid degrading the subgrade. Normally, two to four passes over each section with the proofrolling equipment is required.
