# Demolition Request

## 2130 New Main Street

# Objective: Urban Greenspace 2130 New Main Street

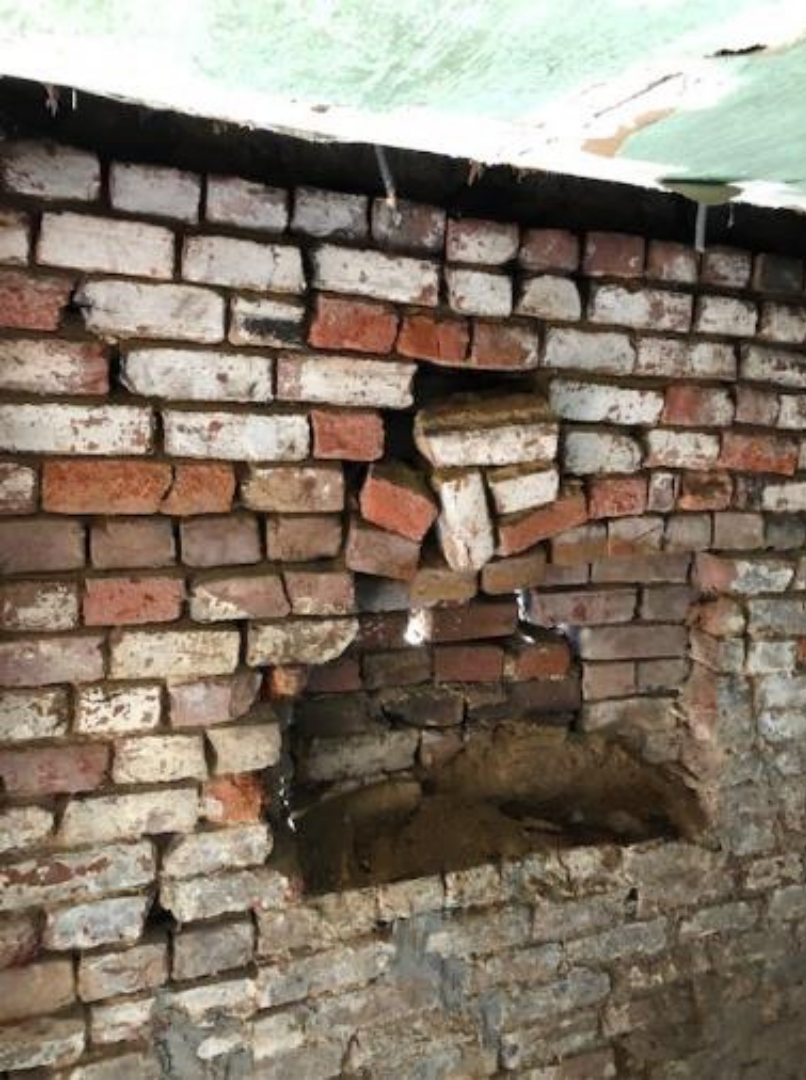
The structural engineer elaborated on the brick foundation walls.

“The sandy nature of this concrete is indicative of the type of low strength concrete hand mixed onsite that was used to construct the foundation walls of this building. Our conclusion regarding the concrete used is that it was an uncontrolled mix, likely made with unwashed river gravel and sand without the benefit of mix control. These conditions normally result in weak concrete that will deteriorate quickly when exposed to weather and stress loading.” (page 3, #5)

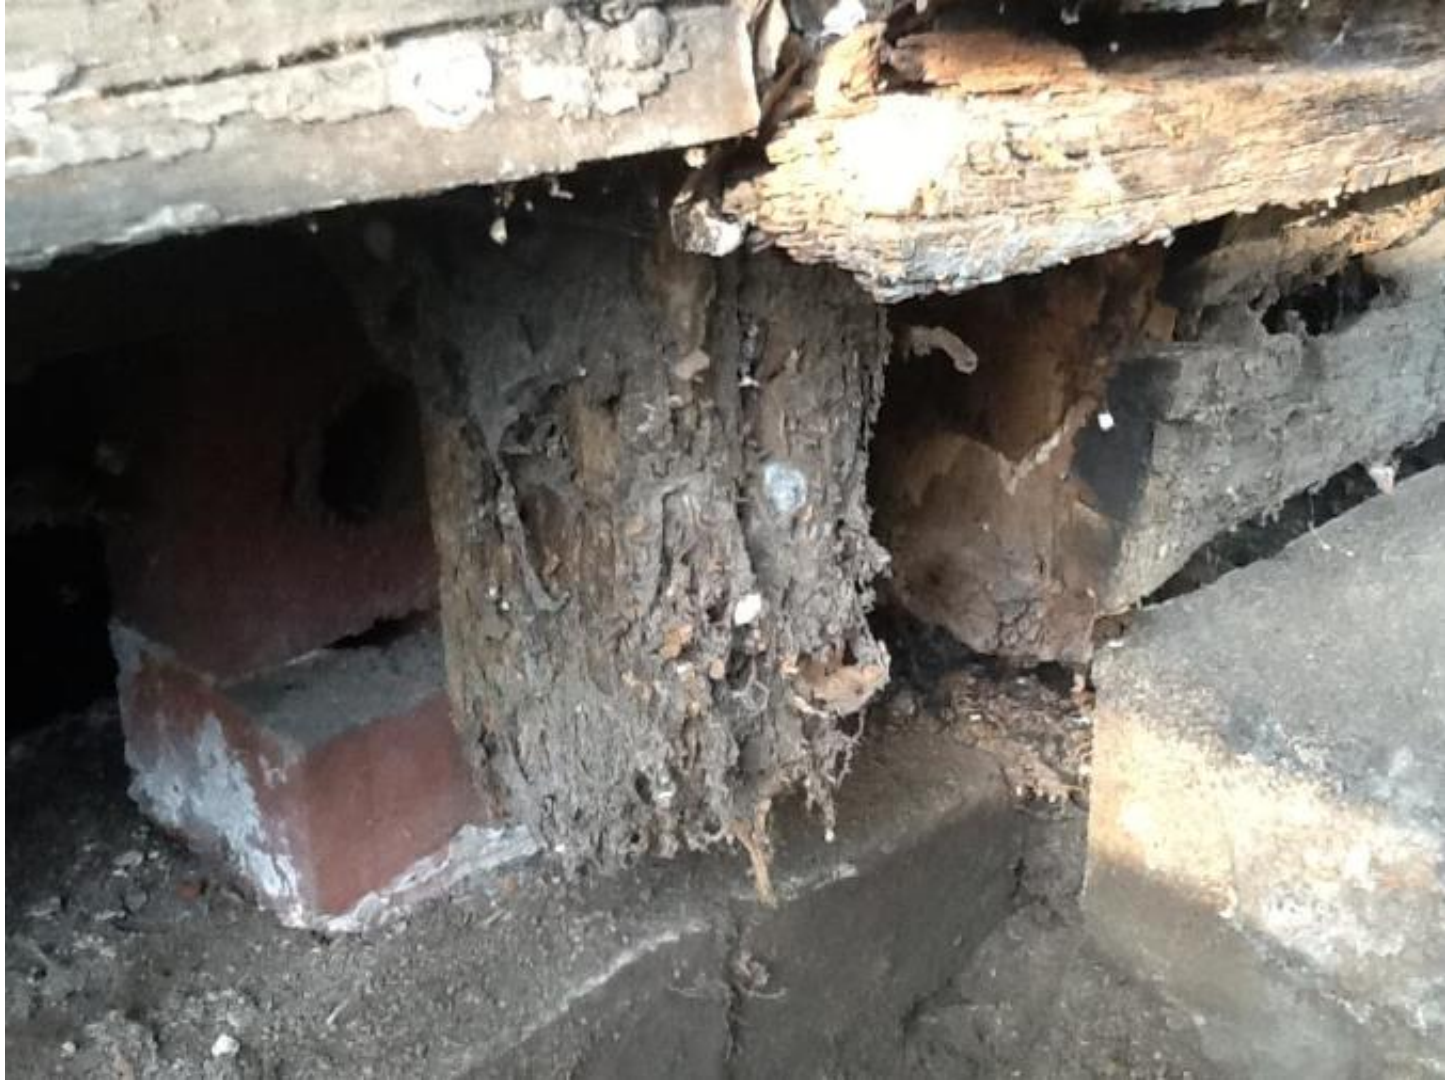
Early 2019

The same stud. The bricks behind the stud are holding up the floor joists. The neglect of the structure clearly pre-dates 2019.

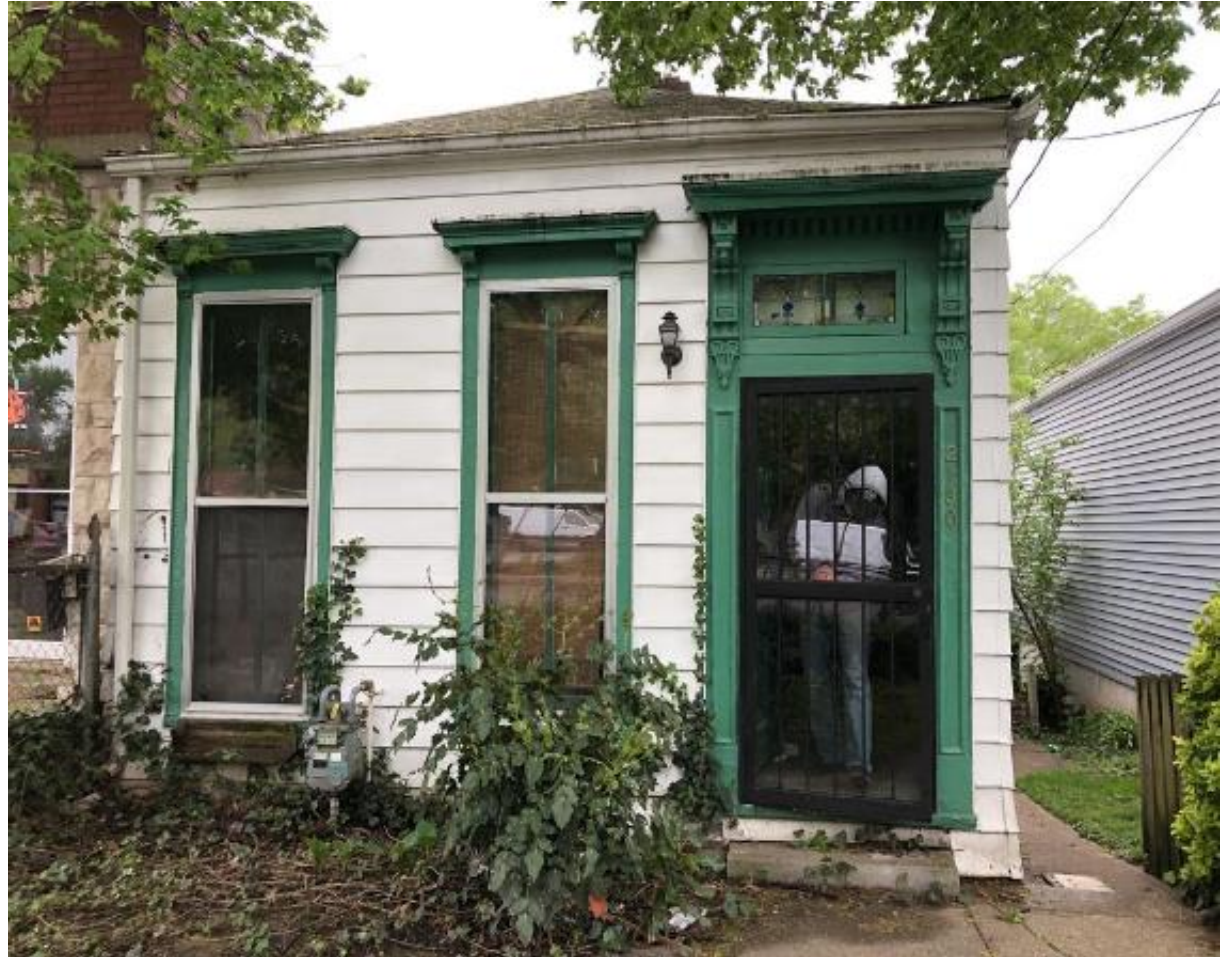
A closer view for comparison between the height of the window sill and the threshold of the USPO door. The latter is a foot higher.

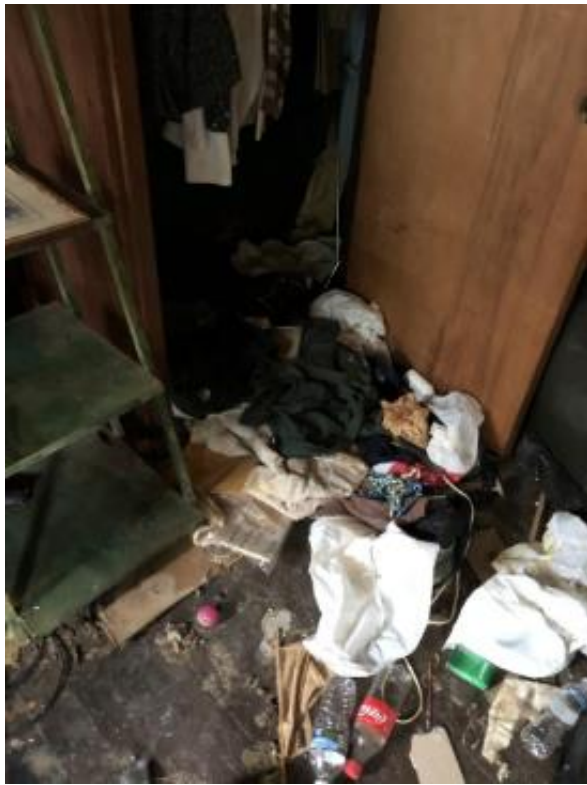
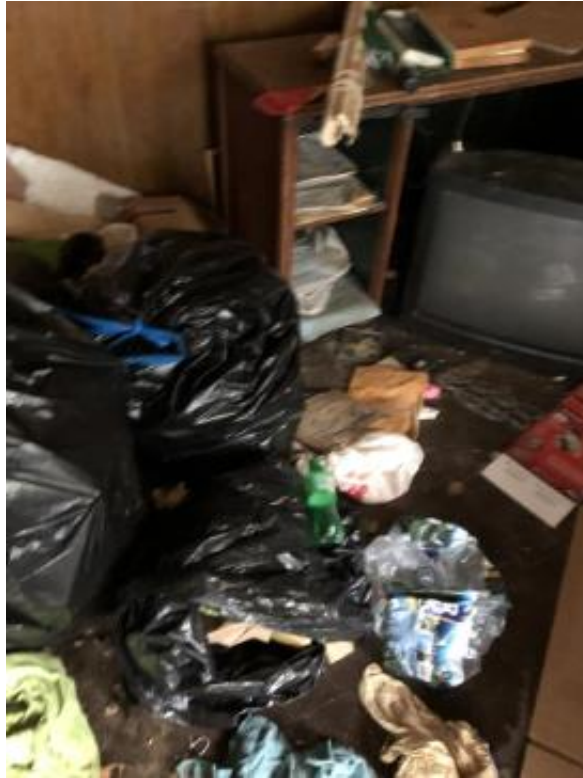
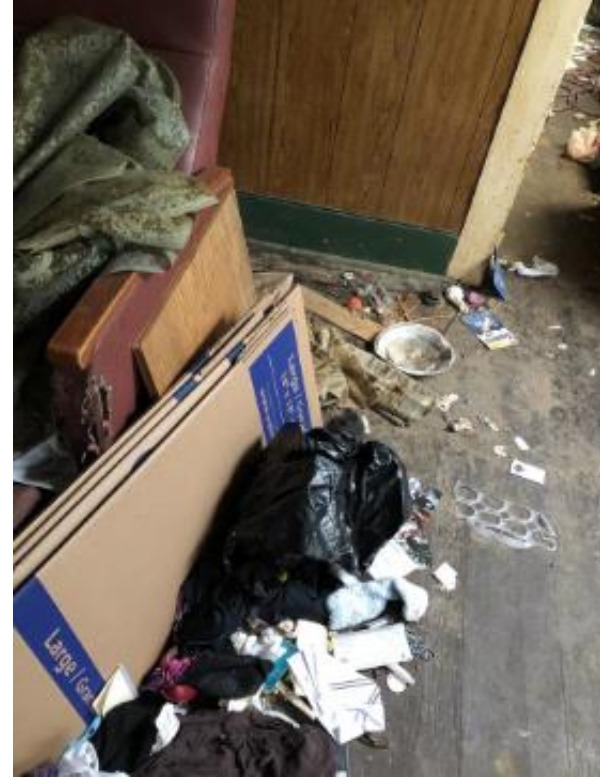
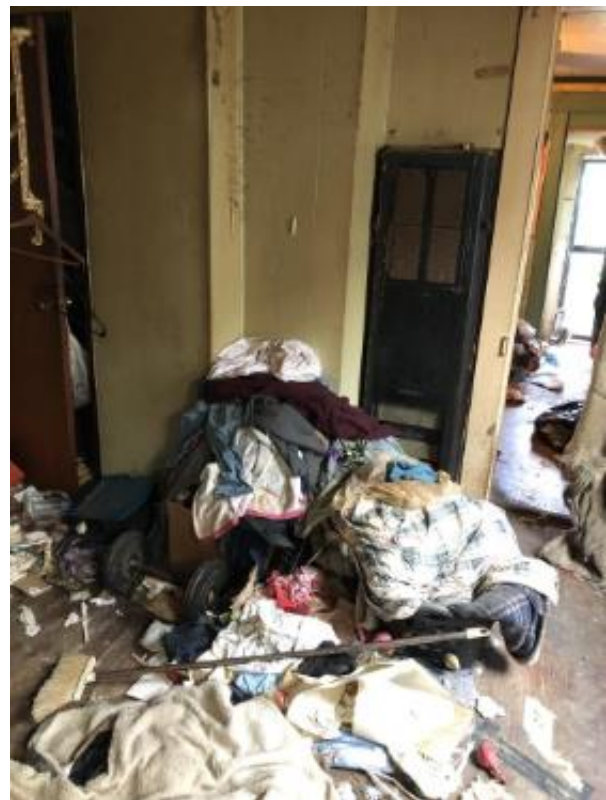
Second Bedroom

Still in the second bedroom.

Beyond the quilt nailed over the doorway is the kitchen.

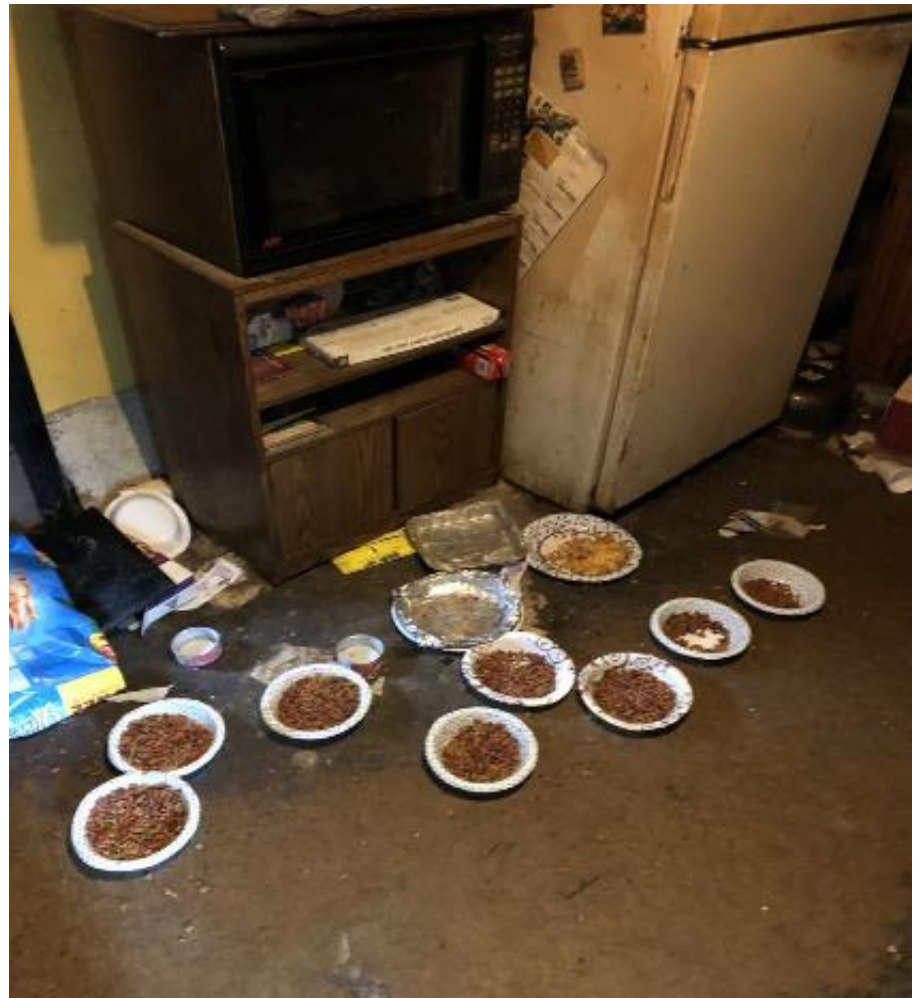
Every room was graced  
with cat food and cat  
feces.

The kitchen sink.

And the fridge? !!!!
