# Former Holy Name School and Convent Evaluation for Use as New Catholic Charities Office Building 8-29-19

# Former Holy Name School Building 3

# Former Holy Name Convent – Building 4

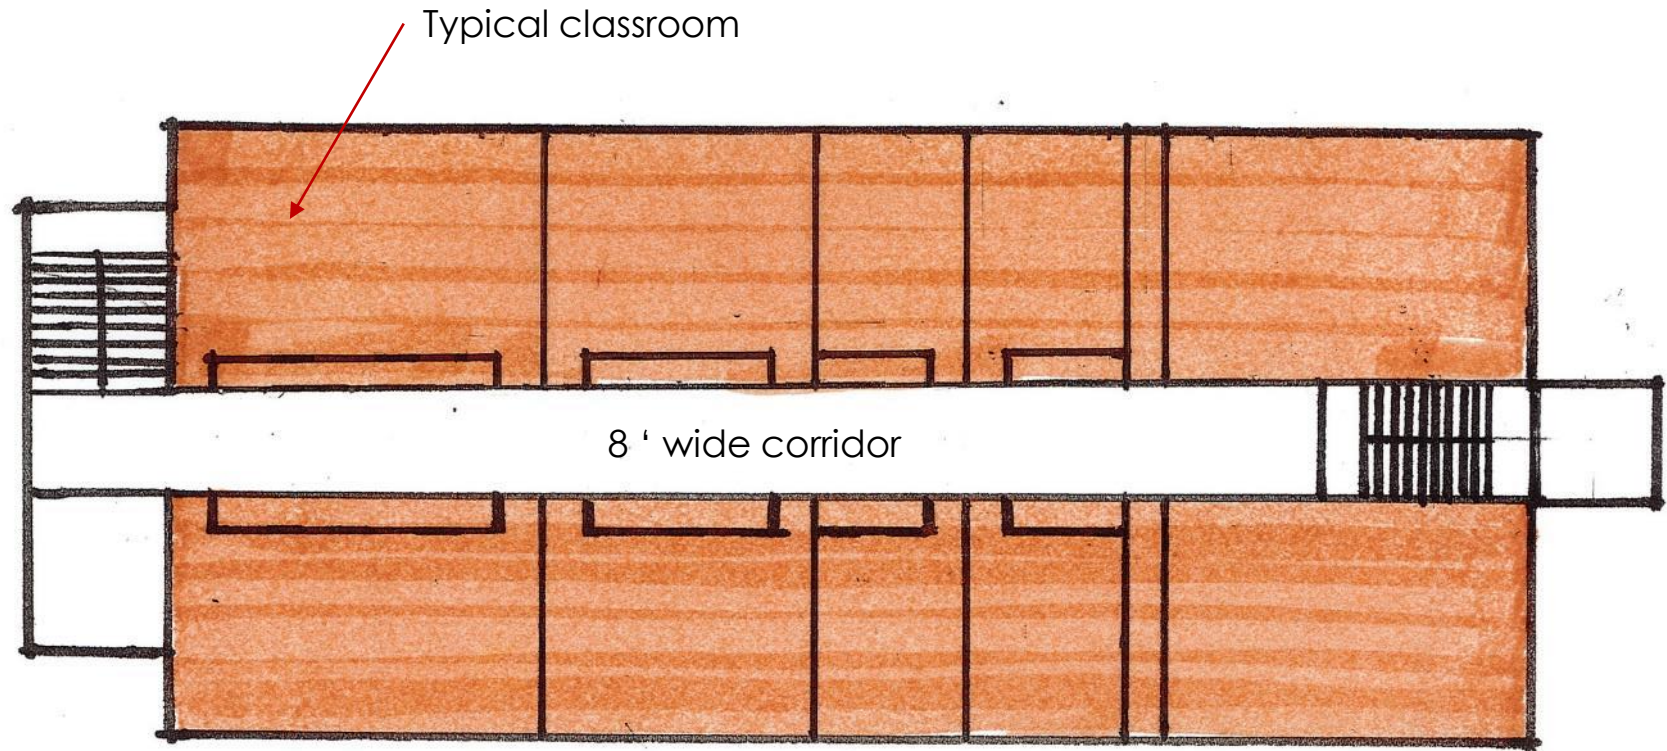
- Existing building has 8 foot wide central corridor

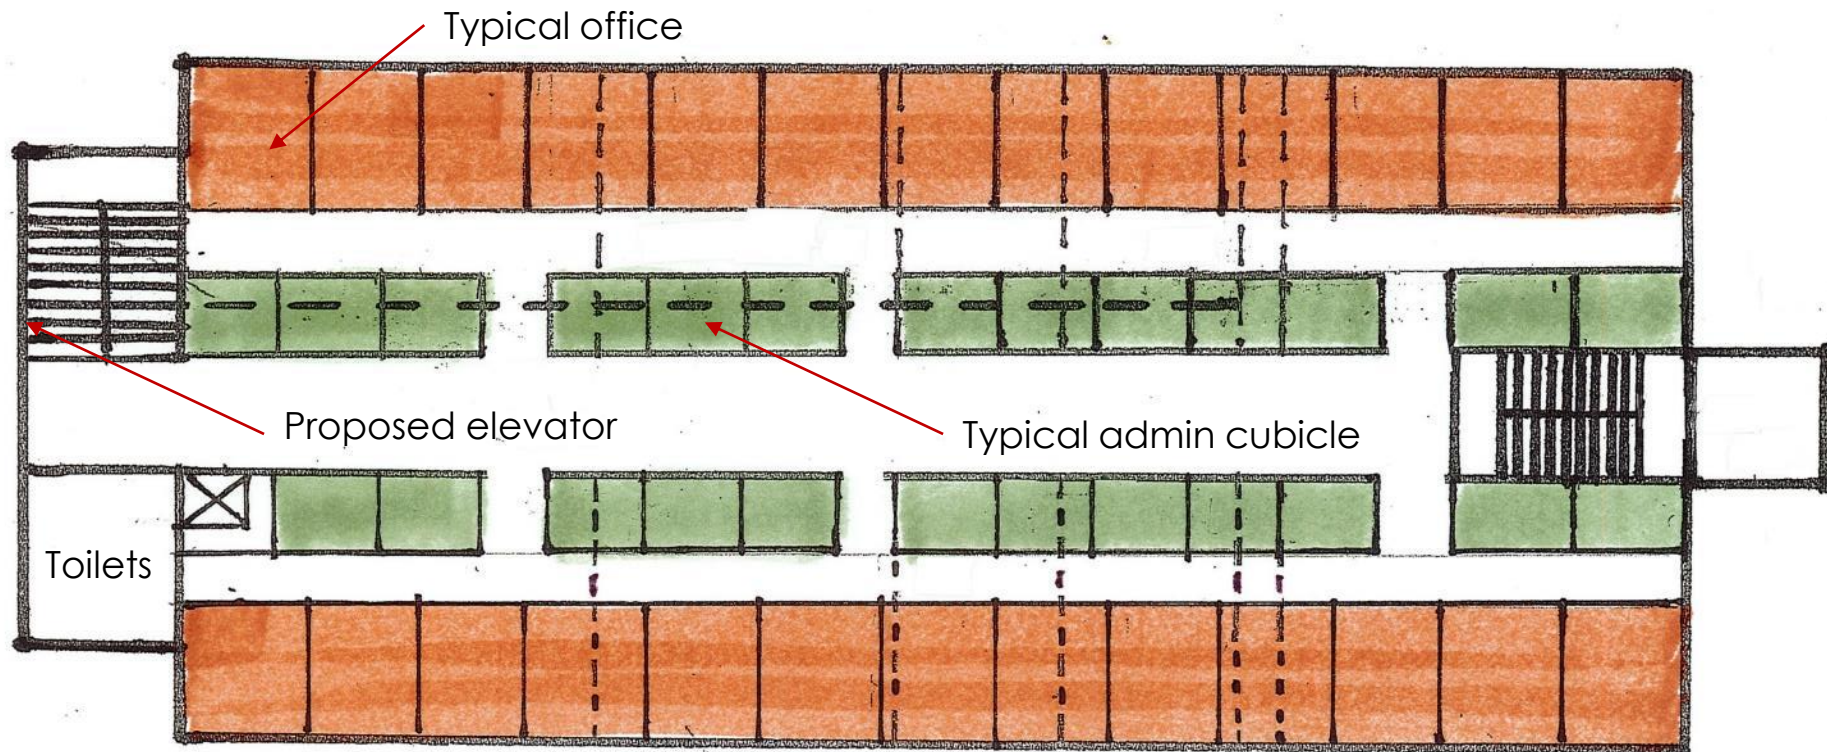
- Inefficient office plan – excessive corridors & wide stairs – Center corridor is 1760 sf unusable space.
- Basement is not usable, reducing usable space from 25,524 sf to 17,016 sf. Will need a 12,305 sf addition

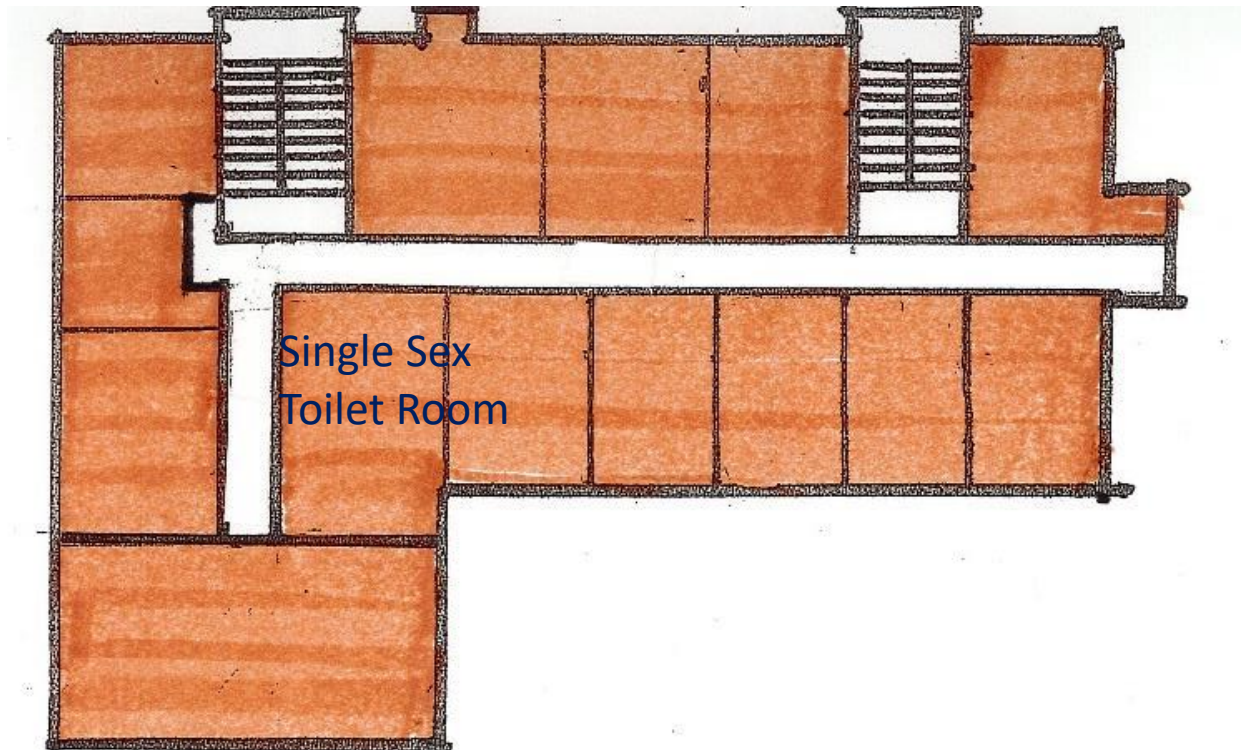
- Central hallway / cell configuration is not conducive for Manager / Admin flexible modern office layout
- Very small footprint of 3644 sf x 3 stories = 10,932 sf – will need a 18,389 sf addition
