RE: Economic Hardship Exemption to 19DESIGNATION1000  
Catholic Charities Headquarters Building  
Holy Name Property – 2911 South 4<sup>th</sup> Street

## **Former Holy Name School and Convent Evaluation for Use as New Catholic Charities Office Building Headquarters**

Draft August 22, 2019

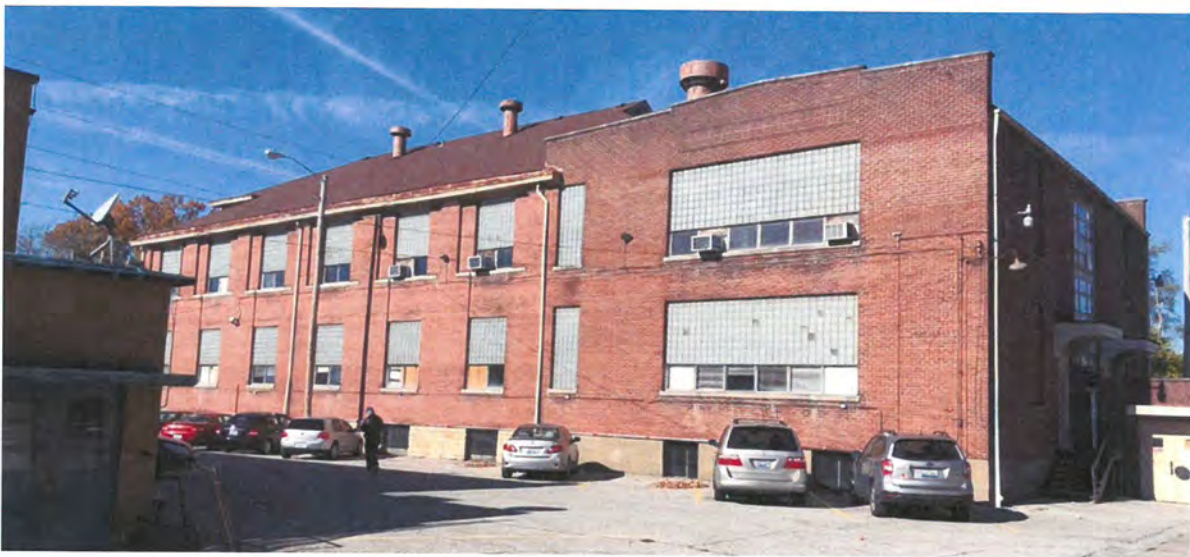
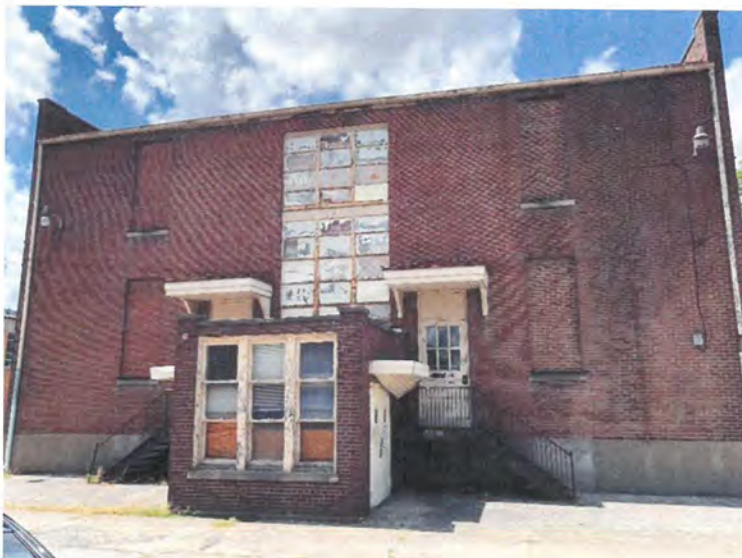
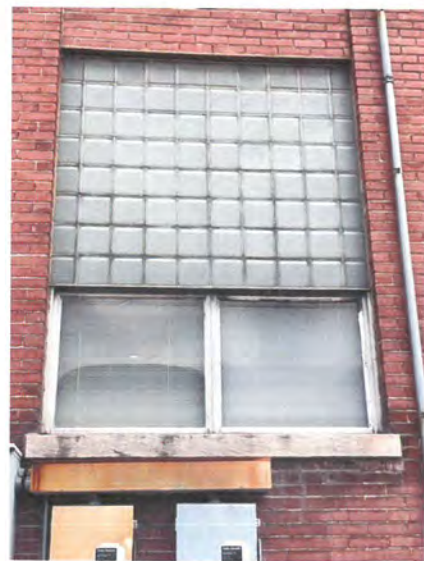
**Building Addition:**

As previously mentioned, a 3 story 7,638 addition was added to the original building. As part of the addition, the double hung windows were replaced with glass block at the upper 3/4 portion of the window, and hopper windows at the lower 1/4. The addition is in the same building plane (no recess) as the original building, and has a flat roof as opposed to the pitched standing seam metal roof. The rear of the building or east elevation has a window pattern totally different than the sides and front. If this design for an addition was to be submitted today to NPS, it would most likely not be approved because it violates their requirements for an addition to a historic structure. Therefore we believe the exterior of the building's original design has been significantly altered and is of low integrity.

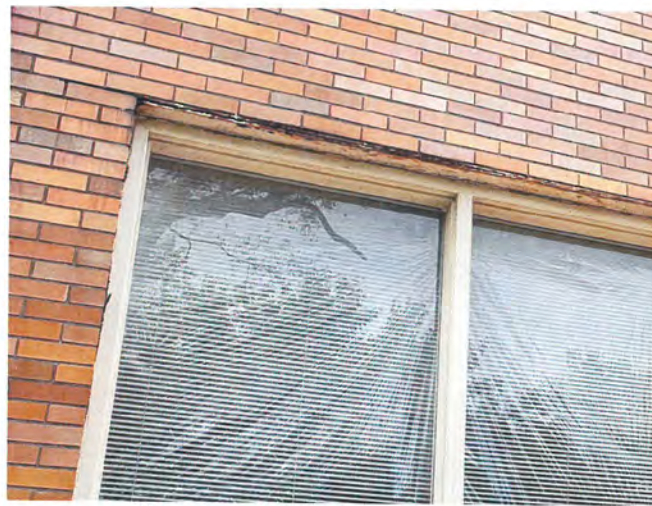
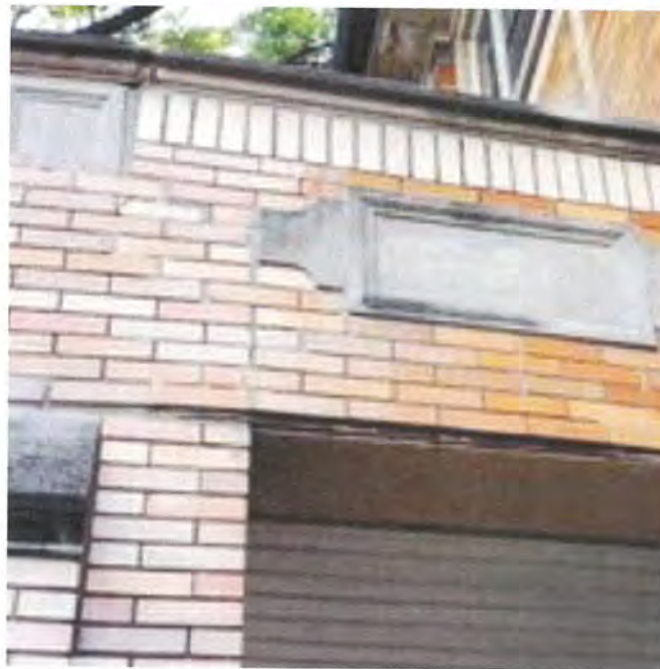
The building needs new windows, HVAC, electrical, finishes, toilets, elevator, roof and gutters, repointed masonry, plus ADA, Energy Code, and other life safety updates. The structure has numerous cracks and rust jacking at the exterior lintels. ICON engineering has done an evaluation ( see attached report) describing these issues. They have also done preliminary calculations and determined that the building's structural system is not adequate to support a change in occupancy to Business floor loading. Furthermore, the existing masonry bearing wall system is inadequate to resist current seismic and wind loads. Structural bracing must be added to the walls for seismic and wind loads and intermediate beams , columns, and foundations need to be added to accommodate the new the floor loads.
